Ballater Flood Protection Study

Defence Condition Survey

April 2018

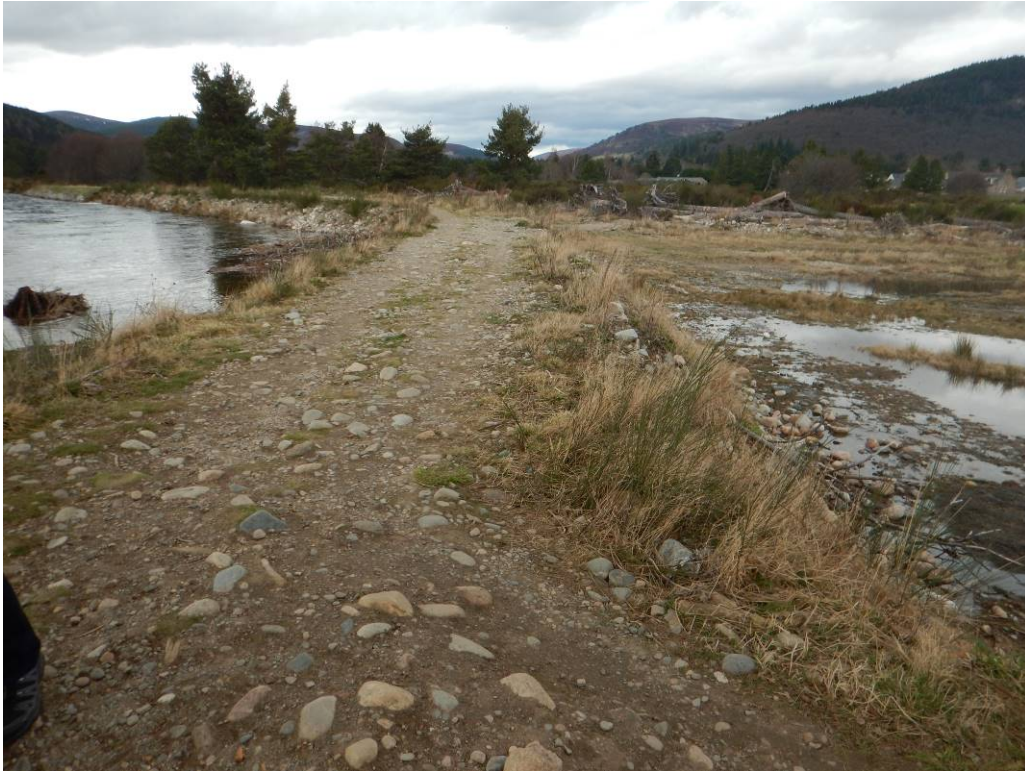
Plate 1: Embankment at south end of Golf Course looking NW

The embankment between 36617,95012 and 36465,95159 was observed to be constructed of river bed material and the observed lack of significant vegetative cover indicates this to be of relatively recent construction. The extensive cover of deposited cobble and gravel on the land behind this section of the defences, shown in Plate 3, was considered indicative of a recent breach and extensive inundation by flood waters. This observation was further reinforced by the presence of extensive tree debris within the forested area to the east of this defence as shown in Plate 4. The embankment in this area stands between 1.5 and 2m above the ground behind with a crest width of 2-3m.

This section of the Ballater flood defences was assessed to be in **Fair** to **Poor** condition on account of the steep faces of the embankment and the lack of significant stabilising vegetation.

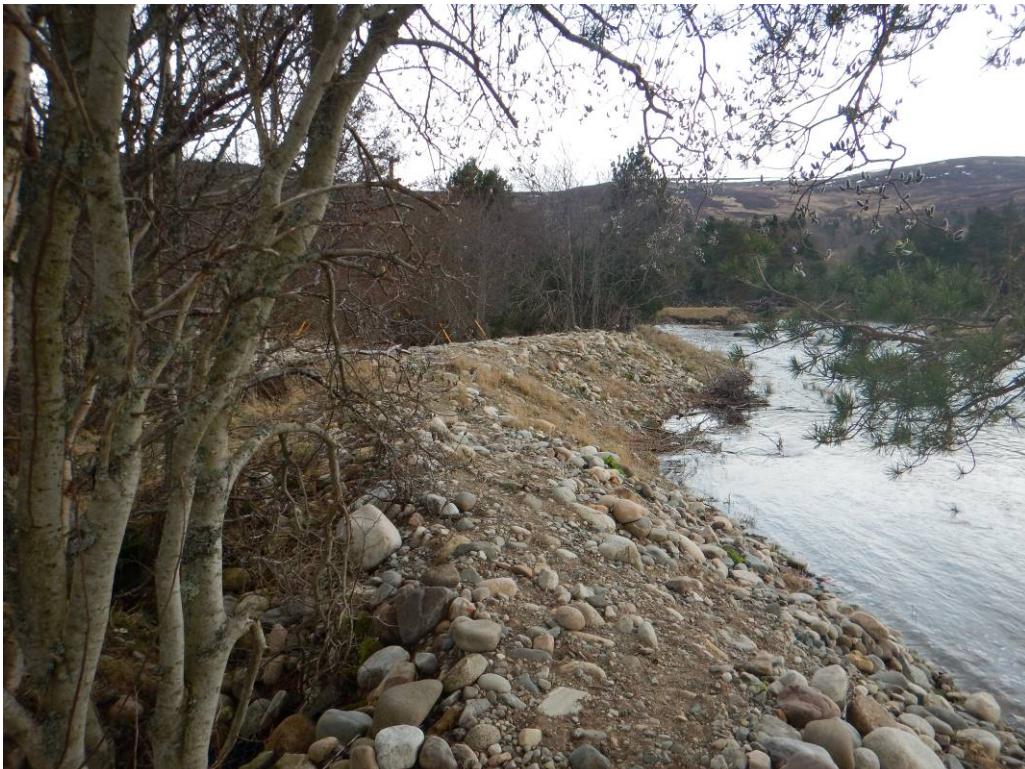
Plate 2: Embankment at south end of Golf Course looking SE

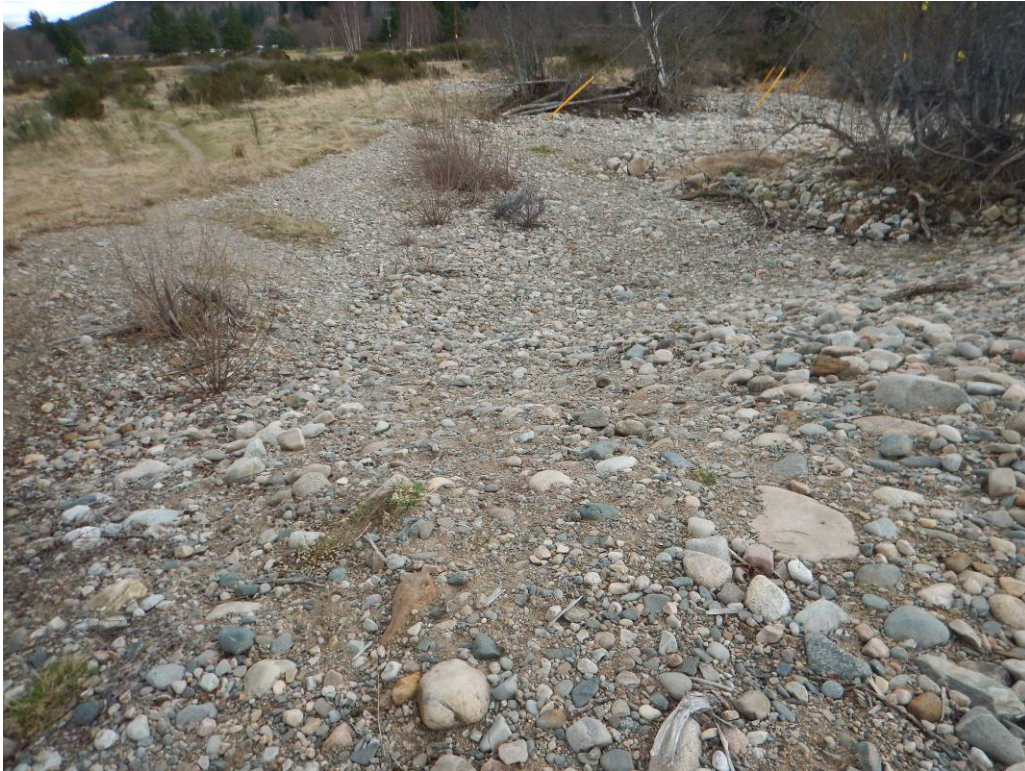
Plate 3 View from embankment at south end of Golf Course looking towards Caravan Park

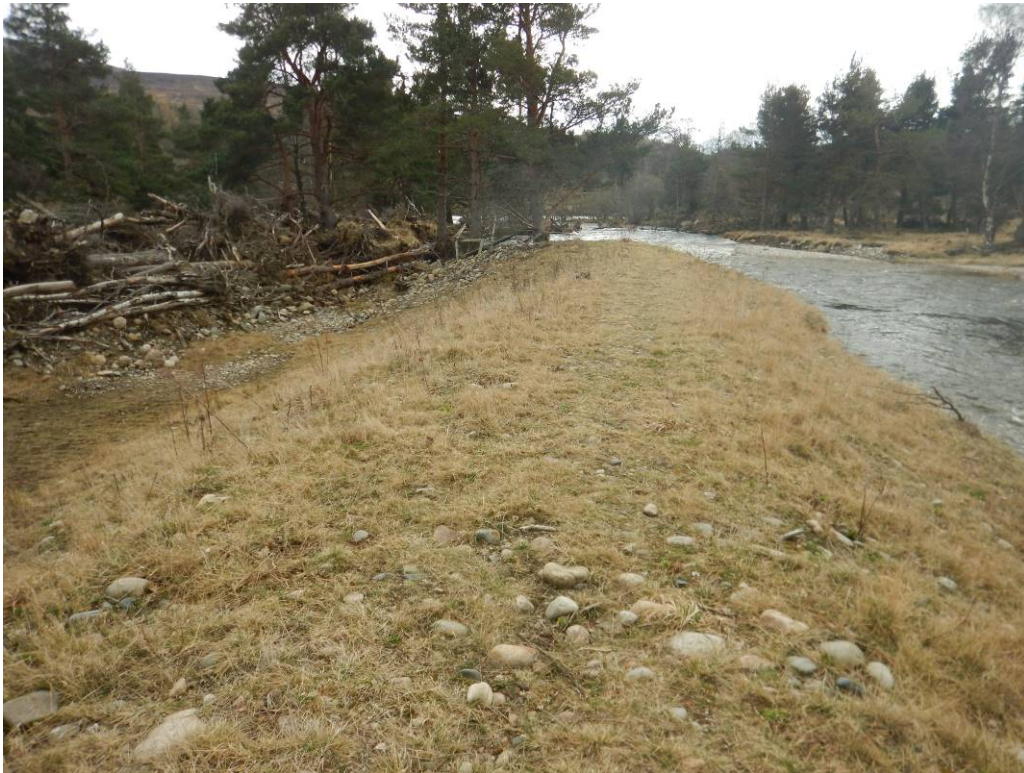
Plate 4: Tree debris behind the defences at the south end of the golf course

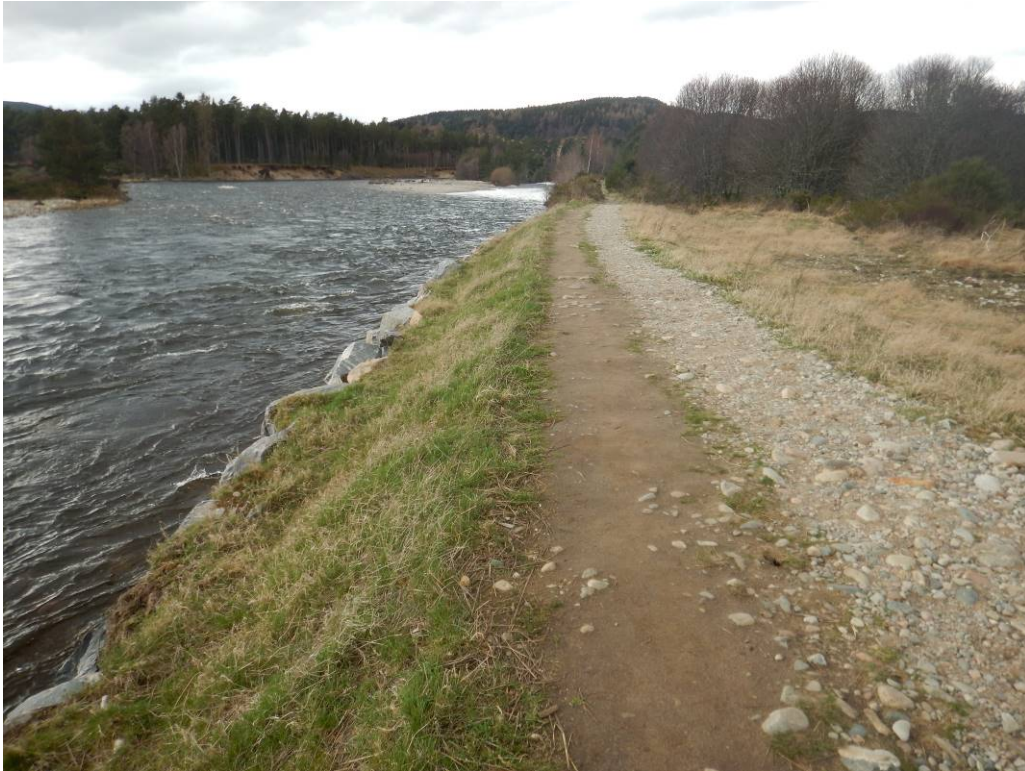
Continuing north-westward along the embankment the formation changes to incorporate a boulder toe on the river side as shown in Plate 5. This form of construction extends from 36465,95139 to around 36323,95186 beyond which the boulder toe ceases although erosion protection is provided by a vegetated bank of river deposits. It was part of this section of the embankment that was the subject of the repairs Aberdeenshire Council undertook in 2016.

Plate 5: River side embankment with boulder toe

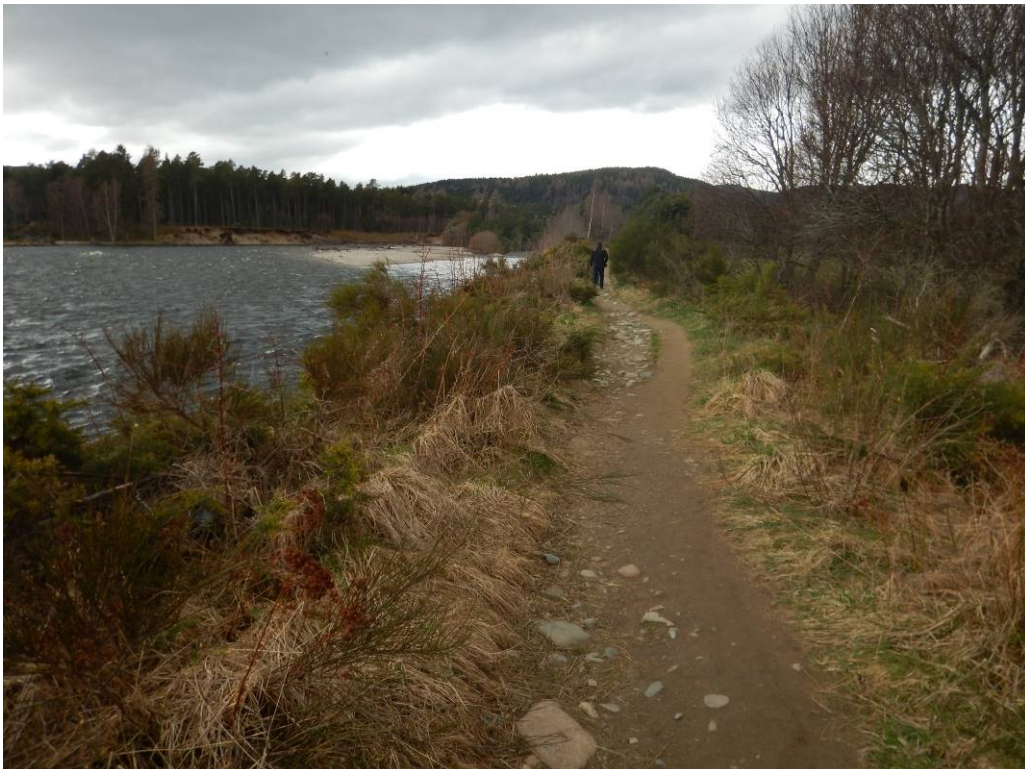
The core of the embankment appears to be composed of a mix of cobble, gravel and sandy soil, potentially river bed material, however it is significantly more heavily vegetated than the embankment to the south, as shown in Plate 6. The ground to the rear of this section of the embankment was noted to be significantly higher than to the south with the embankment height being observed to be circa 1m with a similar crest width to the previous section of the embankment. There was no significant evidence of the deposition of material on the ground behind or of recent breach/over-topping of this section of the embankment. In general this section of the embankment was classified as being in **Good** condition.

Plate 6: Vegetation on section of embankment with boulder toe

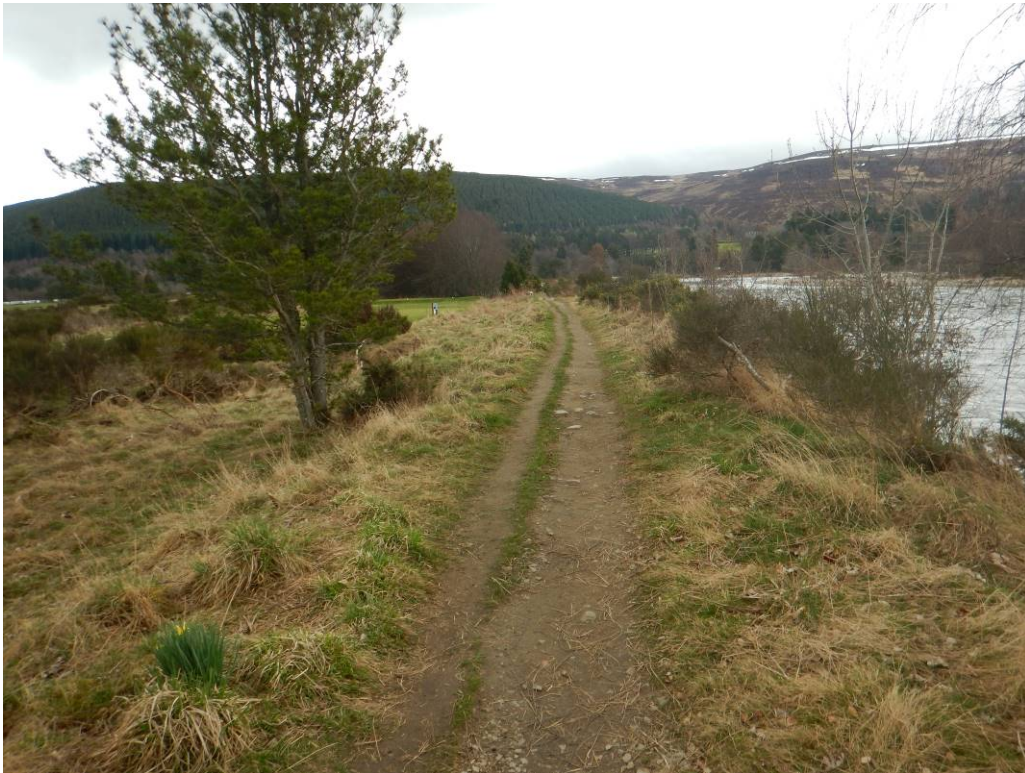
Continuing westwards the embankment remains in **Good** condition, Plates 7 and 8, until approximately 36133,95261 where the river side face was observed to be partially eroded, Plate 9. This was considered to most likely be due to pedestrian activity given the very localised nature of the erosion although it is possible that it was the result of the removal of a large tree and root system during recent floods. However the damage is such that this localised section was assessed as being in **Poor** structural condition due to the exposure of the core material.

Plate 7: Typical view of embankment beyond Golf Road

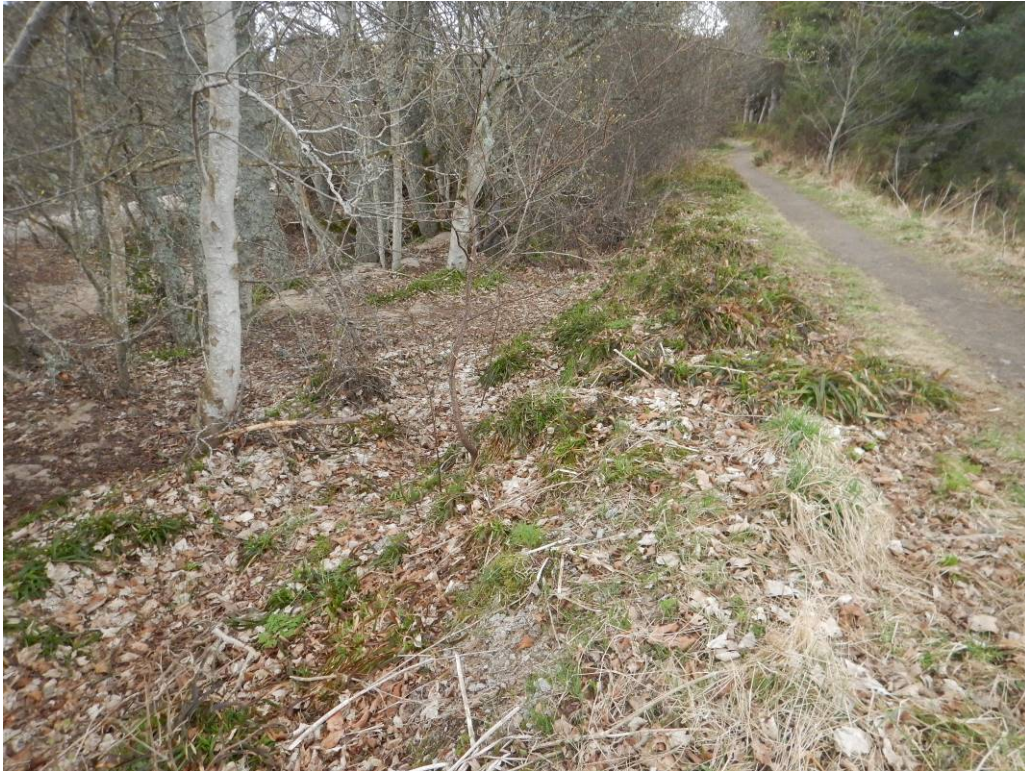
Plate 8: Typical view of embankment

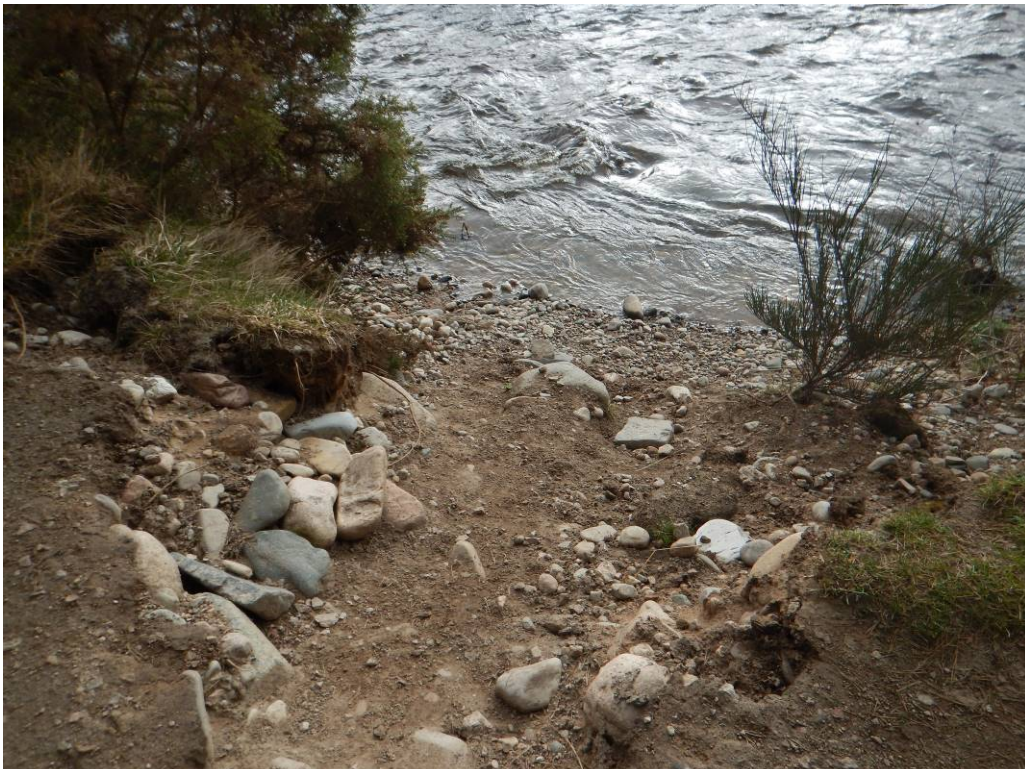
Plate 9: Partial breach of embankment at 36133,95261

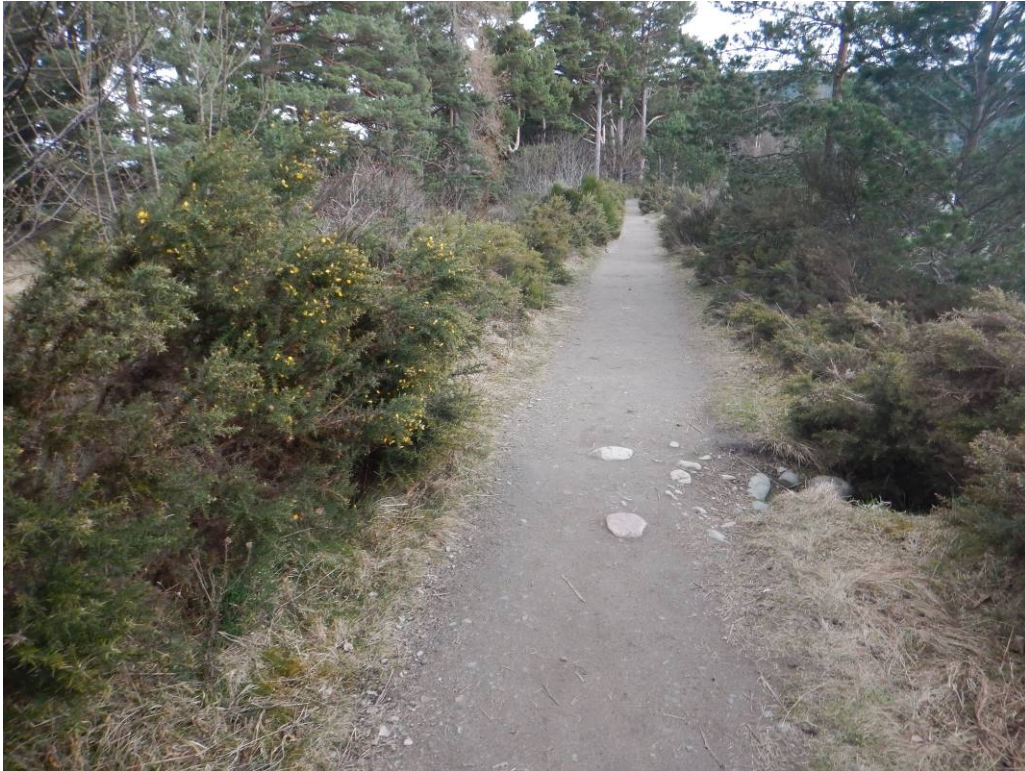
The embankment continues in a similar form with extensive vegetation, including mature trees evident until circa 36000,95275 as shown in Plates 10 and 11.

Plate 10: Pathway on embankment crest

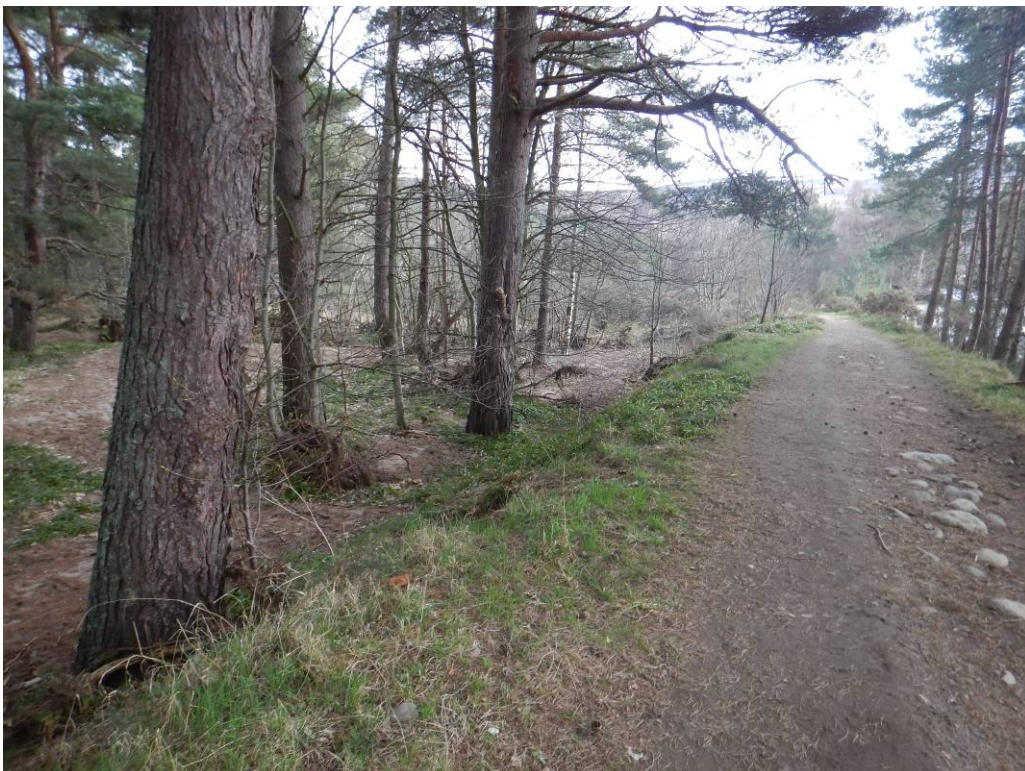
Plate 11: Mature trees both sides of embankment

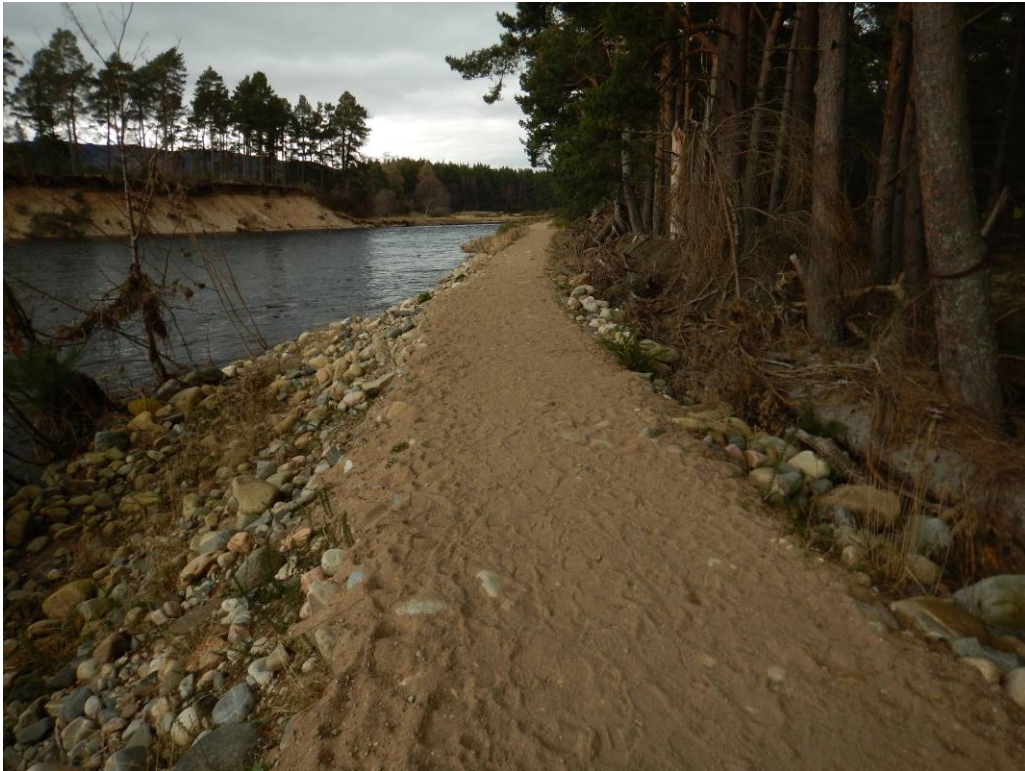
Beyond 35005,05316 the embankment appeared to have been recently re-constructed, re-profiled using sand and gravel as shown in Plates 12 and 13. These works appears to be in response to the

Plate 12: Re-profiled embankment

This condition of the repaired section of the embankment was classified as being **Poor** to **Very Poor**, principally on account of the nature of the material used and the lack of vegetative cover to resist erosion and hold the material in place. It is likely that over time vegetation would establish on this section of the embankment, however even with this in place the condition grading is unlikely to be better than Fair.

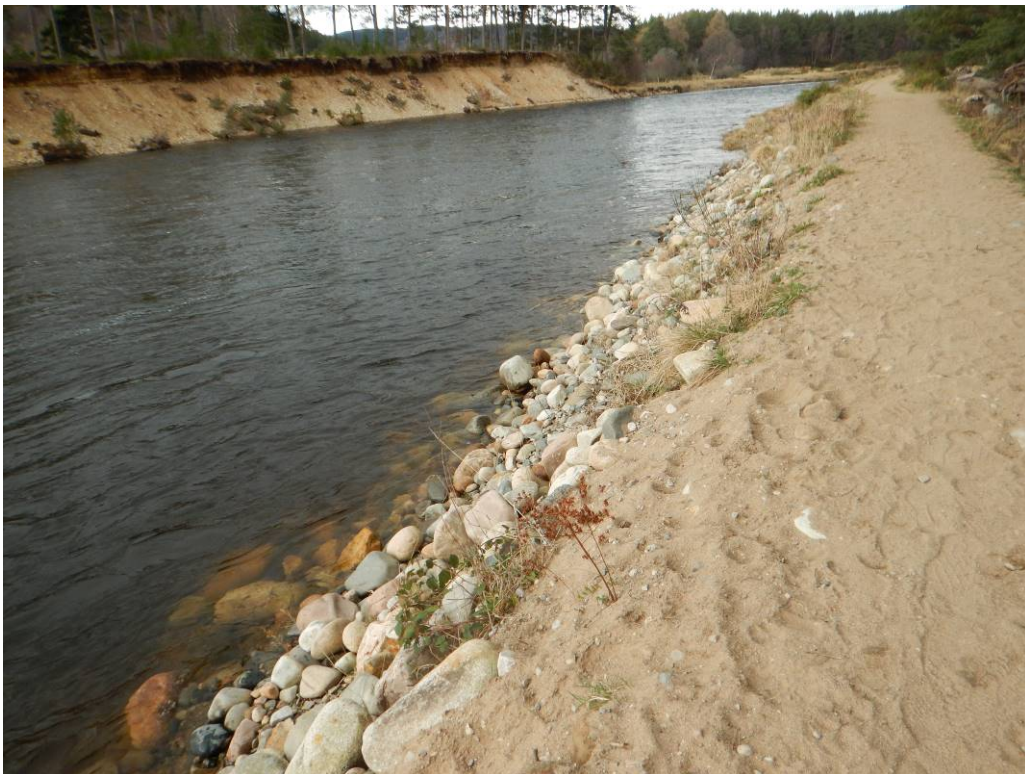
Plate 13: Un-vegetated face of re-profiled embankment

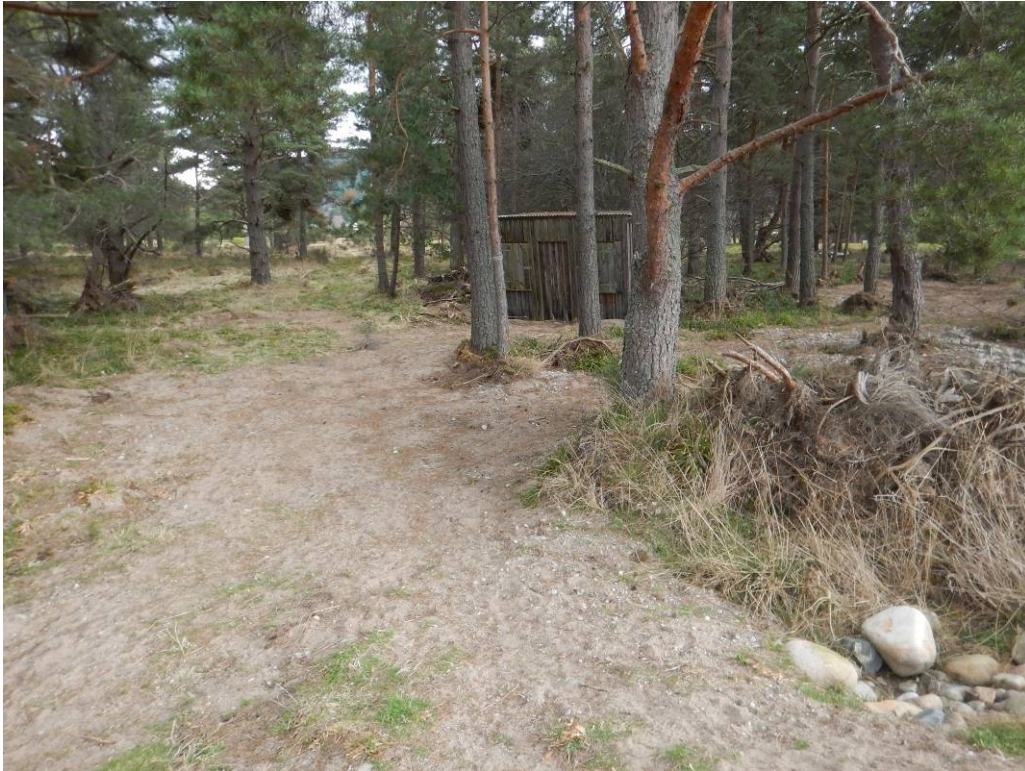
previous embankment having been over-topped as evidenced by the present of riverine detritus and debris scattered amongst the forest area behind, Plate 14.

Plate 14: Riverine deposits behind embankment, including former fisherman's hut

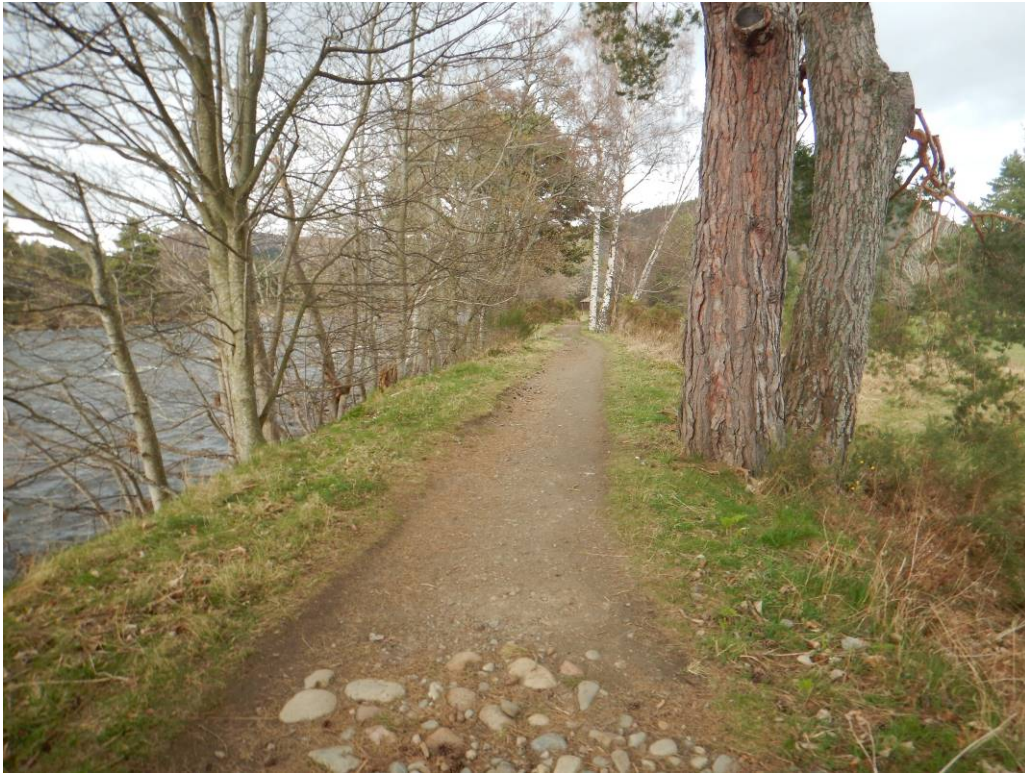
The repairs / re-profiling of the embankment continues with some brief interruption to circa 35958,95482 beyond which it reverts to a similar vegetated form to the previous sections although in this area there was more exposed cobble noted on the river side, Plates 15 and 16. It was not obvious from the visual inspection if this was the remnants of a deliberate attempt to armour the exposed face of the embankment or simply the results of selective erosion having removed much of the finer material, however the embankment appeared relatively stable as evidenced by the presence of mature trees growing out of the river facing slope. The embankment continues in this form, Plate 17, until the 14th Tee.

This section of the embankment was assessed to be in **Good** condition at the time of the site inspection.

Plate 15: Typical view of embankment south of the 14th Tee

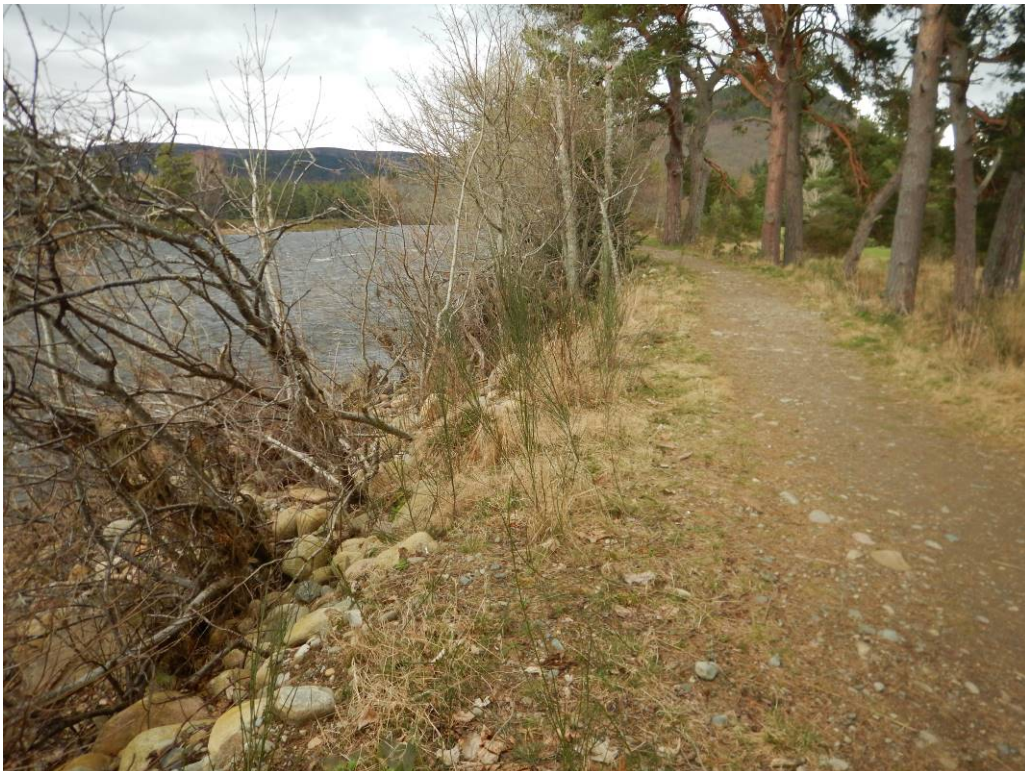
Plate 16: Embankment south of the 14th Tee showing exposed cobble

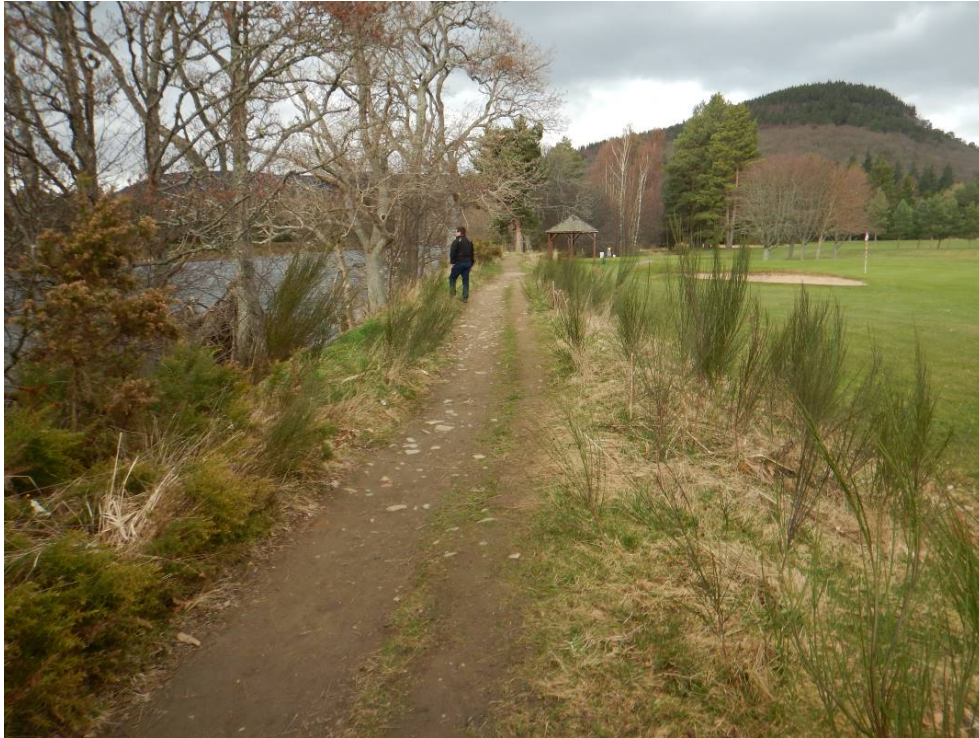
Plate 17: View of embankment approaching 14th Tee

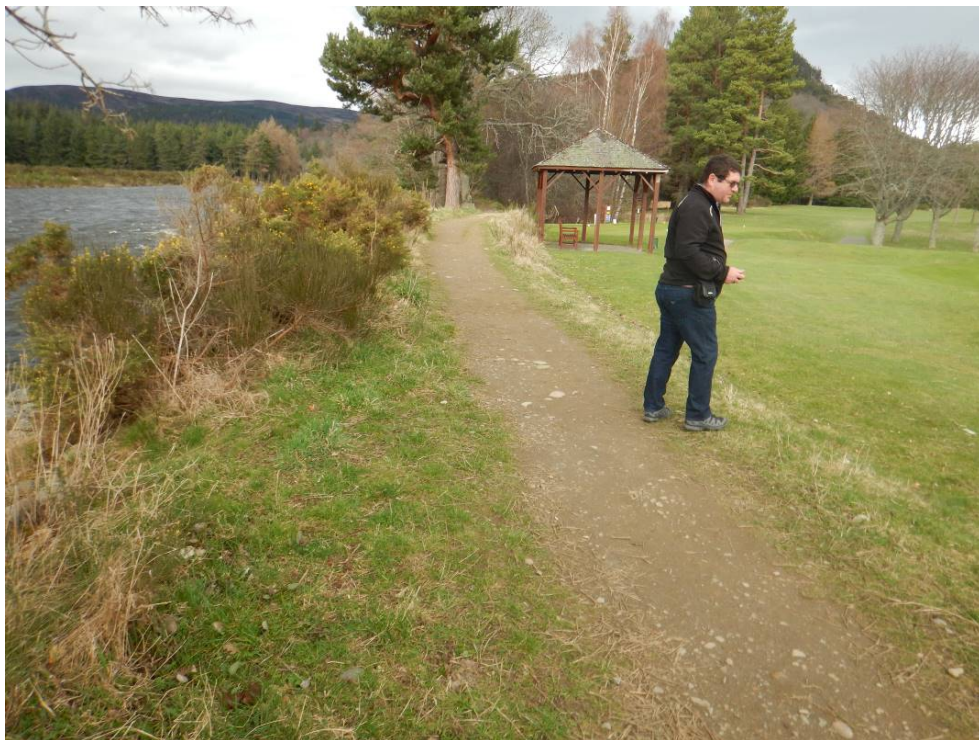
Alongside the 14th Tee there was a noticeable gap in the presence of mature vegetation on the embankment, Plate 18. It is not known if this is a result of deliberate vegetation management or the consequence of a reported breach during storm Frank.

Plate 18: Scrub vegetation on embankment at 14th Tee

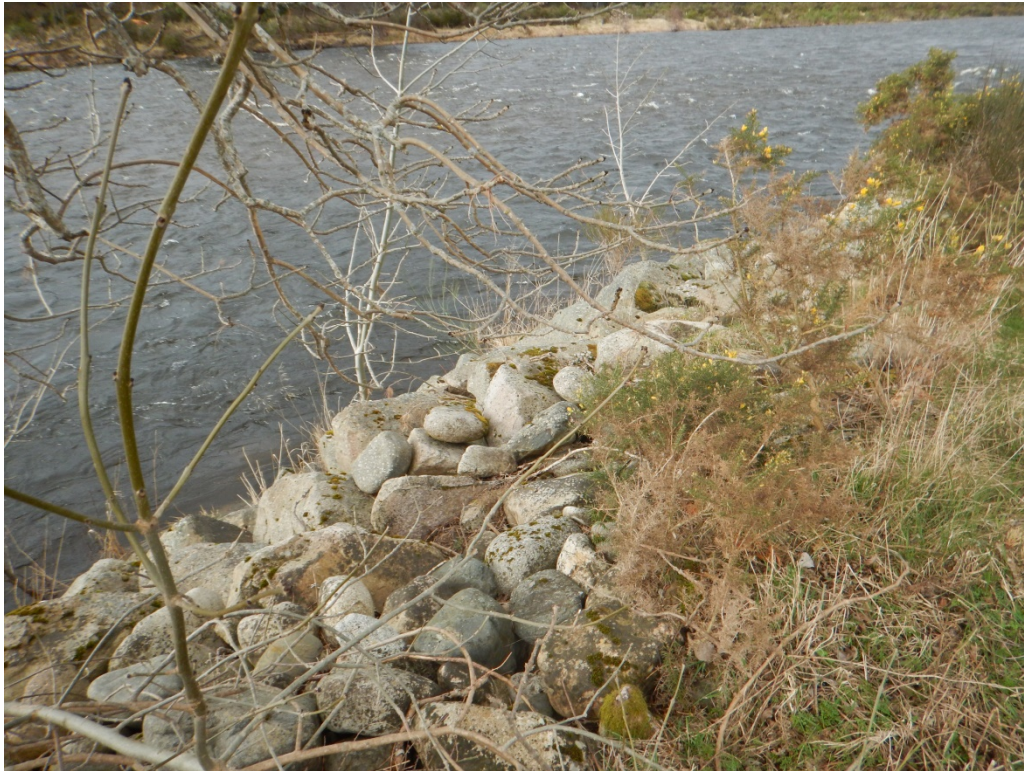
Irrespective of the reason for this lack of mature vegetation the riverside face of the embankment was observed to be “armoured” with exposed boulders and cobble as shown in Plate 19, which was assessed to be in Good condition. There was no evidence of armouring on the landward face and the vegetation cover was limited to grass, but again this would warrant a **Good** classification.

Plate 19: Exposed cobbles/boulders on river side of embankment at 14th Tee

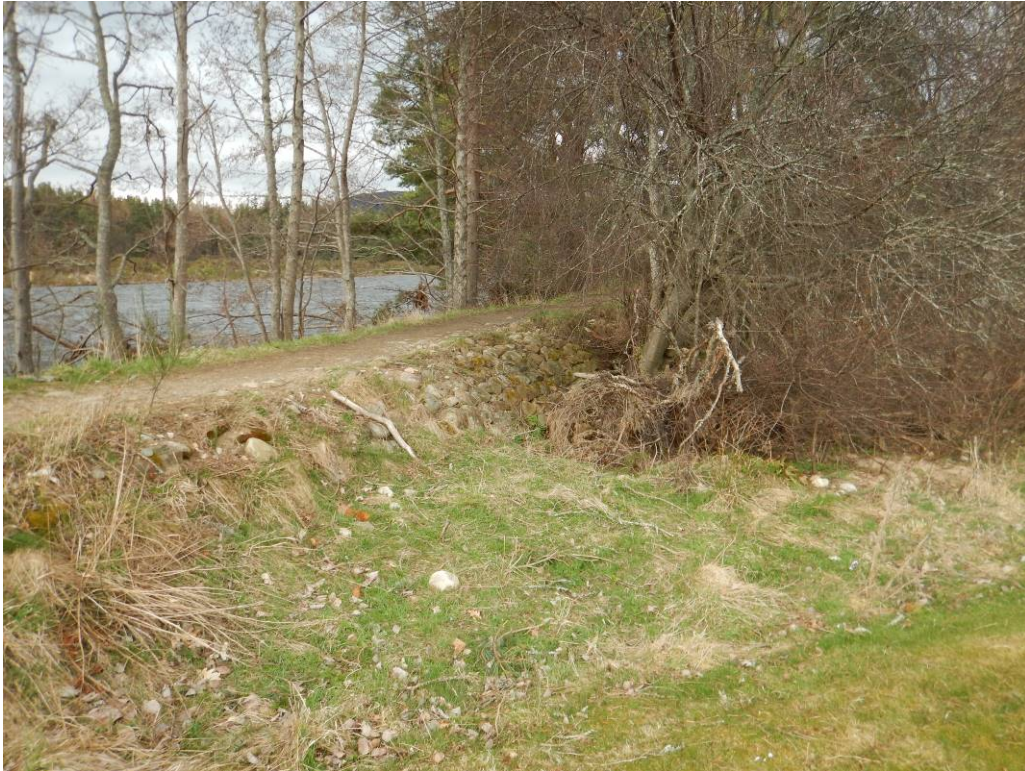
Immediately north of the 14th Tee the landward face of the embankment was composed of built masonry as shown in Plate 20. This form of construction may also have extended to the riverside face, however it is now interrupted by the establishment of mature trees and other vegetation as shown in Plate 21. Generally this section of the embankment appeared to be in **Fair** condition.

Plate 20: Masonry revetment to rear face of embankment north of 14th Tee

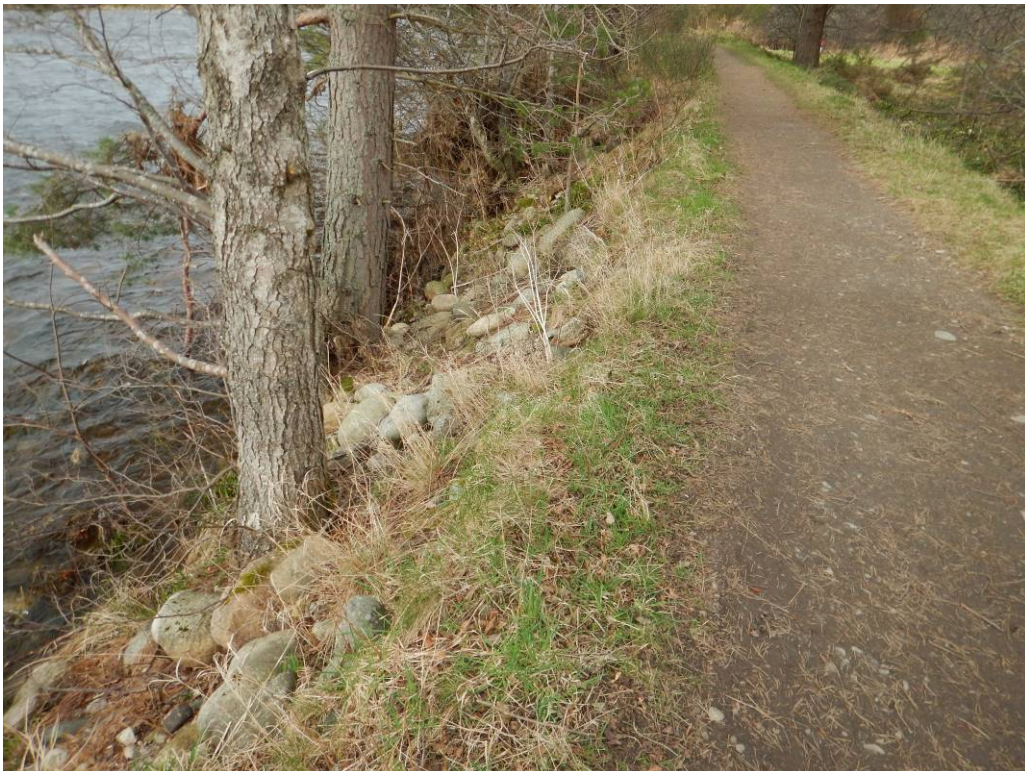
Plate 21: River face of embankment north of 14th Tee

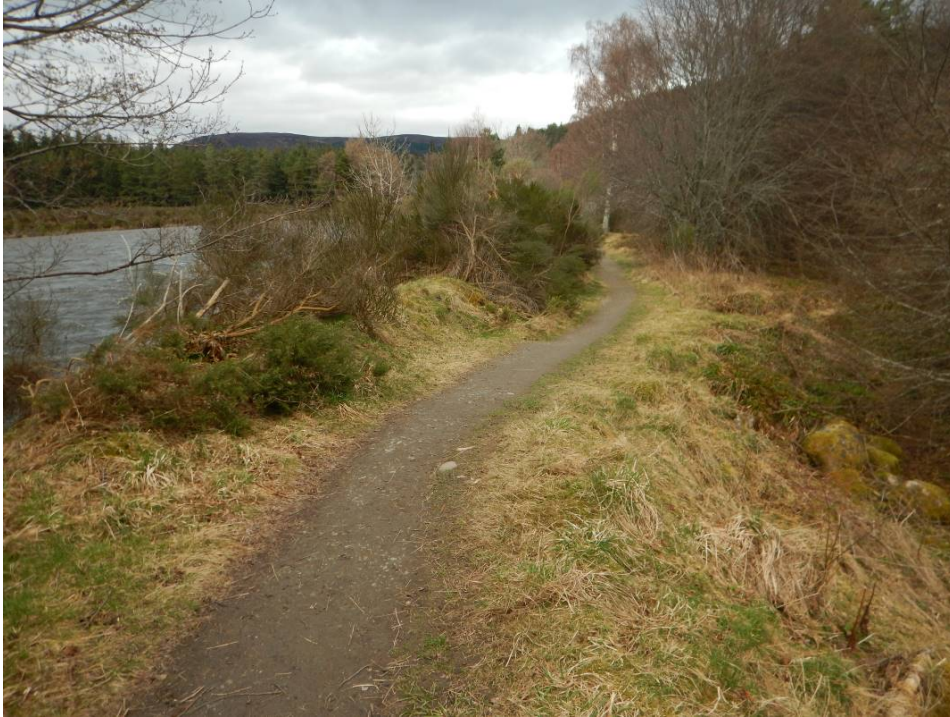
North of approximately 36020,95756 the riverside path drops off the crest of the embankment to run along the ground behind the embankment as shown in Plate 22 and continues like this until circa 36034,95854. The embankment along this section comprised a narrow bank approximately 1.2-1.3m high with no significant crest, Plate 23.

Plate 22: Transition of riverside path from top of embankment to land behind

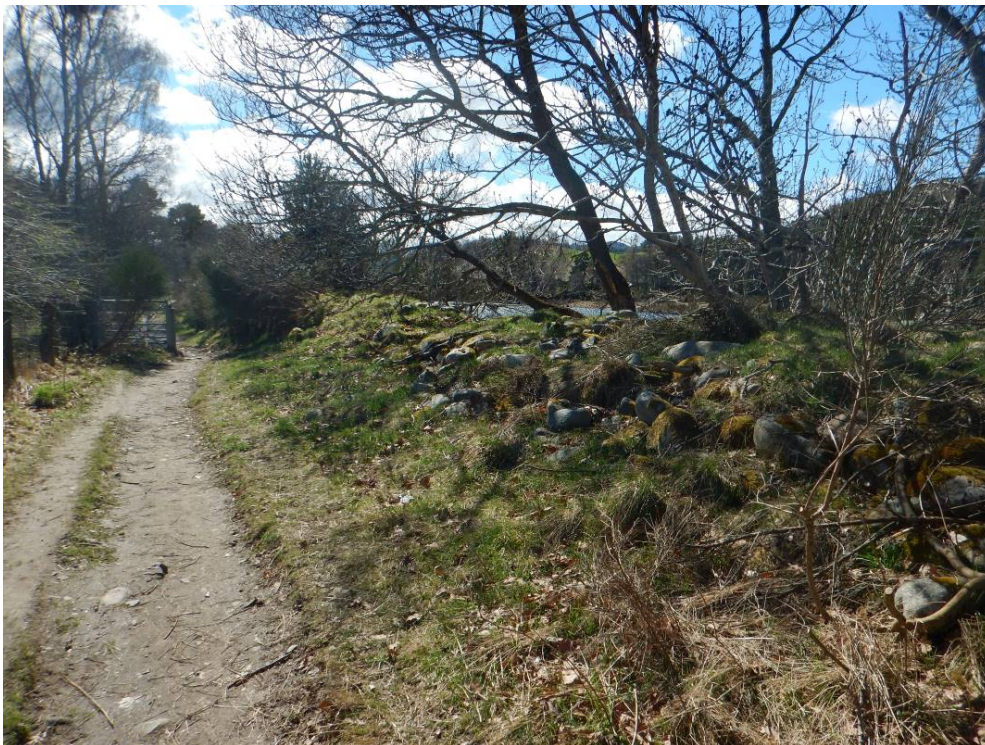
Plate 23: Typical view of embankment north of 36020,95756

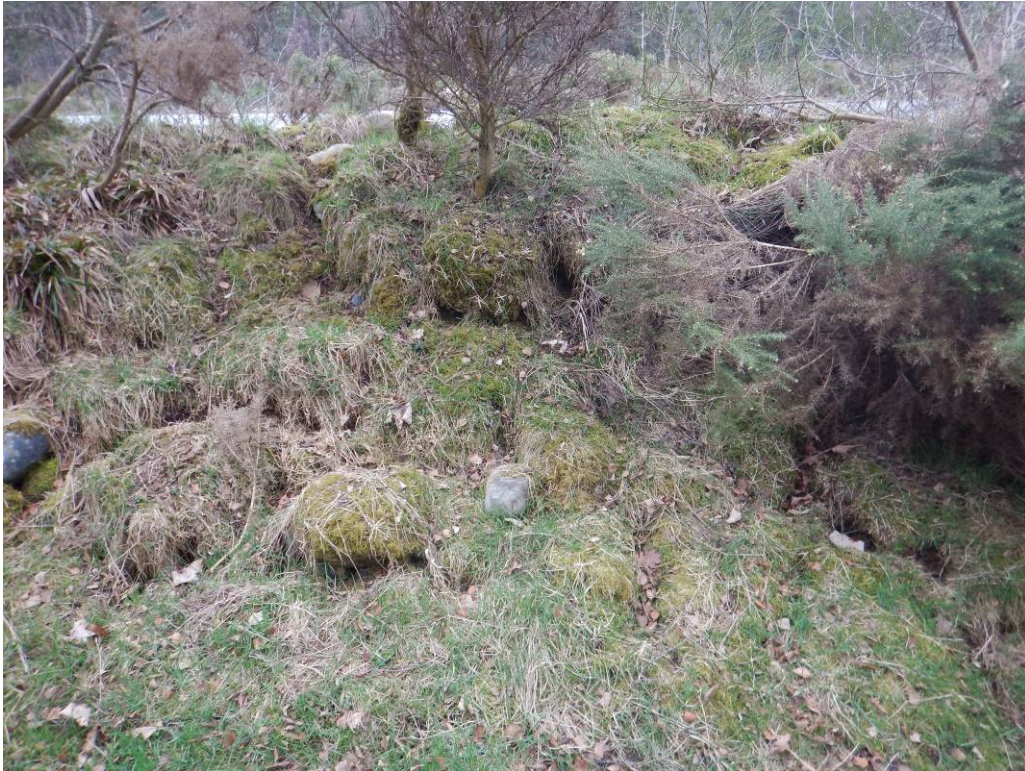
This embankment appears to be formed of a pile of predominantly cobble and while vegetated there were numerous holes visible as shown in Plate 24. These holes did not show any clear evidence of being animal burrows and are thought to be related to the makeup of this structure being predominantly large cobbles and boulders with little fine material. The structure was assessed as being or **Poor** condition.

Plate 24: Holes in raised embankment

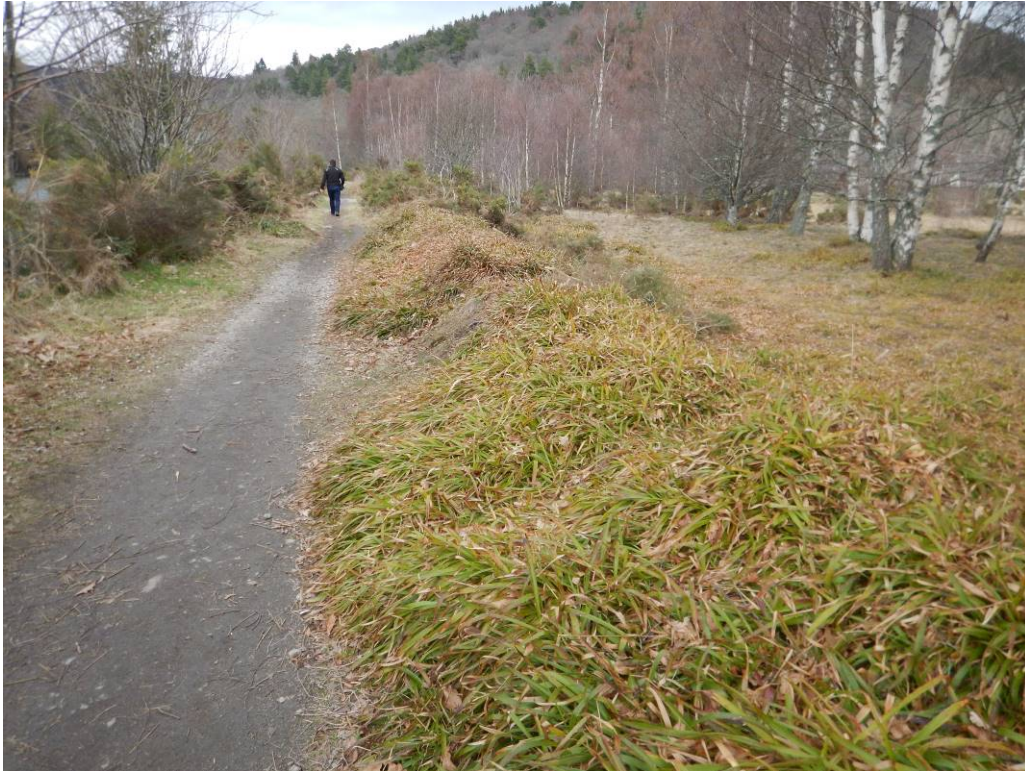
North of approximately 36034,95854 the path again re-joins the riverbank with a low “embankment” running along the landward side of the path as shown in Plate 25 as far as 36049,95965 beyond which no form of flood defence was observed. This structure was noted to be circa 0.5m in height with a similar crest width and was assessed as being in **Good** condition.

Plate 25: **Low embankment on landward side of path**
