BALLATER ADDITIONAL FLOOD STUDY

Defence Condition Inspection

IBE1982_Rp001
D01
30 March 2022

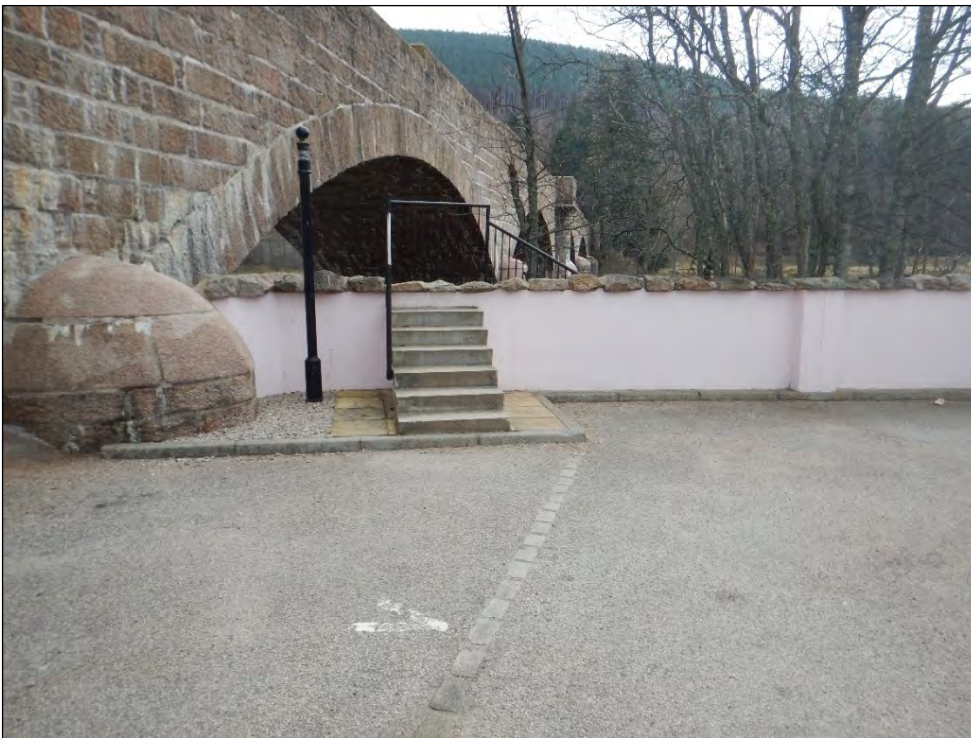
It was noted that a wall alongside the river immediately upstream of the Royal Bridge, not noted in the 2018 inspection appears to provide flood protection to residential properties at Cornelian Square as shown in [Plate 1](#) and [Plate 2](#). This wall appeared to be of relatively recent construction and to be in **Good** condition. Access to the riverside path is facilitated via steps over the wall as shown in [Plate 1](#).

Plate 1 View of rear face of wall at Cornelian Square (2022)

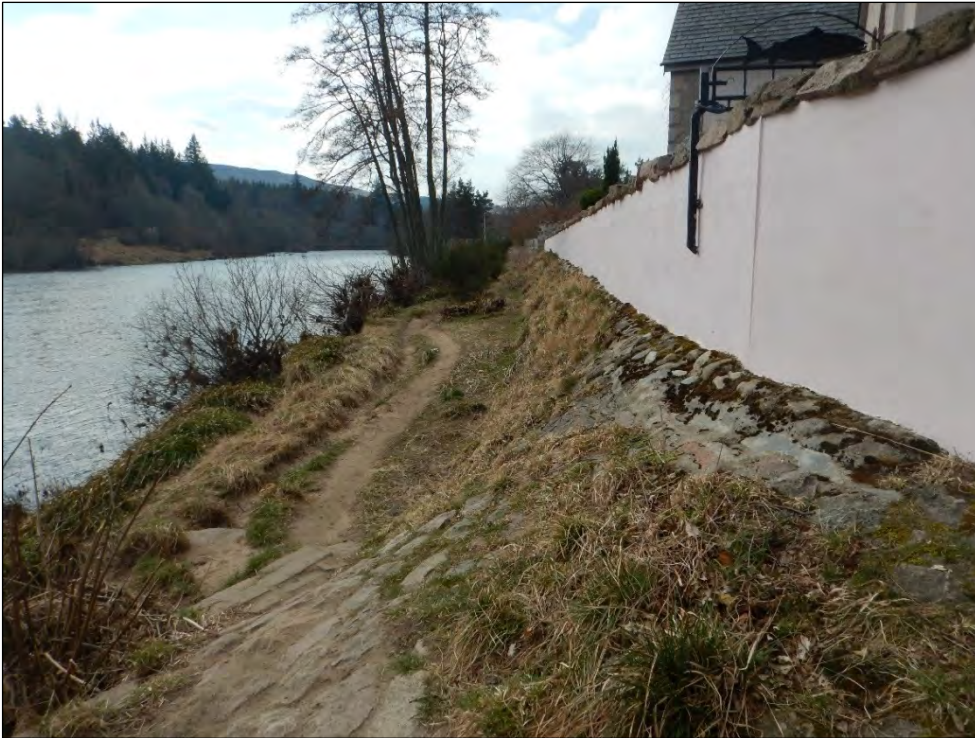
Plate 2 View of riverside face of wall at Cornellian Square (2022)

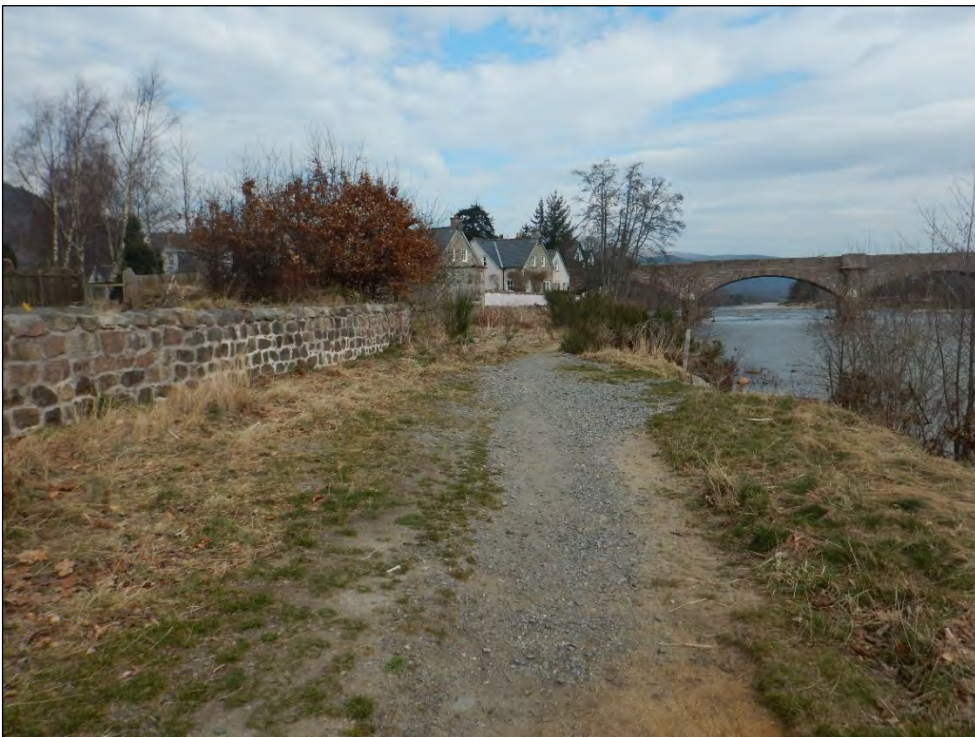
Further upstream, to the south of Cornellian Square, the wall type changes to an older wall of slightly lower height as shown in Plate 3. This wall also appeared to be in **Good** condition, with no obvious defects visible.

Plate 3 Overview of walls upstream of Royal Bridge (2022)

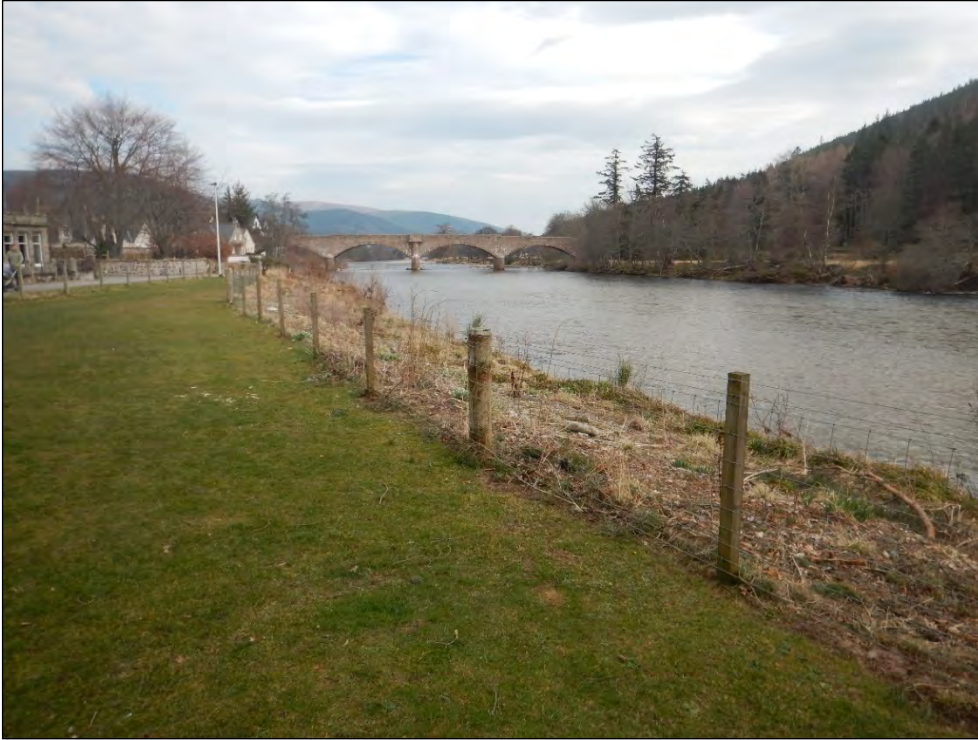
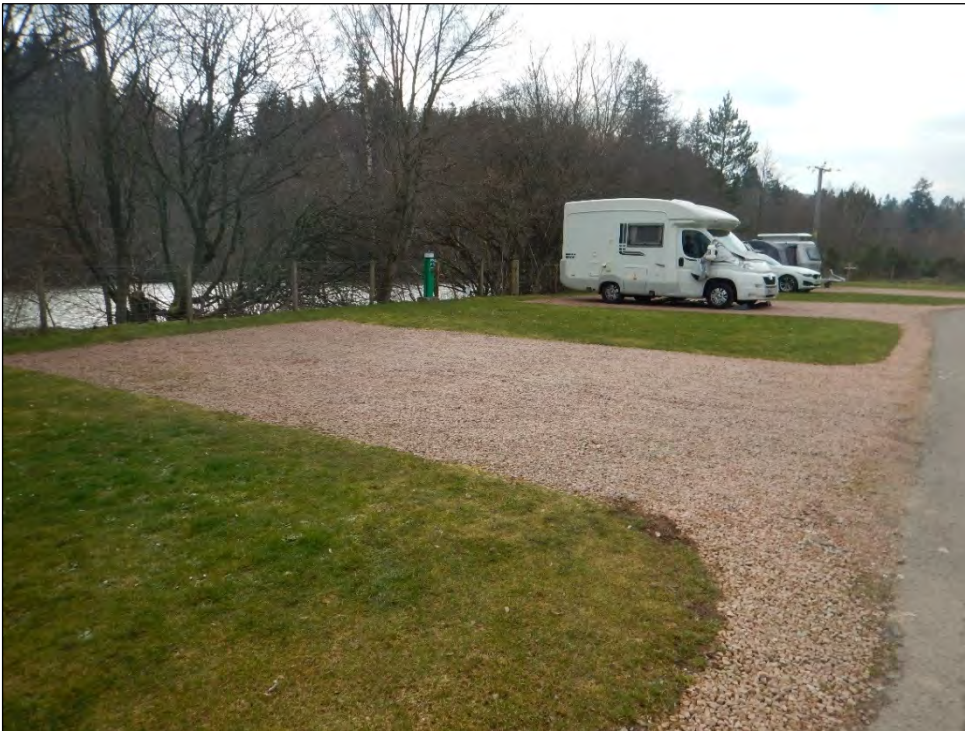
Upstream of Dee Street, no evidence of any raised embankment or other flood defence structures were observed at the Caravan Park, as shown in [Plate 4](#) and [Plate 5](#).

Plate 4 Riverbank upstream of Dee Street (2022)

Plate 5 Riverbank at Caravan Park (2022)

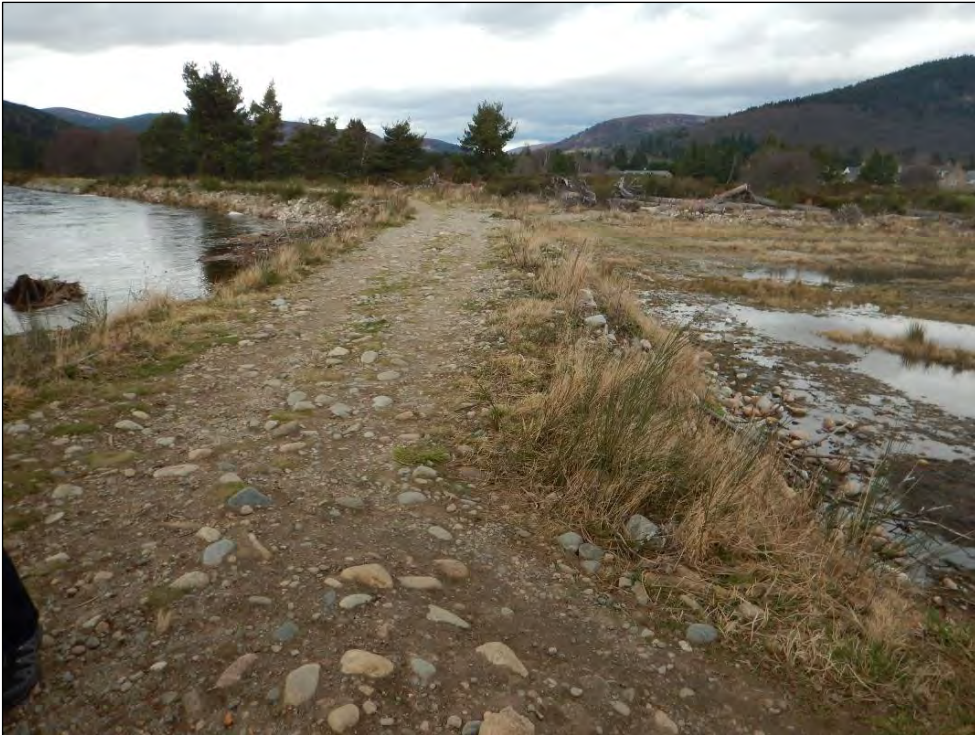
During the 2018 inspection a flood defence embankment was encountered at Grid Reference 36549,95086, see [Plate 7](#), extending upstream along the bank of the River Dee until circa grid reference 36049,95965. In 2018 the embankment between 36617,95012 and 36465,95159 was observed to be constructed of riverbed material and the observed lack of significant vegetative cover indicated this to be of relatively recent construction. The embankment in this area stood between 1.5 and 2m above the ground behind with a crest width of 2-3m. This section of the Ballater flood defences was assessed to be in **Fair** to **Poor** condition in 2018 on account of the steep faces of the embankment and the lack of significant stabilising vegetation.

Plate 7 **Embankment at south end of Golf Course looking NW (2018)**

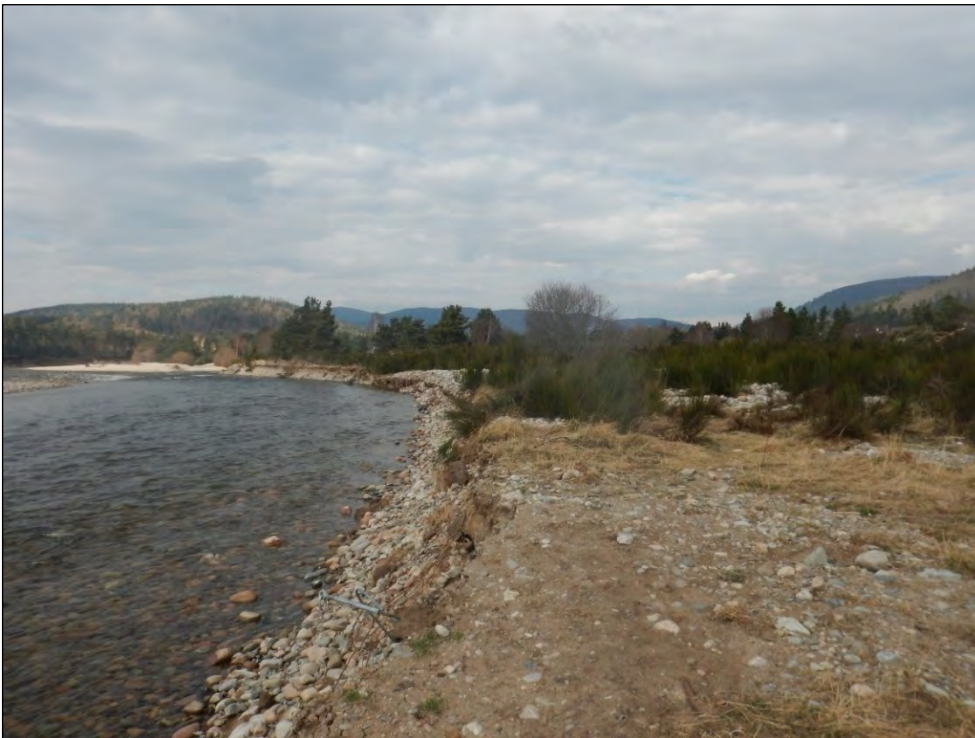
During the 2022 inspection there was no evidence of this embankment, and the riverbank was encountered at 36595,95092, see [Plate 8](#), i.e. approximately 45m east of where it was in 2018. [Plate 9](#) and [Plate 10](#) show the view south from the point at which the path met the river in 2019 and 2022 respectively, and again it is noticeable that there is now no raised embankment. The change in the river course in this area is further illustrated in [Plate 11](#) and [Plate 12](#) which show the route of the main river channel to have switched from right (west, Glen Muick) side to the left (east, Ballater) side.

Plate 8 **Same area at south end of Golf Course looking NW- no embankment present (2022)**

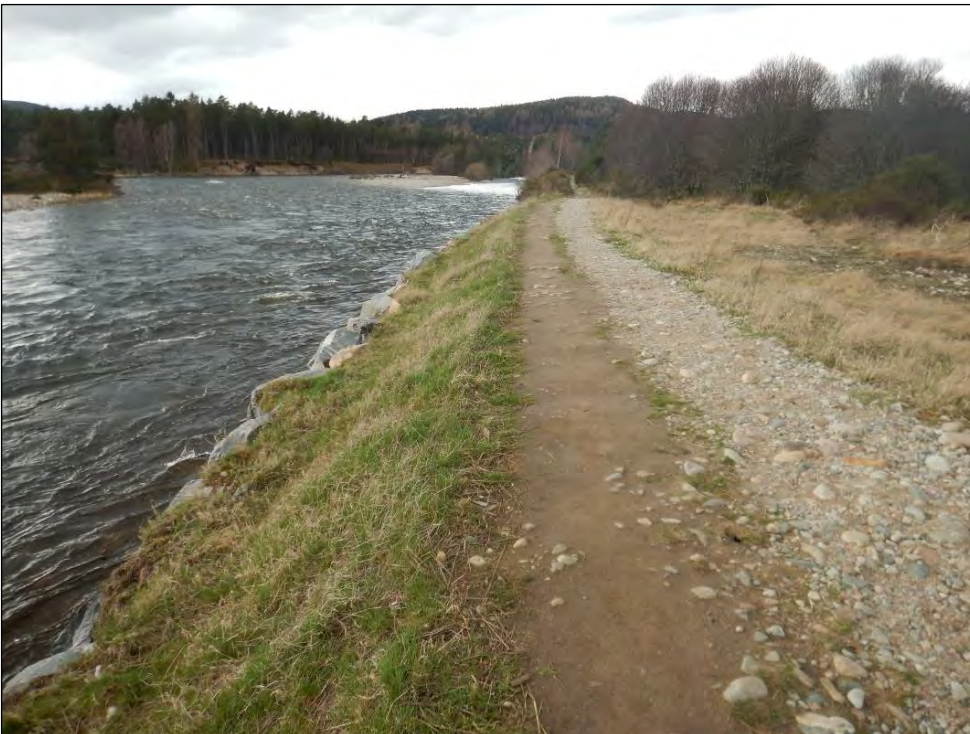
Continuing north-westward along the embankment the 2018 inspection noted the formation of the embankment to incorporate a boulder toe on the river side as shown in [Plate 13](#). This form of construction extended from 36465,95139 to around 36323,95186 beyond which the boulder toe ceased although erosion protection was provided by a vegetated bank of river deposits. This section of the embankment was the subject of the repairs Aberdeenshire Council undertook in 2016.

Plate 13 **Embankment with boulder toe (2018)**

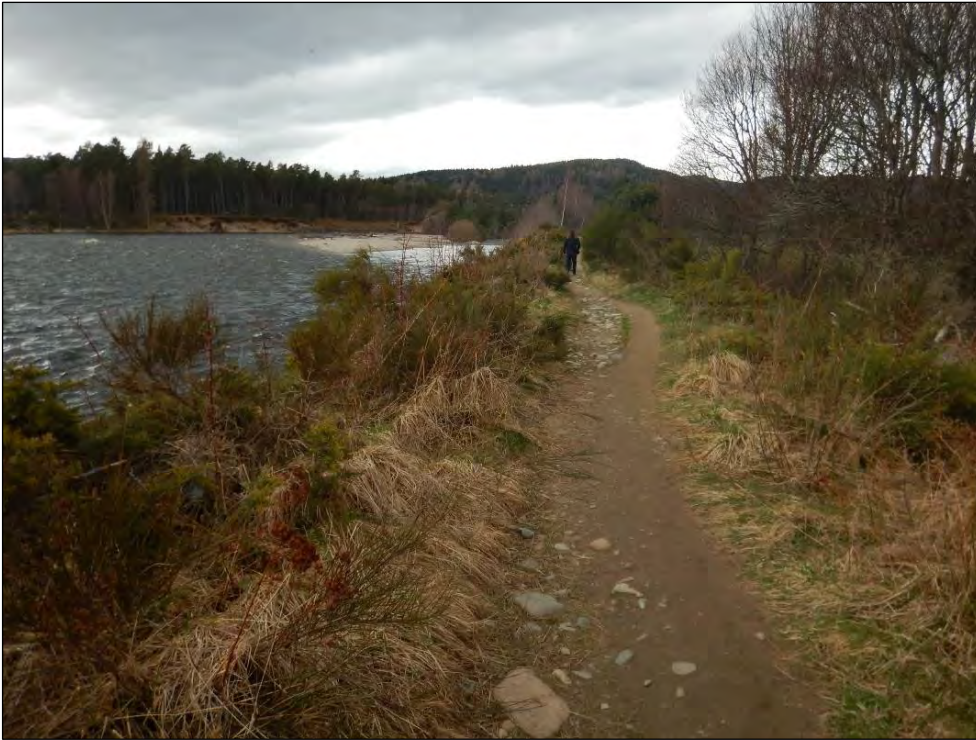
The core of the embankment appears to be composed of a mix of cobble, gravel, and sandy soil, potentially riverbed material, however it was significantly more heavily vegetated than the embankment to the south, as

shown in [Plate 14](#). The ground to the rear of this section of the embankment was noted to be significantly higher than to the south with the embankment height being observed to be circa 1m with a similar crest width to the previous section of the embankment. There was no significant evidence of the deposition of material on the ground behind or of recent breach/over-topping of this section of the embankment. In general, this section of the embankment was classified as being in **Good** condition.

Plate 14 **Vegetation on northern section of embankment with boulder toe (2018)**

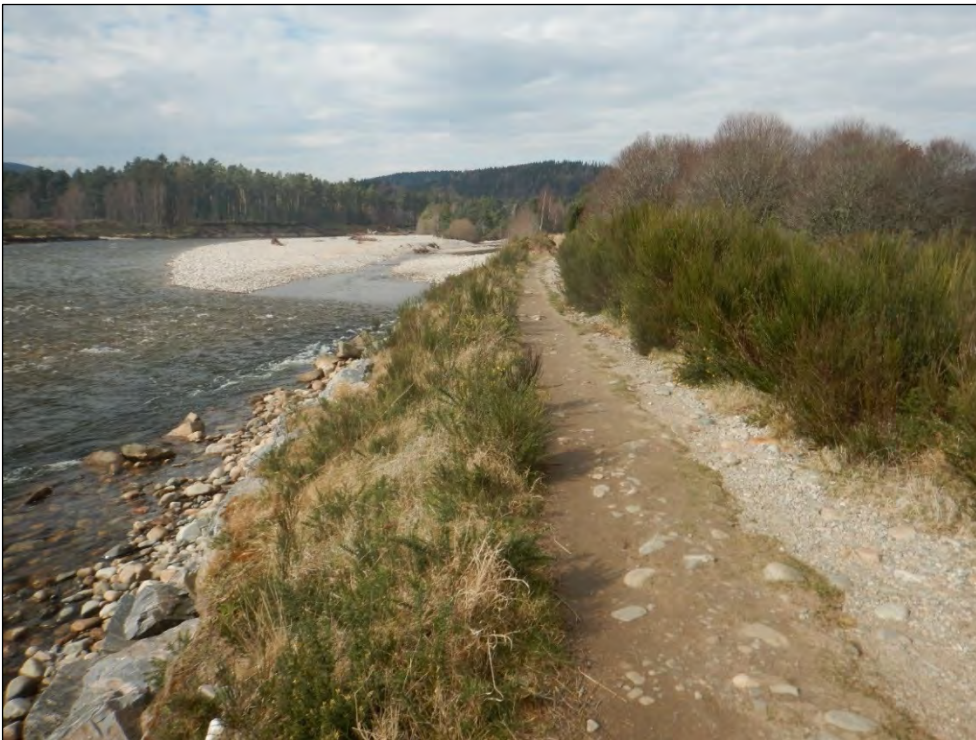
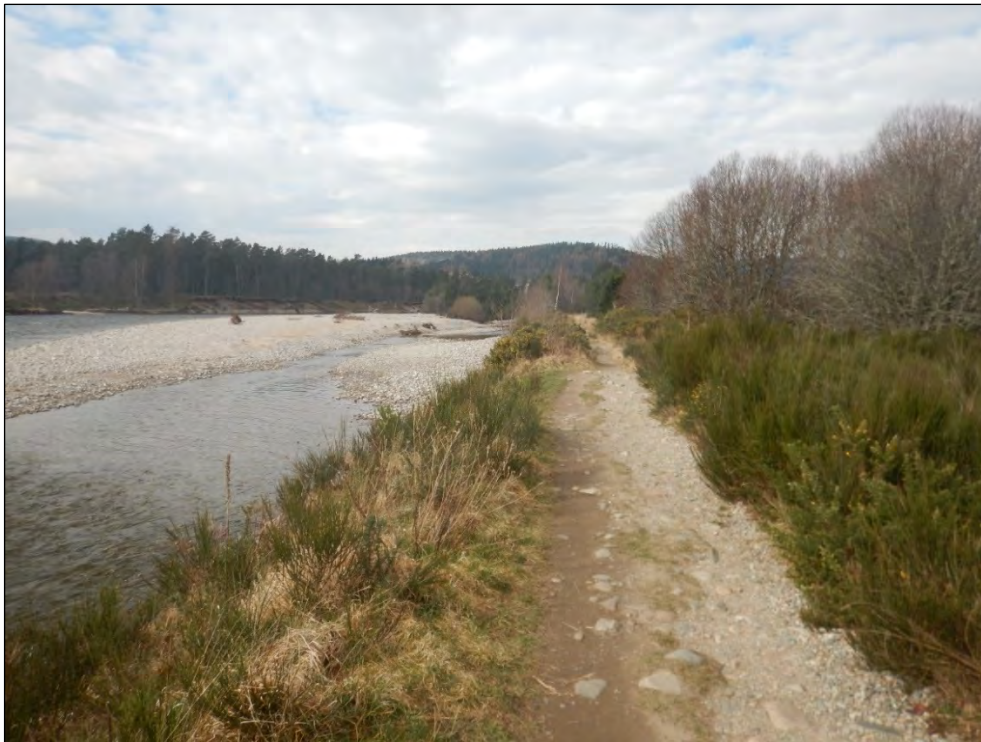
Corresponding images of this embankment from 2022 are presented in [Plate 15](#) and [Plate 16](#) and indicate little change in the formation or condition of this structure. Thus, this part of the flood defence embankment would still be classed as being in **Good** condition although some evidence of the large boulder at the toe starting to move was noted at the southern end.

Plate 15 **Embankment with boulder toe (2022)**

Plate 16 **Vegetation on northern section of embankment with boulder toe (2022)**

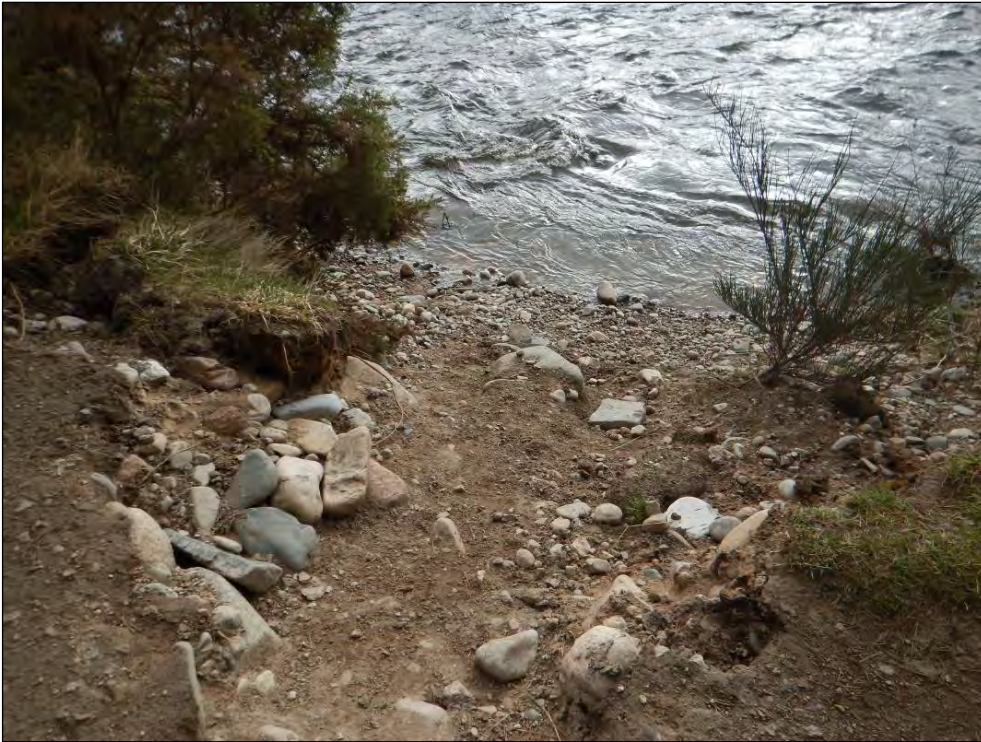
Continuing westwards the 2018 inspection noted the embankment to remain in **Good** condition, [Plate 17](#) and [Plate 18](#), until approximately 36133,95261 where the river side face was observed to be partially eroded, [Plate 19](#). This was considered to most likely be due to pedestrian activity given the very localised nature of the erosion although it is possible that it was the result of the removal of a large tree and root system during recent floods. Similar images from 2022 are presented in [Plate 20](#) to [Plate 22](#) which show very little observable change from the images recorded in 2018 with the same area of damage still being visible.

This section of the embankment has a relatively low height (1-1.5m) and good crest width (circa 3m). Again, the embankment appears to have been formed from typical river/ glacial deposits with evidence of cobble visible amongst the vegetative cover. Generally, this section of the embankment is in **Good** condition, however, the damaged section was assessed as being in **Poor** structural condition due to the exposure of the core material.

Plate 19 Partial breach of embankment at 36133,95261 (2018)

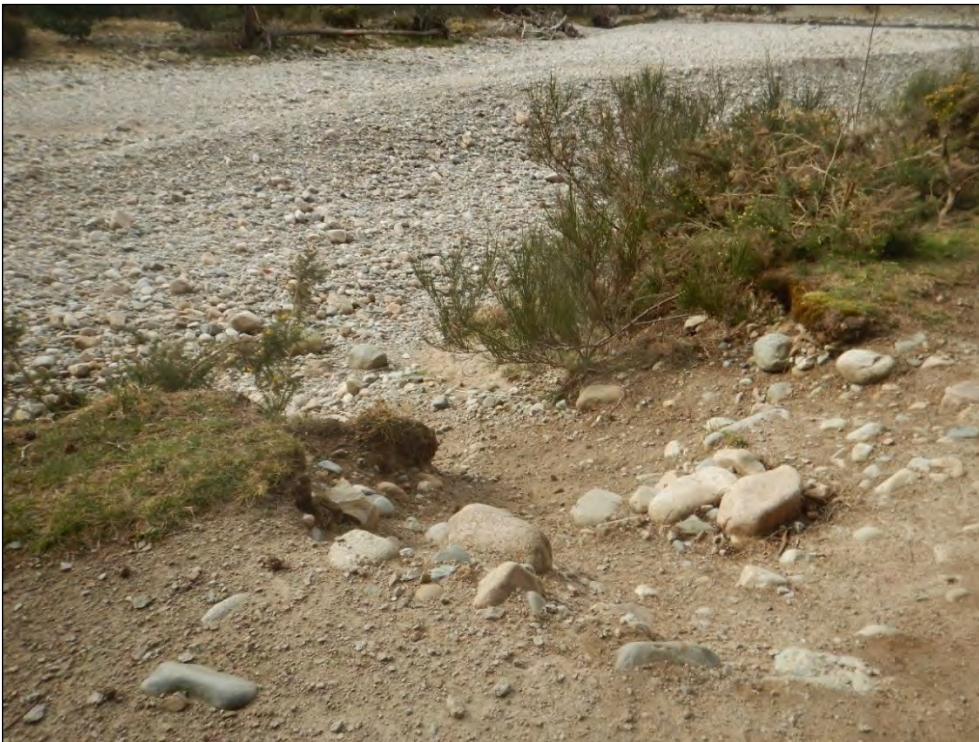
Plate 22 Partial breach of embankment at 36133,95261 (2022)

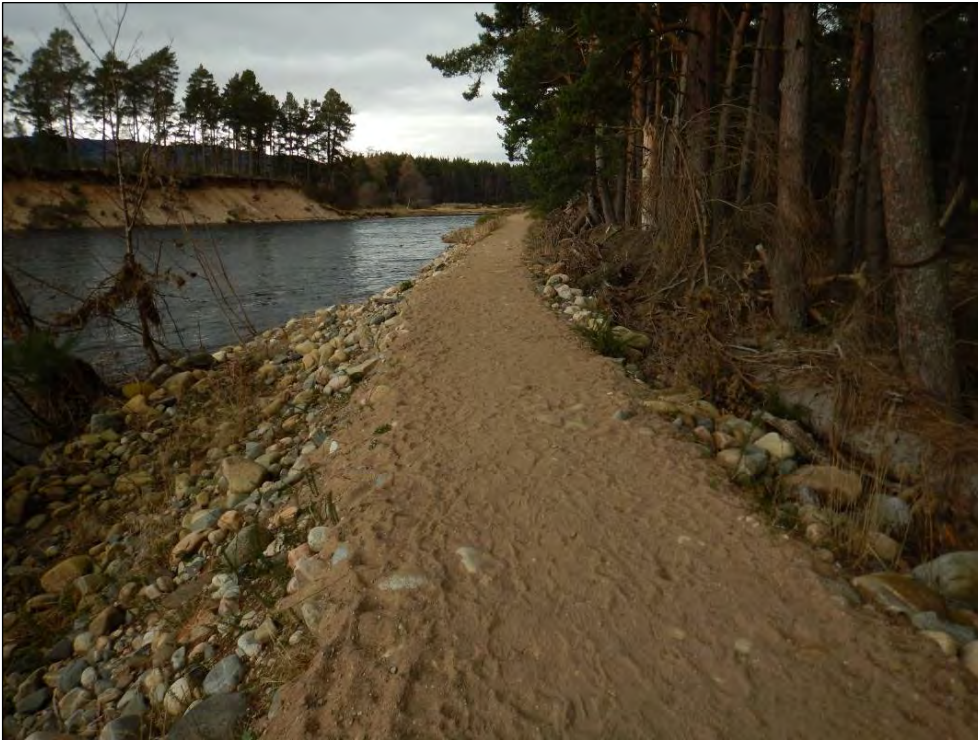
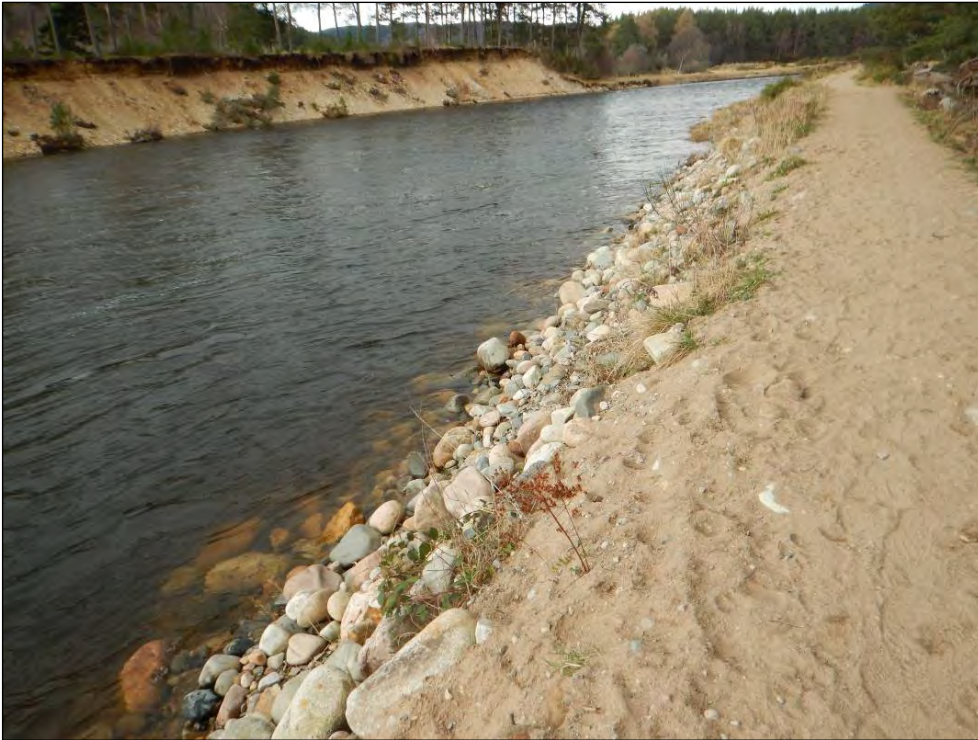
Beyond 35005,05316 the embankment appeared to have been recently re-constructed using sand and gravel at the time of the 2018 inspection as shown in [Plate 27](#) and [Plate 29](#). These works appeared to be in response to the previous embankment having been over-topped as evidenced by the present of riverine detritus and debris scattered amongst the forest area behind, see [Plate 31](#). Equivalent images from 2022 are presented

Plate 27 Re-profiled embankment (2018)

Plate 29 Unvegetated face of re-profiled embankment (2018)

In 2018 the condition of the repaired section of the embankment was classified as being **Poor to Very Poor**, principally on account of the nature of the material used and the lack of vegetative cover to resist erosion and hold the material in place. However, it was noted that over time vegetation would establish on this section of the embankment, potentially increasing the condition grading to Fair. This assumption appears to have been correct based on what was observed during the 2022 inspection and thus this section of embankment can now be classed as **Fair**.

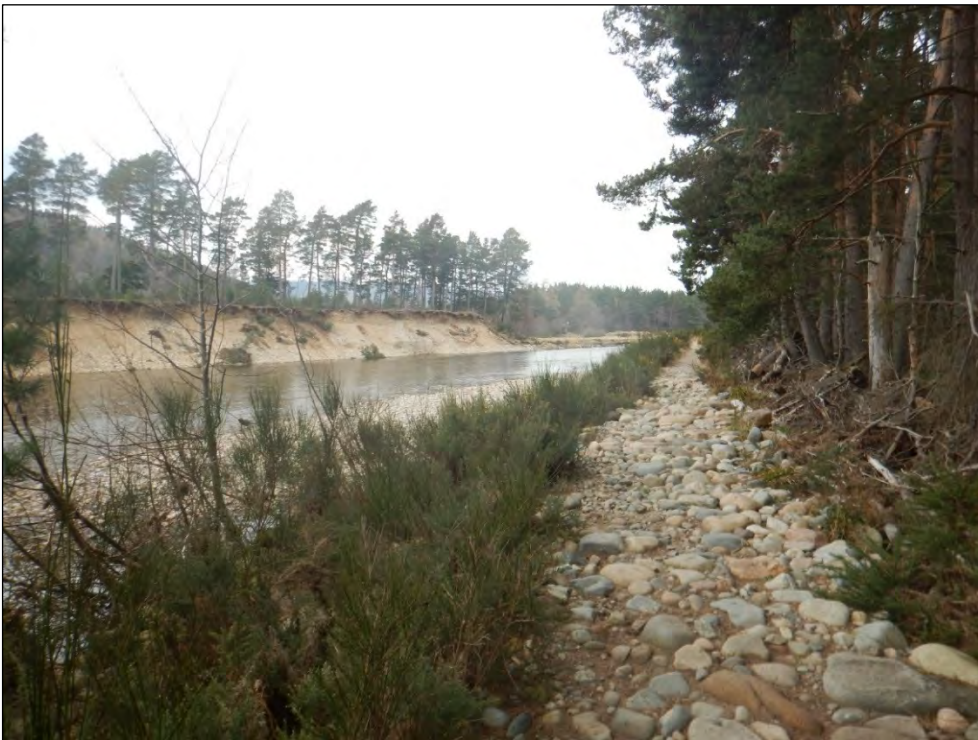
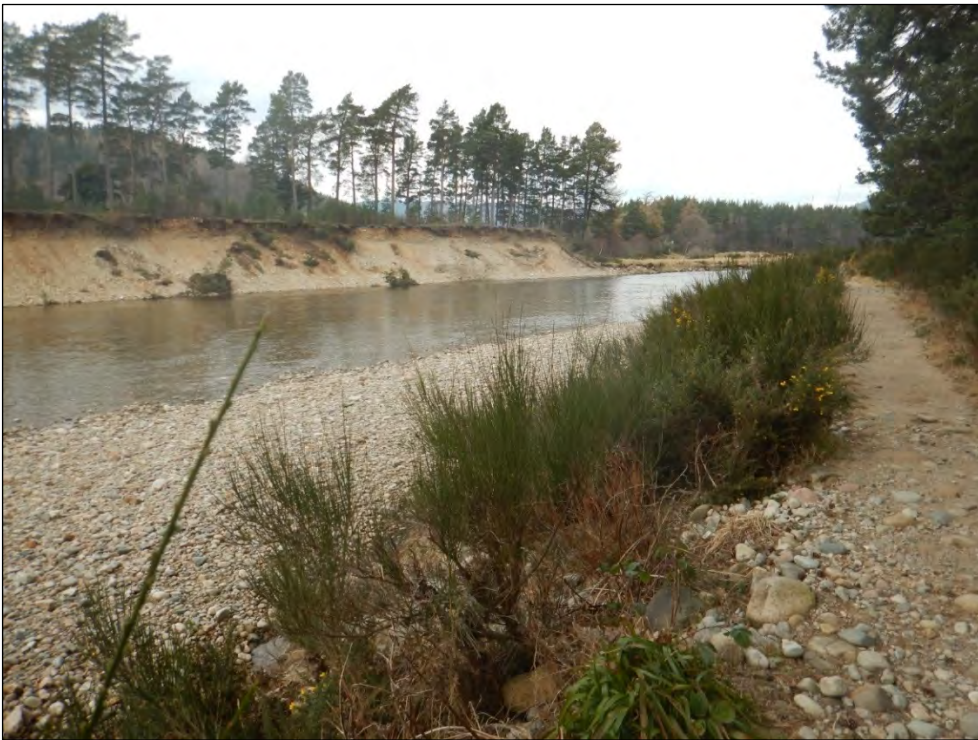
in [Plate 28](#) and [Plate 30](#) which show evidence of scouring of the finer material from the path, potentially indicative of this section of path having been over-topped. However, the riverside face has become extensively vegetated indicating that the underlying structure is reasonably stable.

Plate 28 Re-profiled Embankment (2022)

Plate 30 Former unvegetated face of embankment (2022)

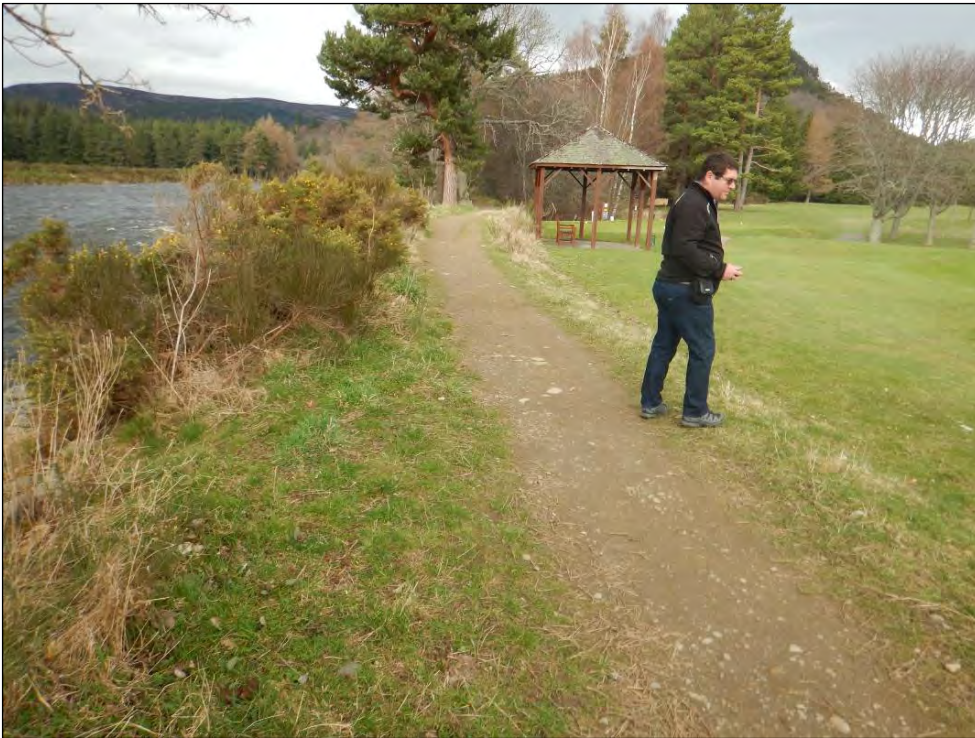
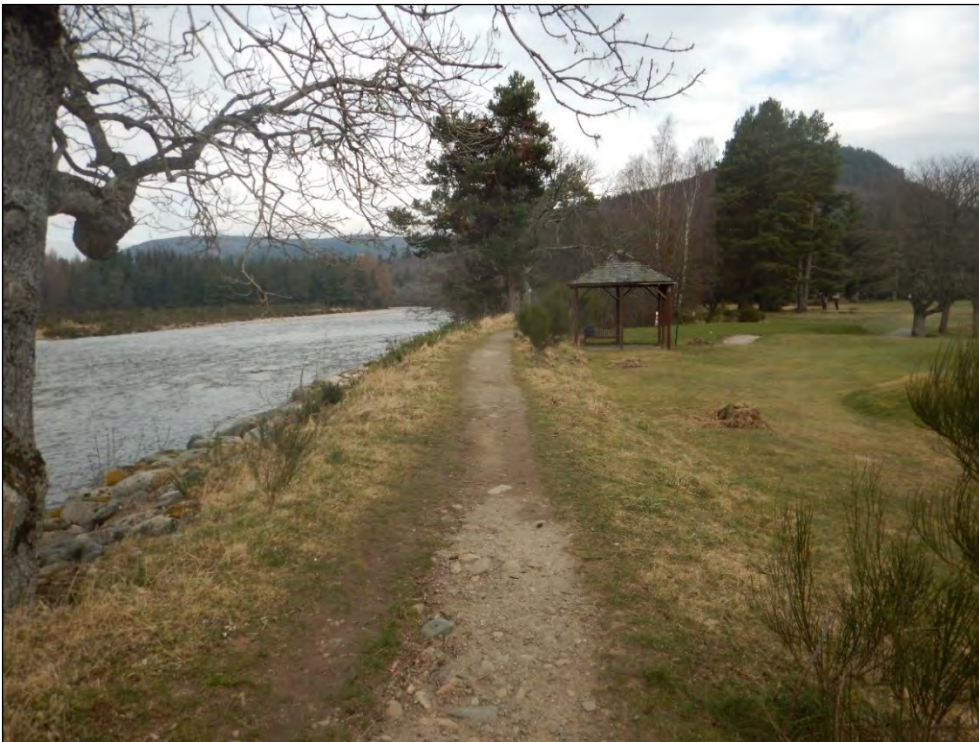
During the 2018 inspection it was noted that there was a noticeable gap in the presence of mature vegetation on the embankment alongside the 14th Tee, [Plate 38](#). It was not known if this was a result of deliberate vegetation management or the consequence of a reported breach during Storm Frank. [Plate 39](#) shows the

same area at the time of the 2022 inspection and shows even less scrub vegetation than in 2018 indicating that the limited scrub coverage is probably a consequence of vegetation management.

Plate 38 Scrub vegetation on embankment at 14th Tee (2018)

Plate 39 Scrub vegetation on embankment at 14th Tee (2022)

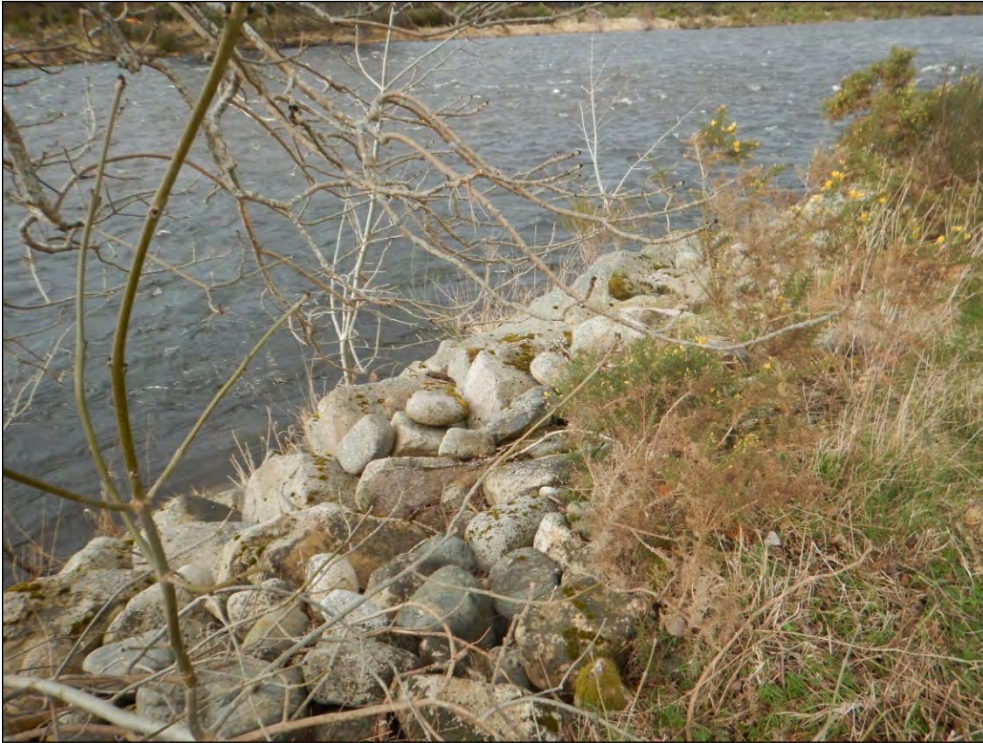
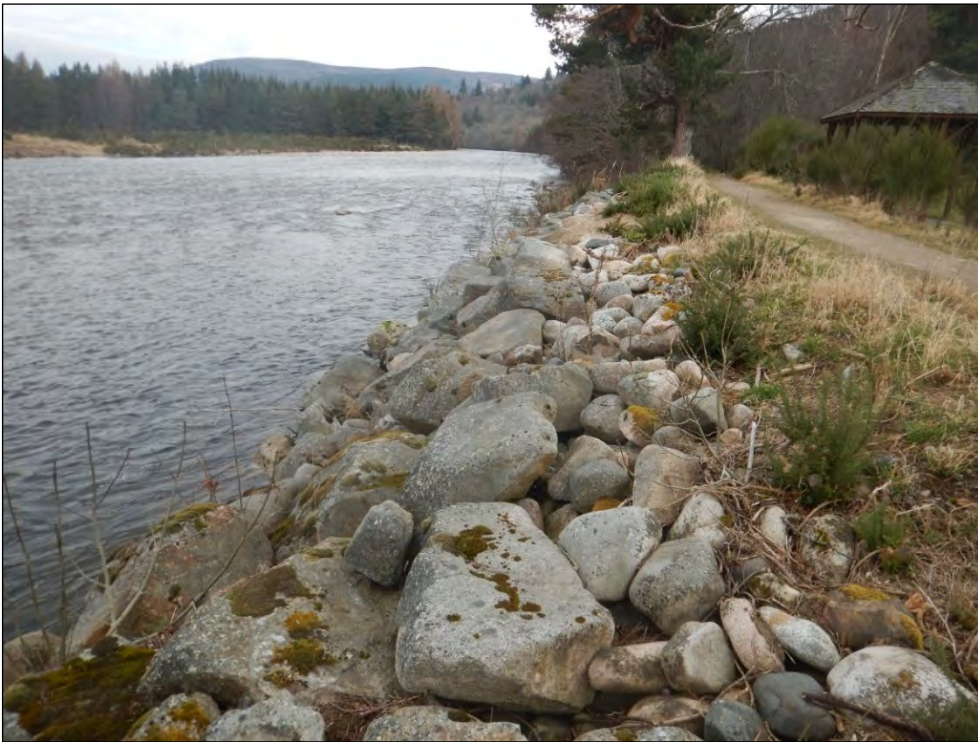
Irrespective of the reason for the lack of mature vegetation, the riverside face of the embankment was observed to be “armoured” with exposed boulders and cobble as shown in [Plate 40](#), which was assessed to be in **Good** condition. There was no evidence of armouring on the landward face and the vegetation cover was limited to grass, but again this warrants a **Good** classification. [Plate 41](#), shows the same area in 2022 and confirms the 2018 classification of **Good** condition.

Plate 40 Exposed cobbles/boulders on river side of embankment at 14th Tee (2018)

Plate 41 Exposed cobbles/boulders on river side of embankment at 14th Tee (2022)

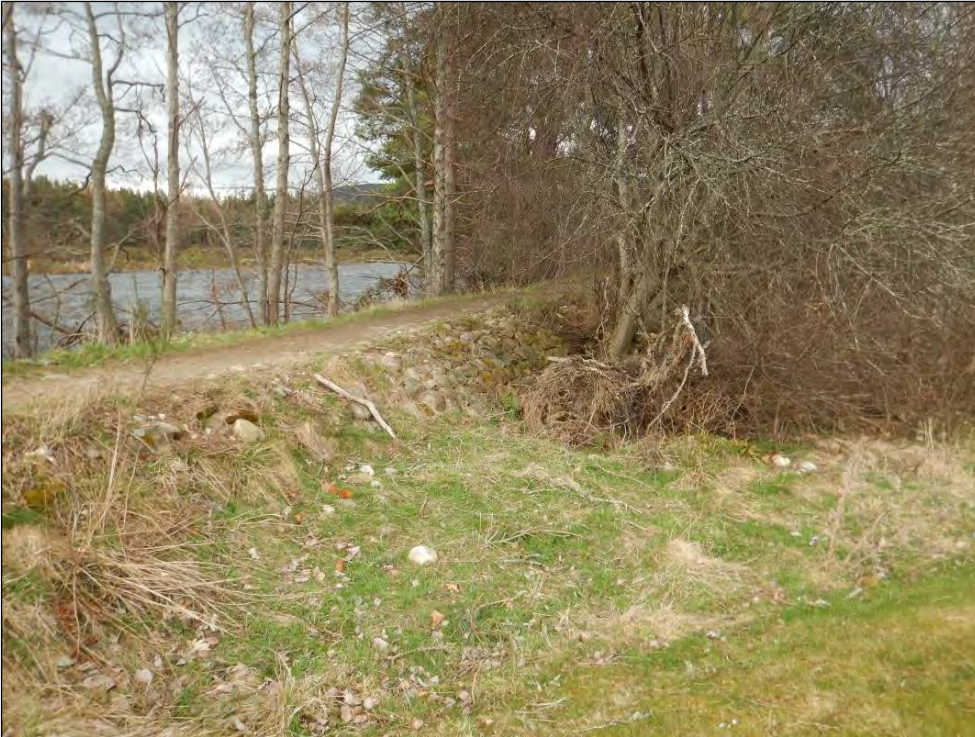
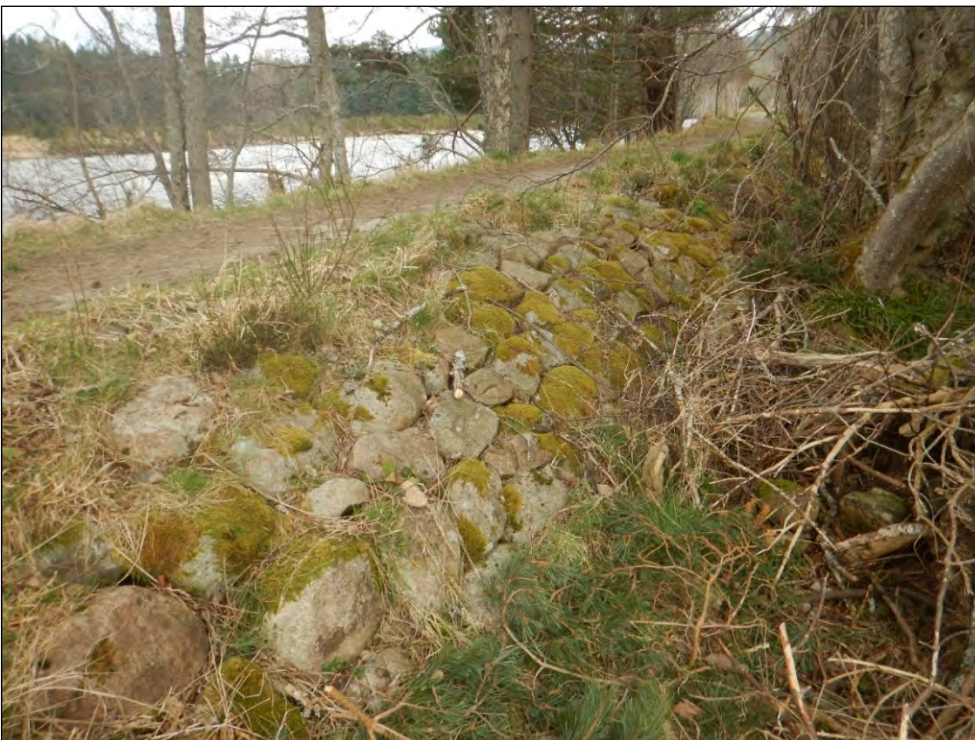
Immediately north of the 14th Tee the landward face of the embankment is composed of built masonry as shown in [Plate 42](#) and [Plate 43](#). This form of construction may also have extended to the riverside face, however it is now interrupted by the establishment of mature trees and other vegetation as shown in [Plate 44](#) and [Plate 45](#). Generally, this section of the embankment appears to be in **Fair to Good** condition.

Plate 42 Masonry revetment to rear face of embankment north of 14th Tee (2018)

Plate 43 Masonry revetment to rear face of embankment north of 14th Tee (2022)

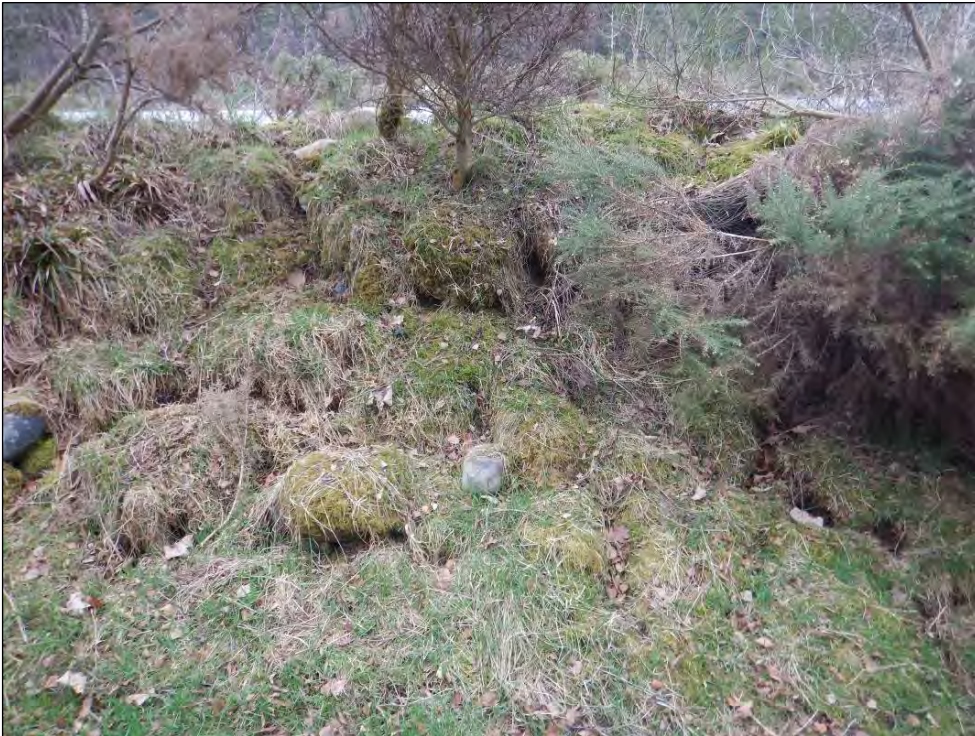
This embankment appears to be formed of a pile of predominantly cobble and while vegetated, the 2018 inspection identified numerous small holes as shown in [Plate 50](#). These holes did not show any clear evidence of being animal burrows and were thought to be related to the makeup of this structure being predominantly

large cobbles and boulders with little fine material. The structure was assessed as being in **Poor** condition. At the time of the 2022 inspection there was less vegetation cover and none of the holes noted in 2018 were visible, **Plate 51**, however a precautionary grading of **Poor** was still considered relevant.

Plate 50 Holes in raised embankment (2018)

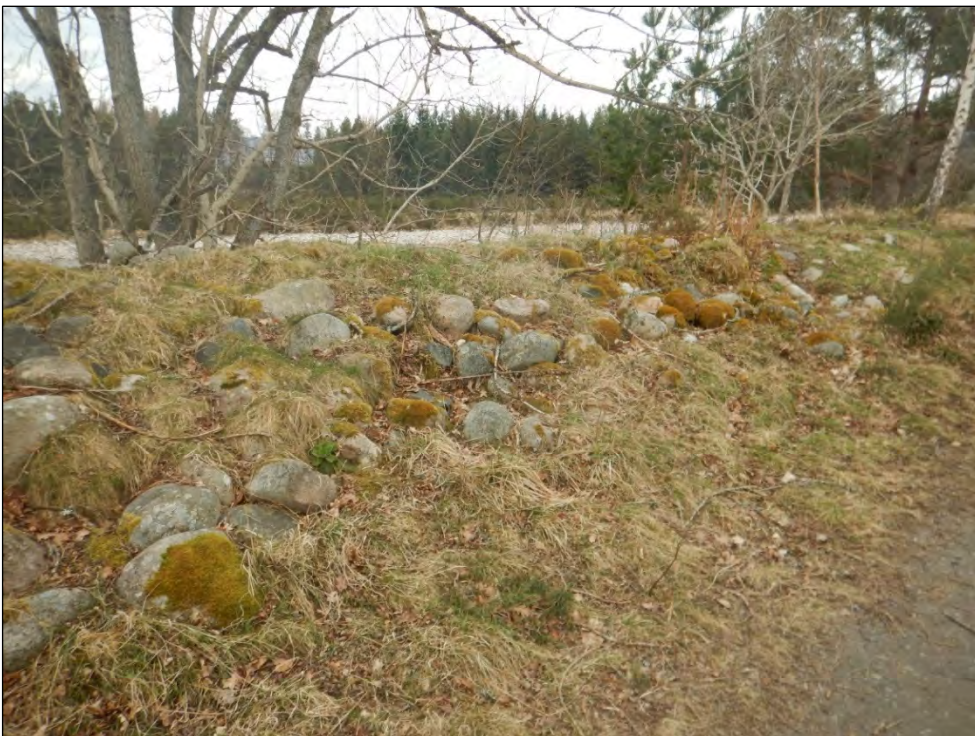
Plate 51 Rear face of raised embankment (2022)

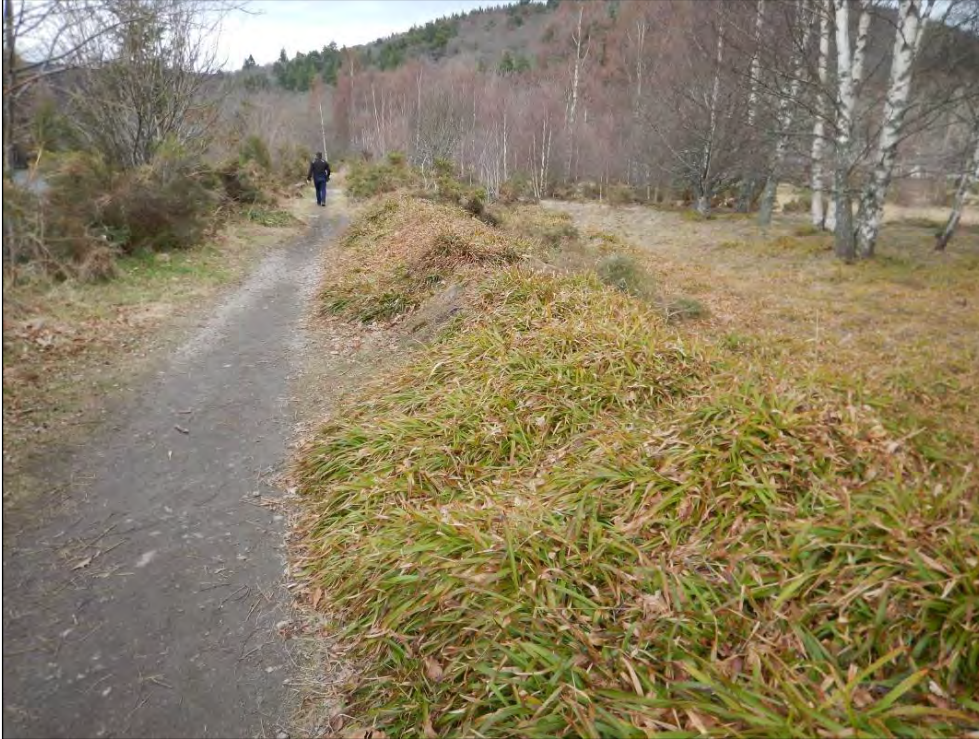
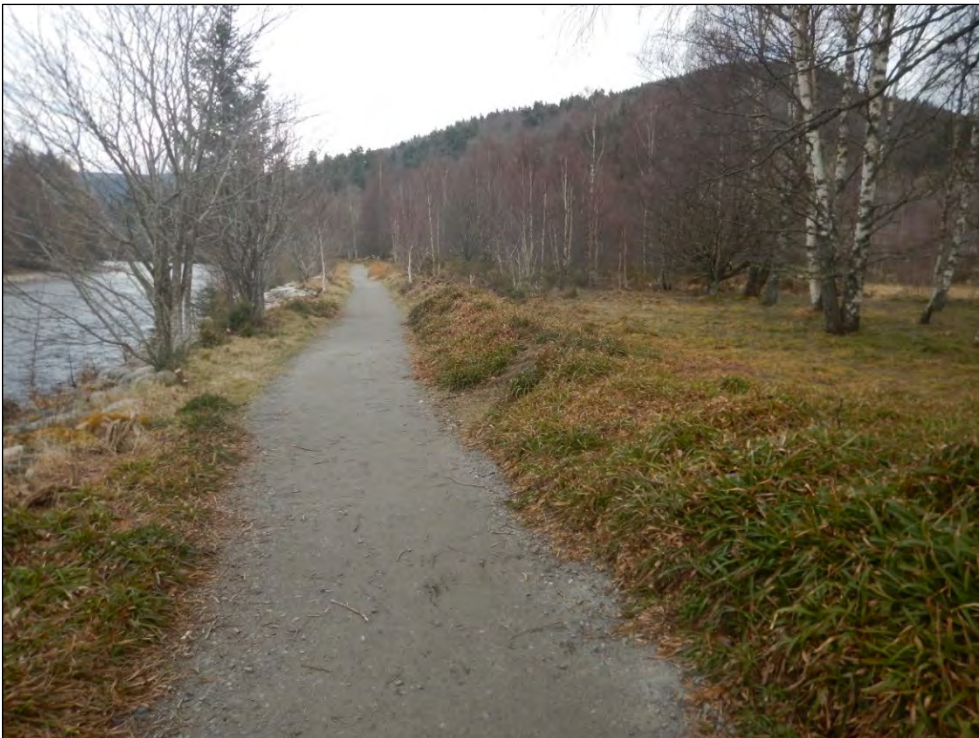
North of approximately 36034,95854 the path again re-joins the riverbank with a low “embankment” running along the landward side of the path as shown in **Plate 52** and **Plate 53** as far as 36049,95965 beyond which no form of flood defence was observed. This structure was noted to be circa 0.5m in height with a similar crest width and was assessed as being in **Good** condition.

Plate 52 Low embankment on landward side of path (2018)

Plate 53 Low embankment on landward side of path (2022)
