BALLATER ADDITIONAL FLOOD STUDY

Defence Condition Inspection

IBE1982_Rp001
D01
30 March 2022

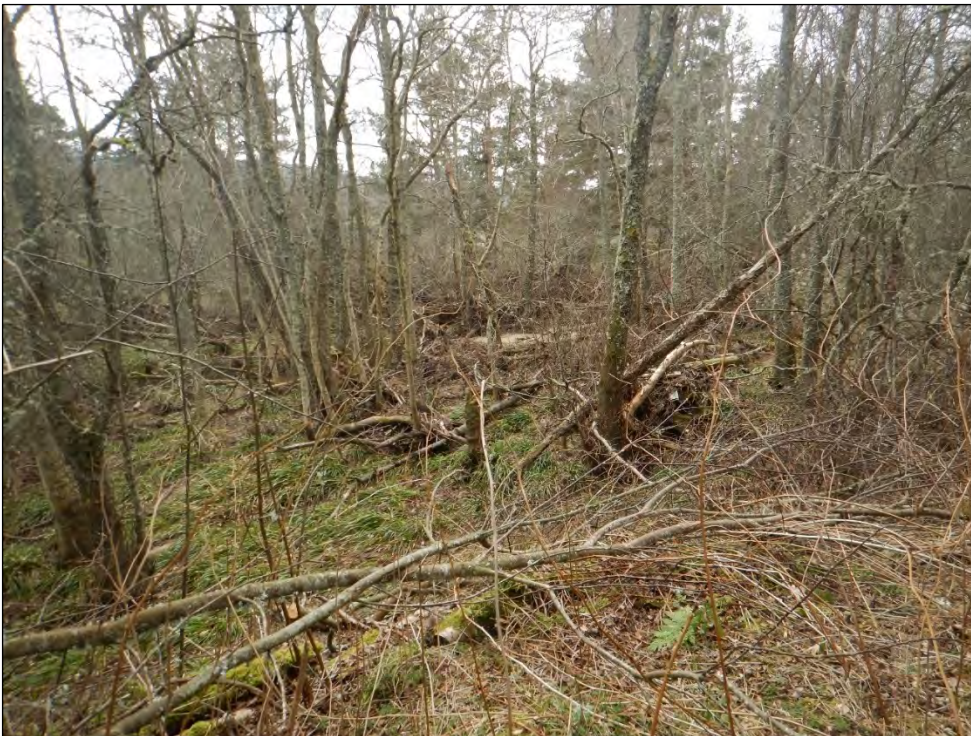
During the site inspection it was noted that significant amounts of fallen trees and other debris, were caught between the standing tree on the floodplain, [Plate 54](#), particularly on the left bank upstream of the caravan park. This debris will represent a significant resistance to water flow through this area during flood events and potentially increases water levels upstream.

Plate 54 View of debris caught amongst standing trees on floodplain and bend upstream of Caravan Park

Removal/ clearance of this debris should increase conveyance along this section of the flood plain, however the impact of this would need to be assessed using the hydraulic model to determine if it would make any significant difference to water levels adjacent to the Golf Course even during low return period flood events. Consideration would also need to be given the potential for the enhanced conveyance resulting from the removal of this material to increase flood risk at the Caravan Park, some that again would be best quantified by use of the hydraulic model before and extensive clearance is undertaken.

Assuming that the modelling does identify a beneficial impact of removing this material, it is entirely reasonable that the material extracted could be used to enhance the erosion resistance of existing defence structure or any new defence, such as that discussed in Section 3.4. However, if this approach is adopted it will be imperative that the material is adequately secured to prevent it from being washed away and further contributing to potential blockage of flow downstream.

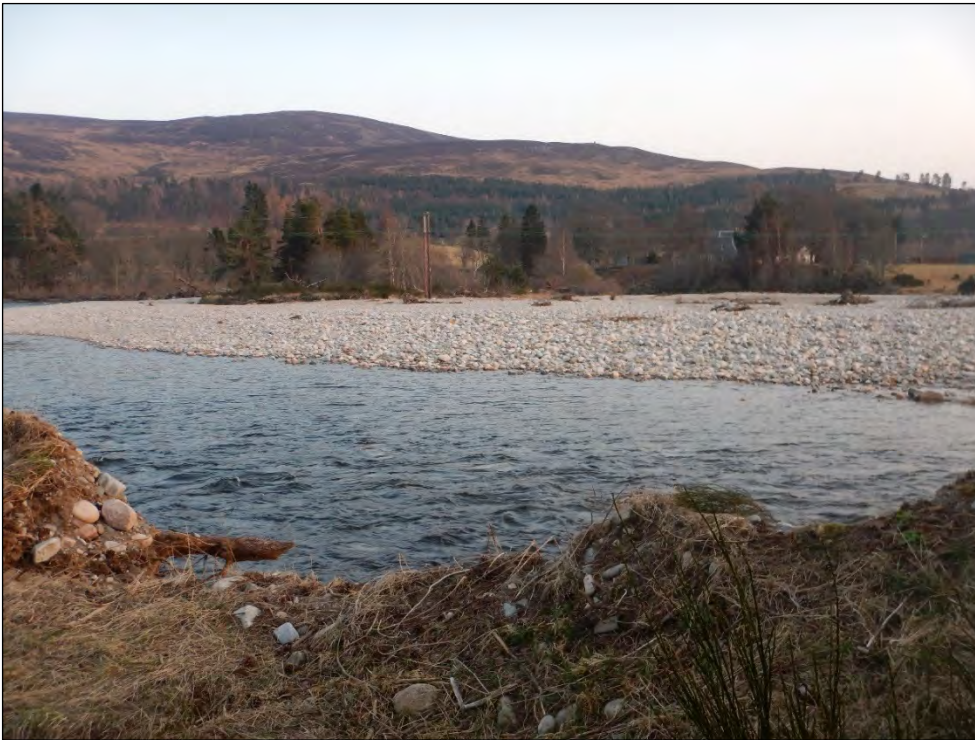
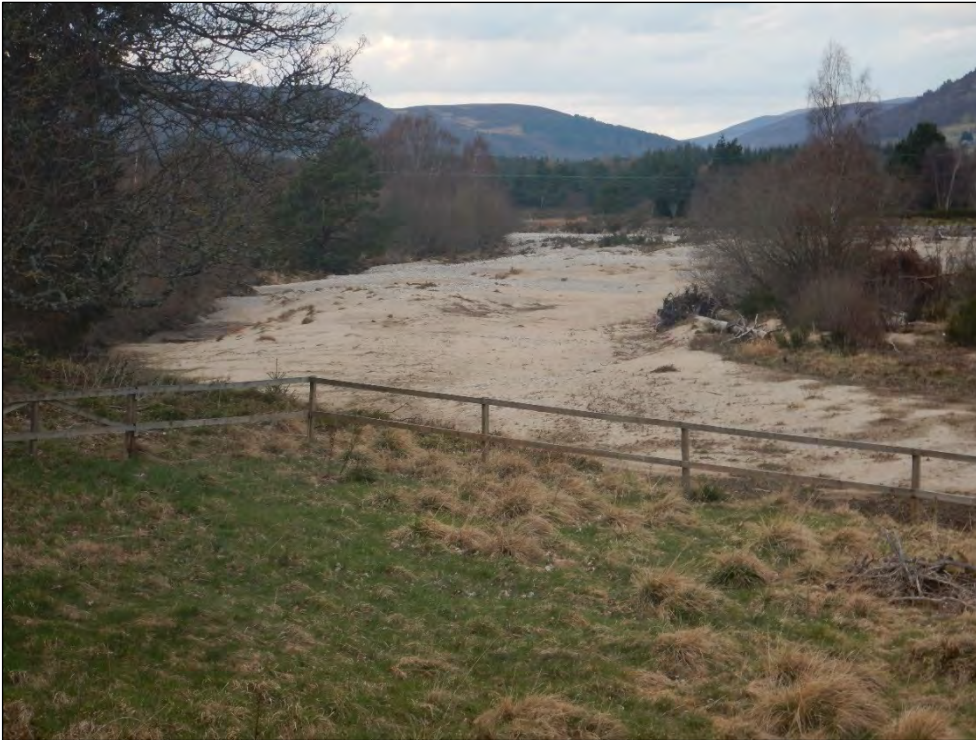
It was obvious from the 2022 site visit that the main flow channel of the River Dee had migrated from the Glenmuick side to the Ballater side in the area around the confluence with the River Muick, see [Plate 11](#) and [Plate 12](#). This change in flow path has been associated with infilling of the former flow channel with riverine gravel and sand, to the extent that the feature formerly known as the Manse Pool on the Glenmuick side no longer exists, [Plate 55](#) and [Plate 56](#).

Plate 55 View downstream toward the former area of the Manse Pool

The change in flow path of the River Dee is such that the flow approaching the former channel on the Glenmuick side of the river is now deflected to the east, towards Ballater which is probably what has contributed to the bypassing of the former Glenmuick channel. The exact reason for this change in flow path is uncertain, however from what could be observed on site, and derived from a review of online historic mapping it appears that the left-hand bend upstream has become more pronounced, which combined with potentially more resistant bank material on the Glenmuick side has resulted in the change in flow direction. Thus, while it may appear desirable to excavate the deposited material from the former channel on the Glenmuick side, it is very doubtful that alone would result in the River Dee returning to its former path. It was also observed that the quantity of material to be moved in such an operation would not be insignificant for potentially limited benefit.

Plate 56 View upstream of the former site of the Manse Pool

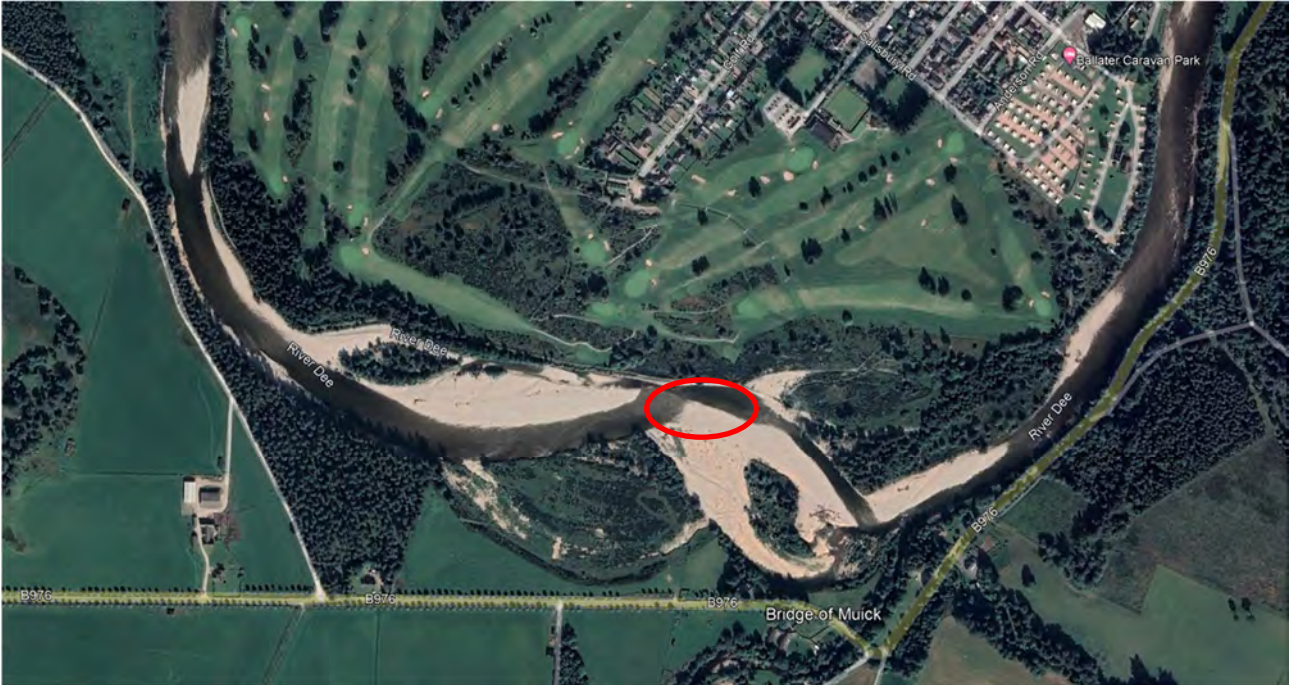
the red oval in [Plate 58](#), which clearly shows how this gravel bank was forcing flow northwards at the time the image was captured. It is unlikely that this would make any significant direct contribution to the management of flood risk at Ballater, however it may reduce the potential threat of further erosion along the left bank of the river and hence the risk of further section of the informal flood embankment/ footpath being lost.

Plate 58 Google Image showing area of cobble bank that is deflecting flow towards Ballater

While complete removal of the deposited material from the former channel on the Glenmuick side of the River Dee channel is unlikely to be an achievable solution, there may be merit in the removal or redistribution of some material from the northern end of the cobble bank that has become established to try to encourage the Dee to take a more southerly trajectory. The suggested area for consideration for re-profiling is indicated by

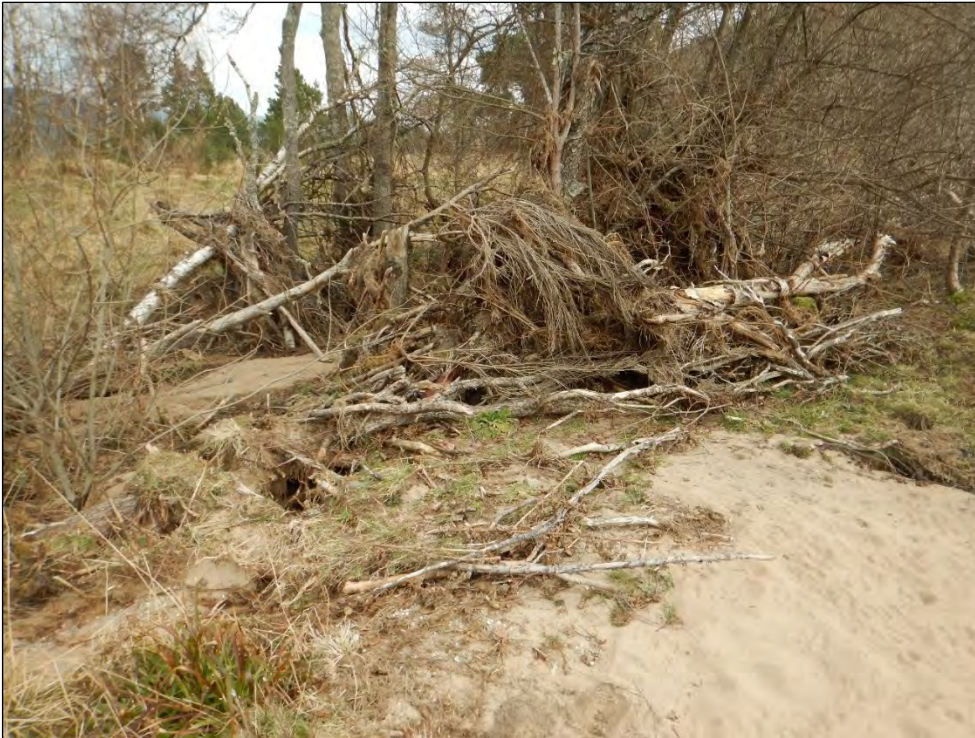
The minor watercourse that flows through/ under the Golf Course discharges to the River Dee just upstream of the caravan park. Whilst the channel within the Golf Course is well maintained and free of debris, once it passes beyond the actual playing course it flows through the area of tress and scrub on the inside of the bend of the river at the confluence of the River Dee and River Muick and this section is heavily choked with debris from previous flood event on the Dee. [Plate 59](#) show a typical example of the accumulation of debris and silt/sand across the channel which is an obvious impediment to flow.

Plate 59 Typical debris pile in Golf Course stream channel

Clearance of this channel would increase its conveyance potential, which should assist in draining flood waters from the area of the Golf Course and hence might to some degree reduce the flood risk to the developed area of Ballater particularly during more frequent flood events. However, as with the general clearance of flood debris from the floodplain the effect of clearing this channel would need to be examined via the hydraulic model to ascertain what benefit would accrue. Whilst it is unlikely there is also a possibility that clearance of this channel could allow any backed-up flood water from the area immediately upstream of the Royal Bridge to flow back on to the Golf Course potentially increasing the flood risk to the developed area on Ballater. Thus, before any decision can be made on the effectiveness of this measure the updated hydraulic model simulations would need to be completed.

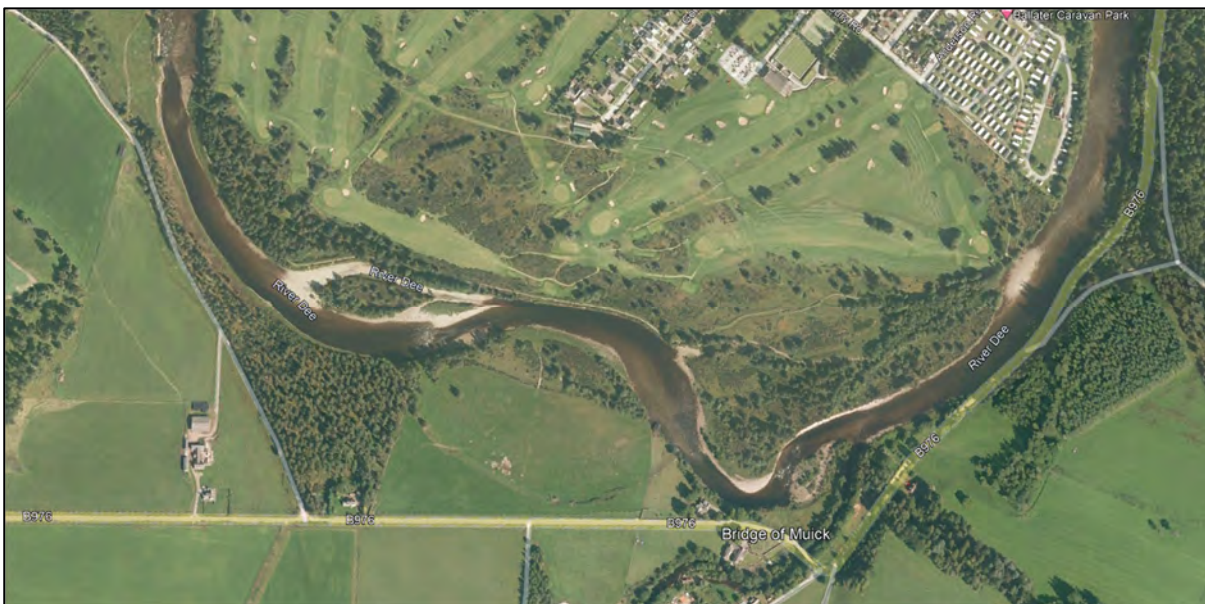
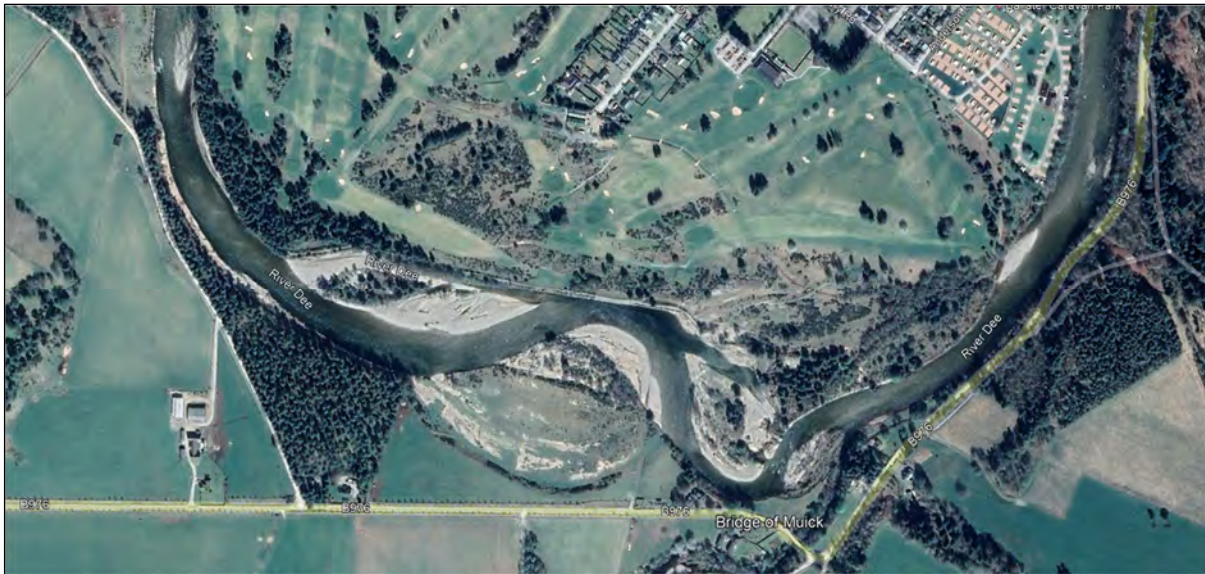
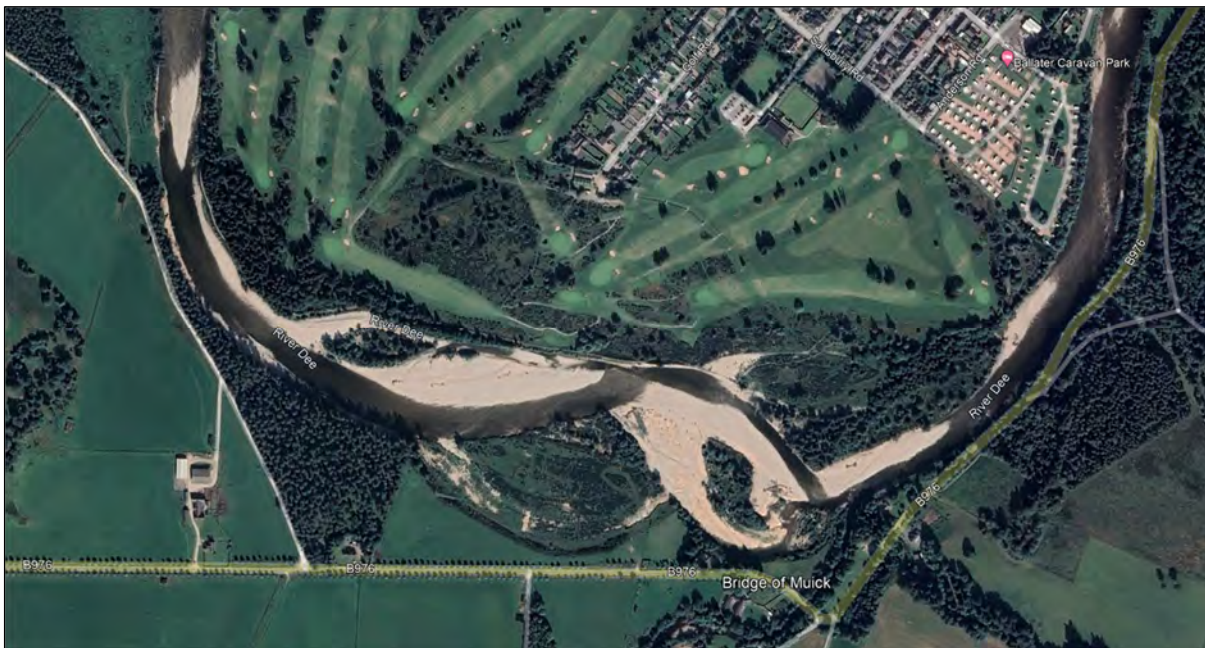
The series of images below, **Plate 60** to **Plate 62**, illustrate how the course of the Dee has changed in this area over the past 12 years and clearly show how it is now starting to bypass the bend that once held the Manse Pool. By constructing any flood defence along the alternative alignment indicated above, the course of the Dee would be able to continue to evolve in the area to the south, indeed it is foreseeable that the change in the path of the Dee may eventually cut right through the wooded area south of the Golf course given its present trajectory.

Irrespective of the outcome of the modelling, it was clear from the site inspection that the re-establishment of a flood defence along the present riverbank is unlikely to be sustainable due to the change in orientation of the River Dee, something that is also accepted by the Golf Club and local representatives. Visual examination of the topography within the area of rough ground belonging to the golf Club at the south end of the course identified a potential alternative line making use of generally raised ground levels extending in a more or less straight line between circa, 36599,95143 and 36491, 95162 that might represent a more sustainable alignment for any future flood embankment. Construction of an embankment along this alignment would involve crossing the watercourse draining the Golf Course, which flows through a low point in the topography, however culverting of this short stretch should not be a significant challenge, there are already numerous culverts and crossing throughout the Golf course and where the existing riverside pathway crosses a short distance to the south of the identified alignment.
