# Ballater Flood Protection Scheme

Fluvial Audit Report

cbec eco-engineering UK Ltd

June 2022

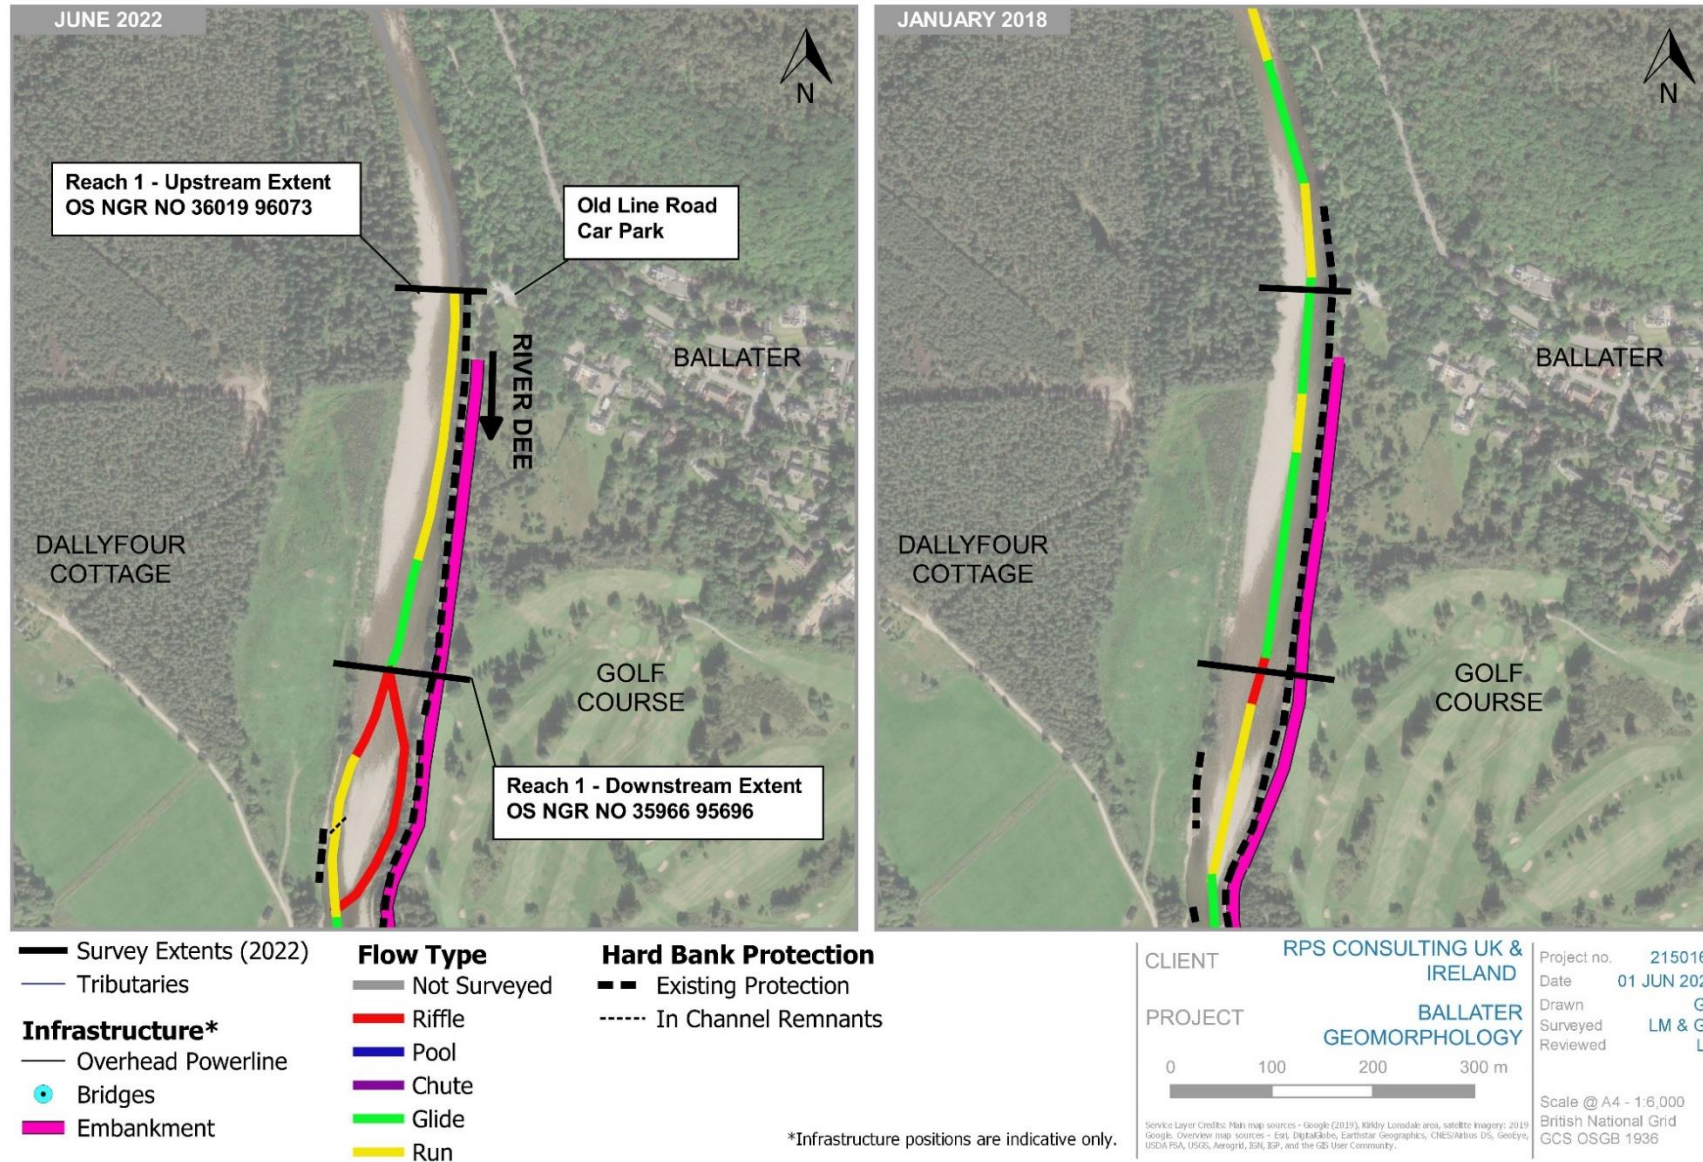
Figure 2.2 Morphological units and engineering pressures: Reach 1.

River Dee at Ballater, Reach 1	
<p><b>Dominant features</b></p> <ul style="list-style-type: none"> <li>• Units dominated by glides and runs</li> <li>• Historical bank protection along left bank for entire reach</li> <li>• Embankment present along footpath to left bank (runs along floodplain side of footpath in upper section and river side further downstream)</li> <li>• No additional morphological pressures noted</li> <li>• Alluvial bar form present along much of right bank</li> <li>• Bed substrate dominated by boulder/cobble and cobble/boulder units</li> <li>• Bed substrate generally active and clean</li> <li>• Trees present along river left channel margin for much of reach</li> <li>• Floodplain more open and covered with gorse to river right</li> <li>• Golf course located on river left floodplain</li> <li>• Large wood otherwise absent</li> <li>• Banks generally stable, with minor erosion of right bank at downstream end of reach supplying sand/silt and cobbles</li> </ul>

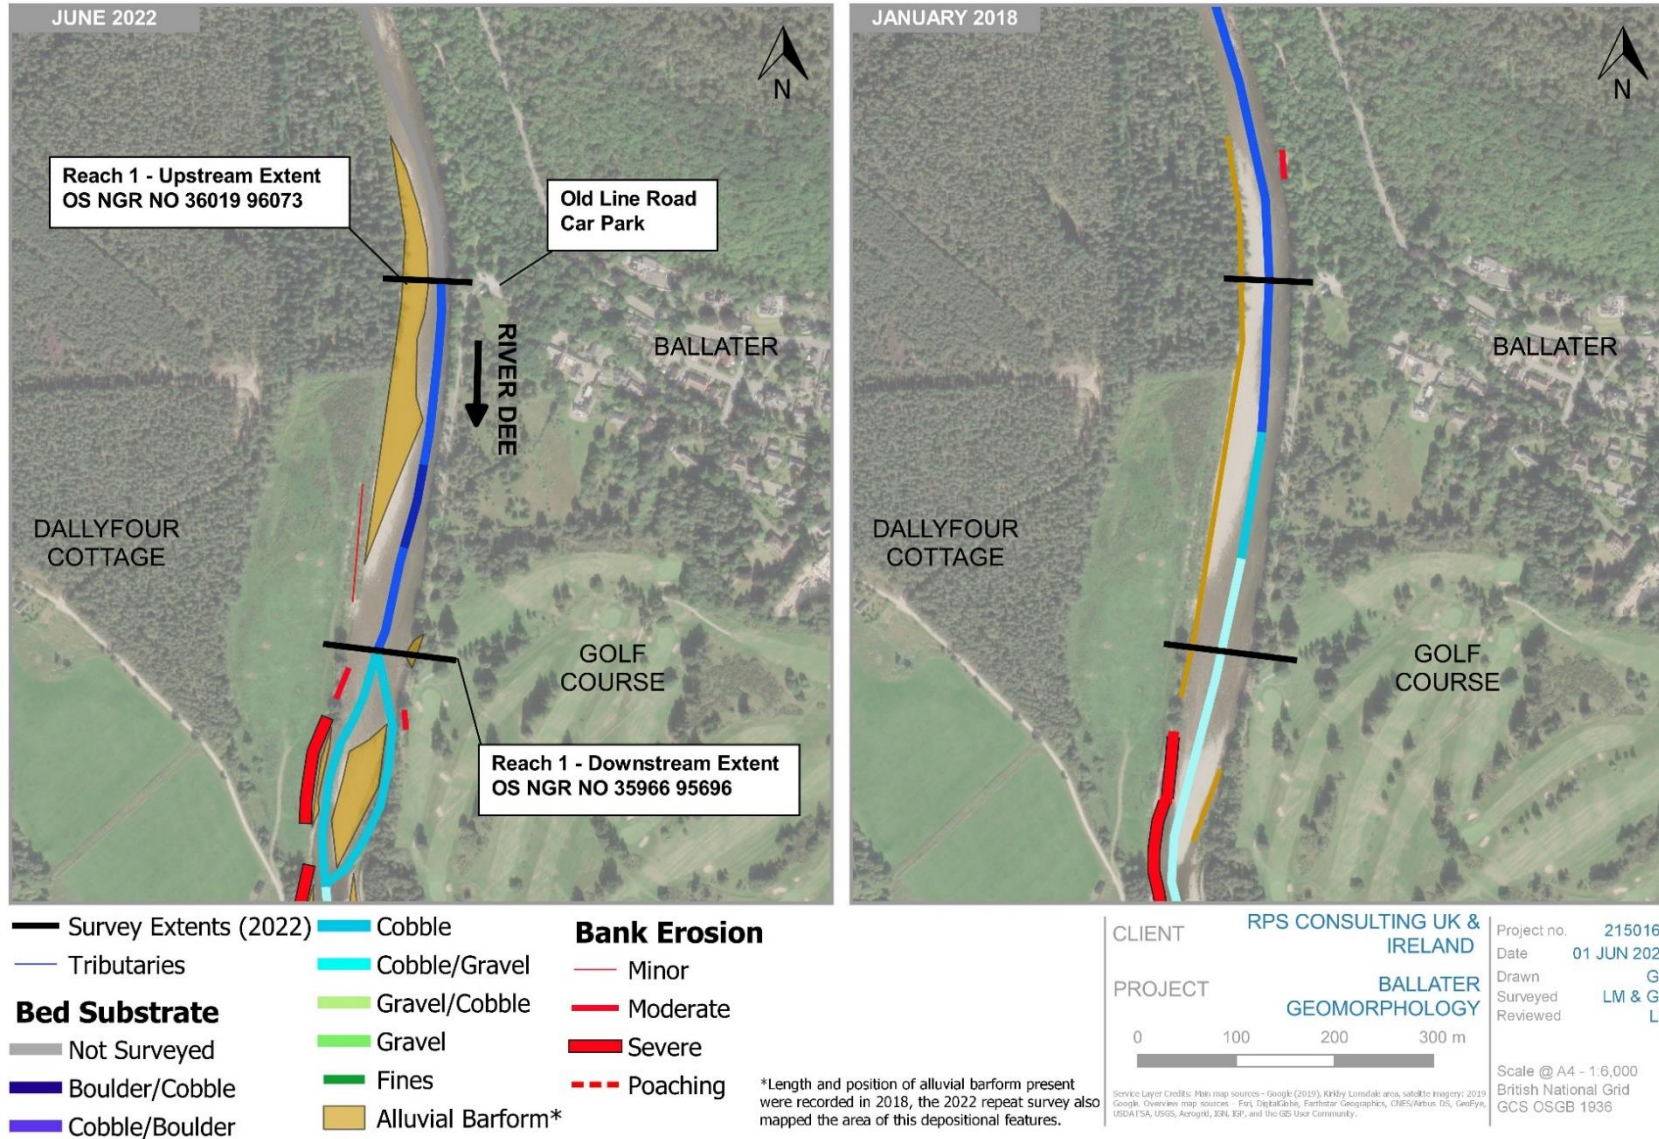
Figure 2.3 Sediment dynamics: Reach 1.

- No notable change in planform
- Still dominated by run and glide morphology, although run section more extensive
- General coarsening of bed substrate with less gravel observed now
- No notable change in configuration of alluvial bar forms (lateral bar)

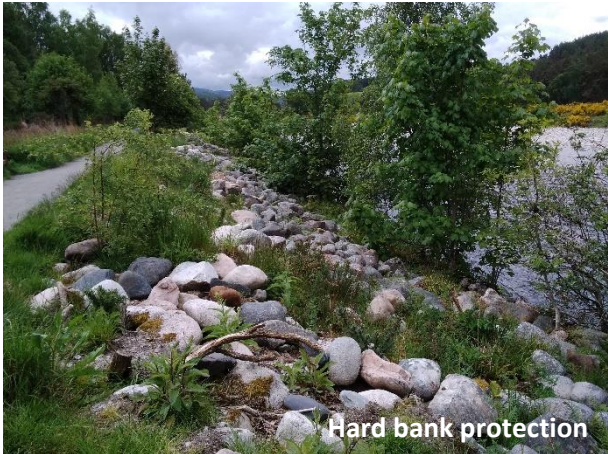
<p>Hard bank protection</p>

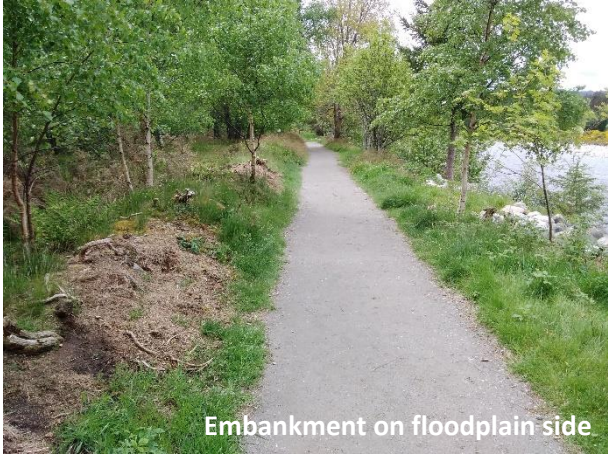
<p>Embankment on floodplain side</p>

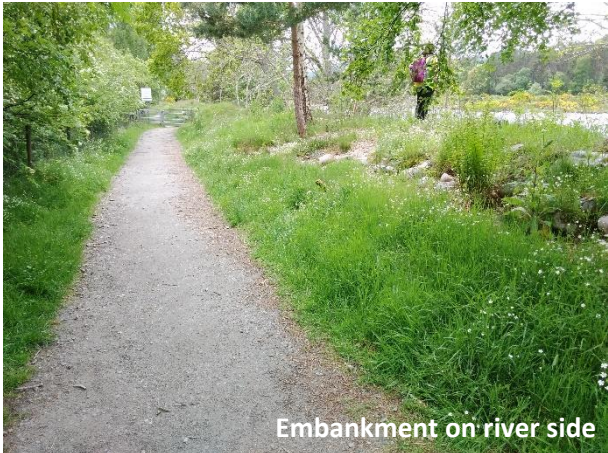
<p>Embankment on river side</p>

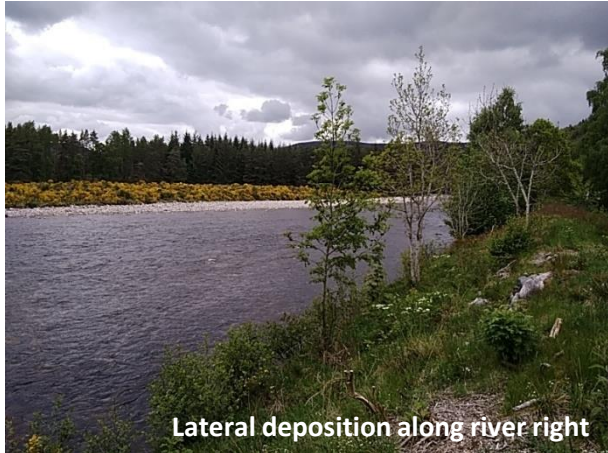
<p>Lateral deposition along river right</p>

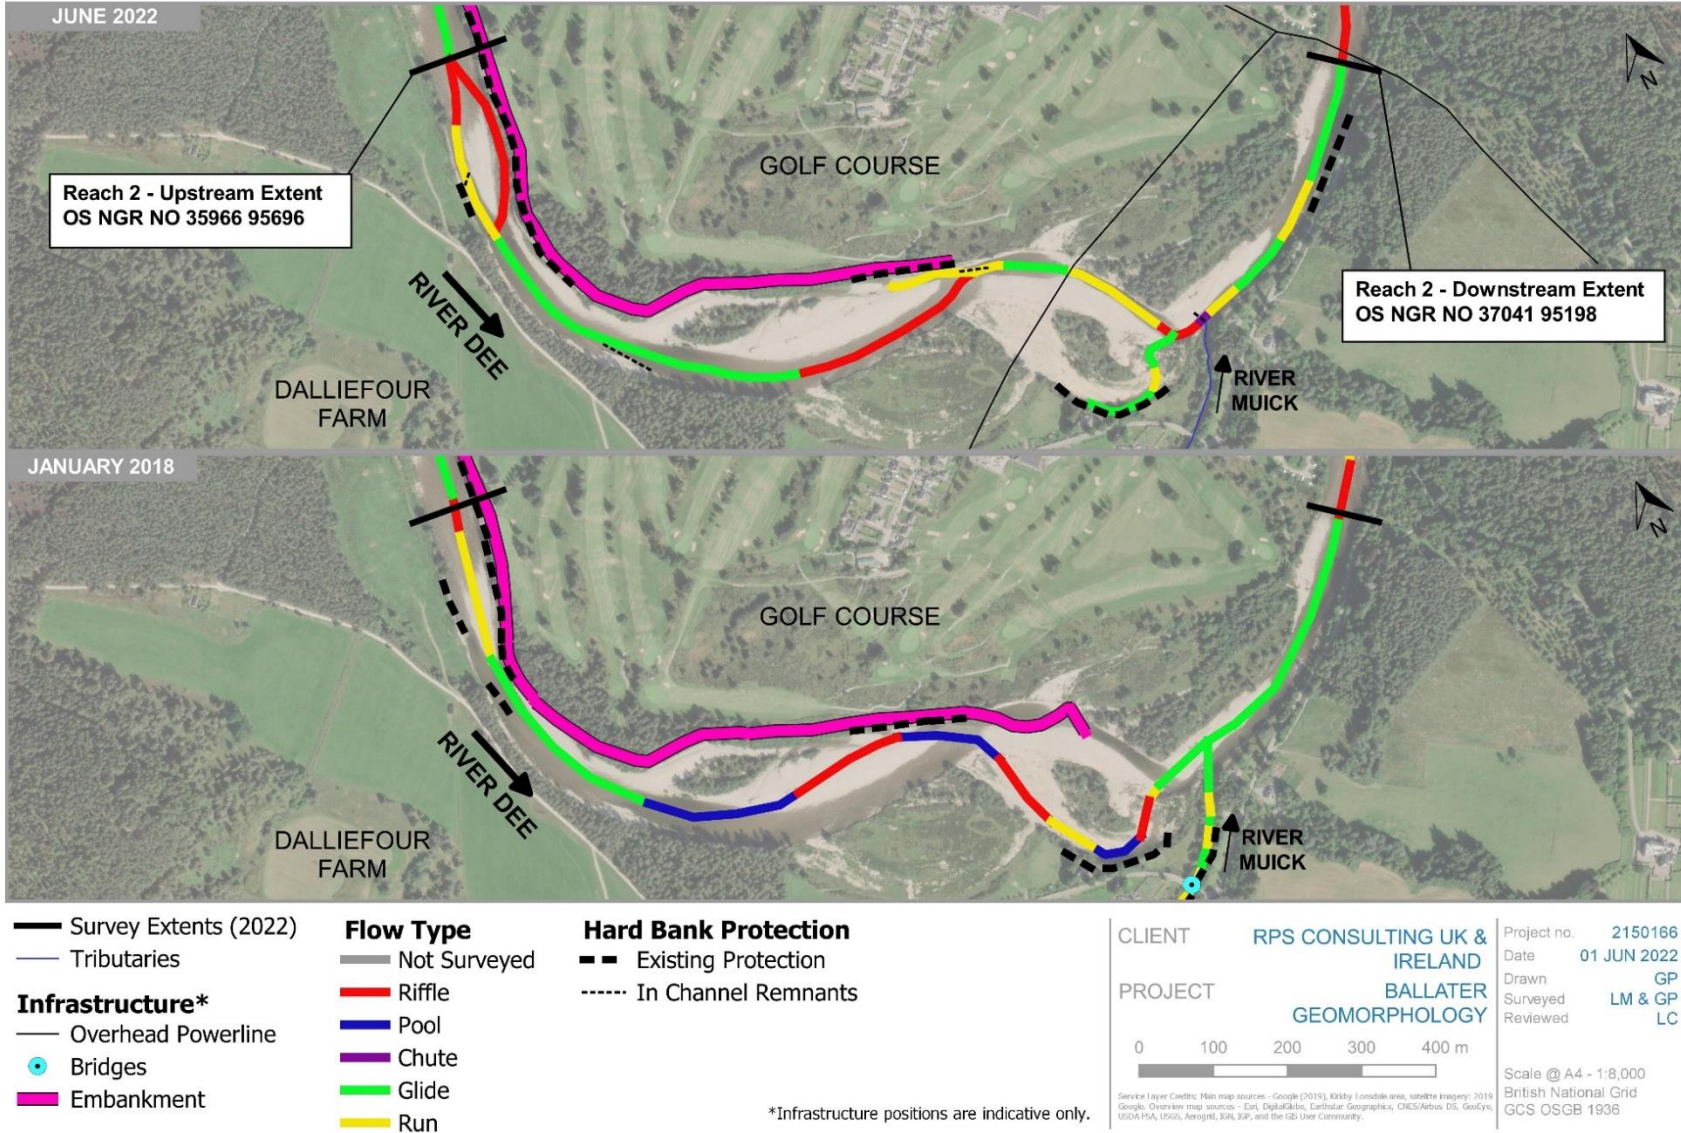
Figure 2.4 Morphological units and engineering pressures: Reach 2.

<b>River Dee at Ballater, Reach 2</b>	
<p><b>Dominant features</b></p> <ul style="list-style-type: none"><li>• Dominated by glides, riffles and runs, with short chute section near Muick confluence</li><li>• Historical bank protection present but discontinuous along both banks</li><li>• Embankment continues along much of upstream part of reach, with associated hard bank protection in place</li><li>• Some failing hard bank protection observed in channel</li><li>• River Muick enters mainstem Dee from river right</li><li>• Variable bed substrate ranging from gravel/cobble to boulder/cobble</li><li>• Bank erosion extensive and severe, particularly on outsides of bends, providing abundant supply of coarse sediment</li><li>• Bed substrate generally active and clean</li><li>• Alluvial bar forms both medial and lateral (point bars) in upstream part, gravel-dominated</li><li>• Extensive alluvial deposition in middle to lower sections, often with considerable aggradation</li><li>• Large complex bar form to river right upstream of Muick confluence, partly vegetated, abundant large wood present across full extent of deposition area</li></ul>

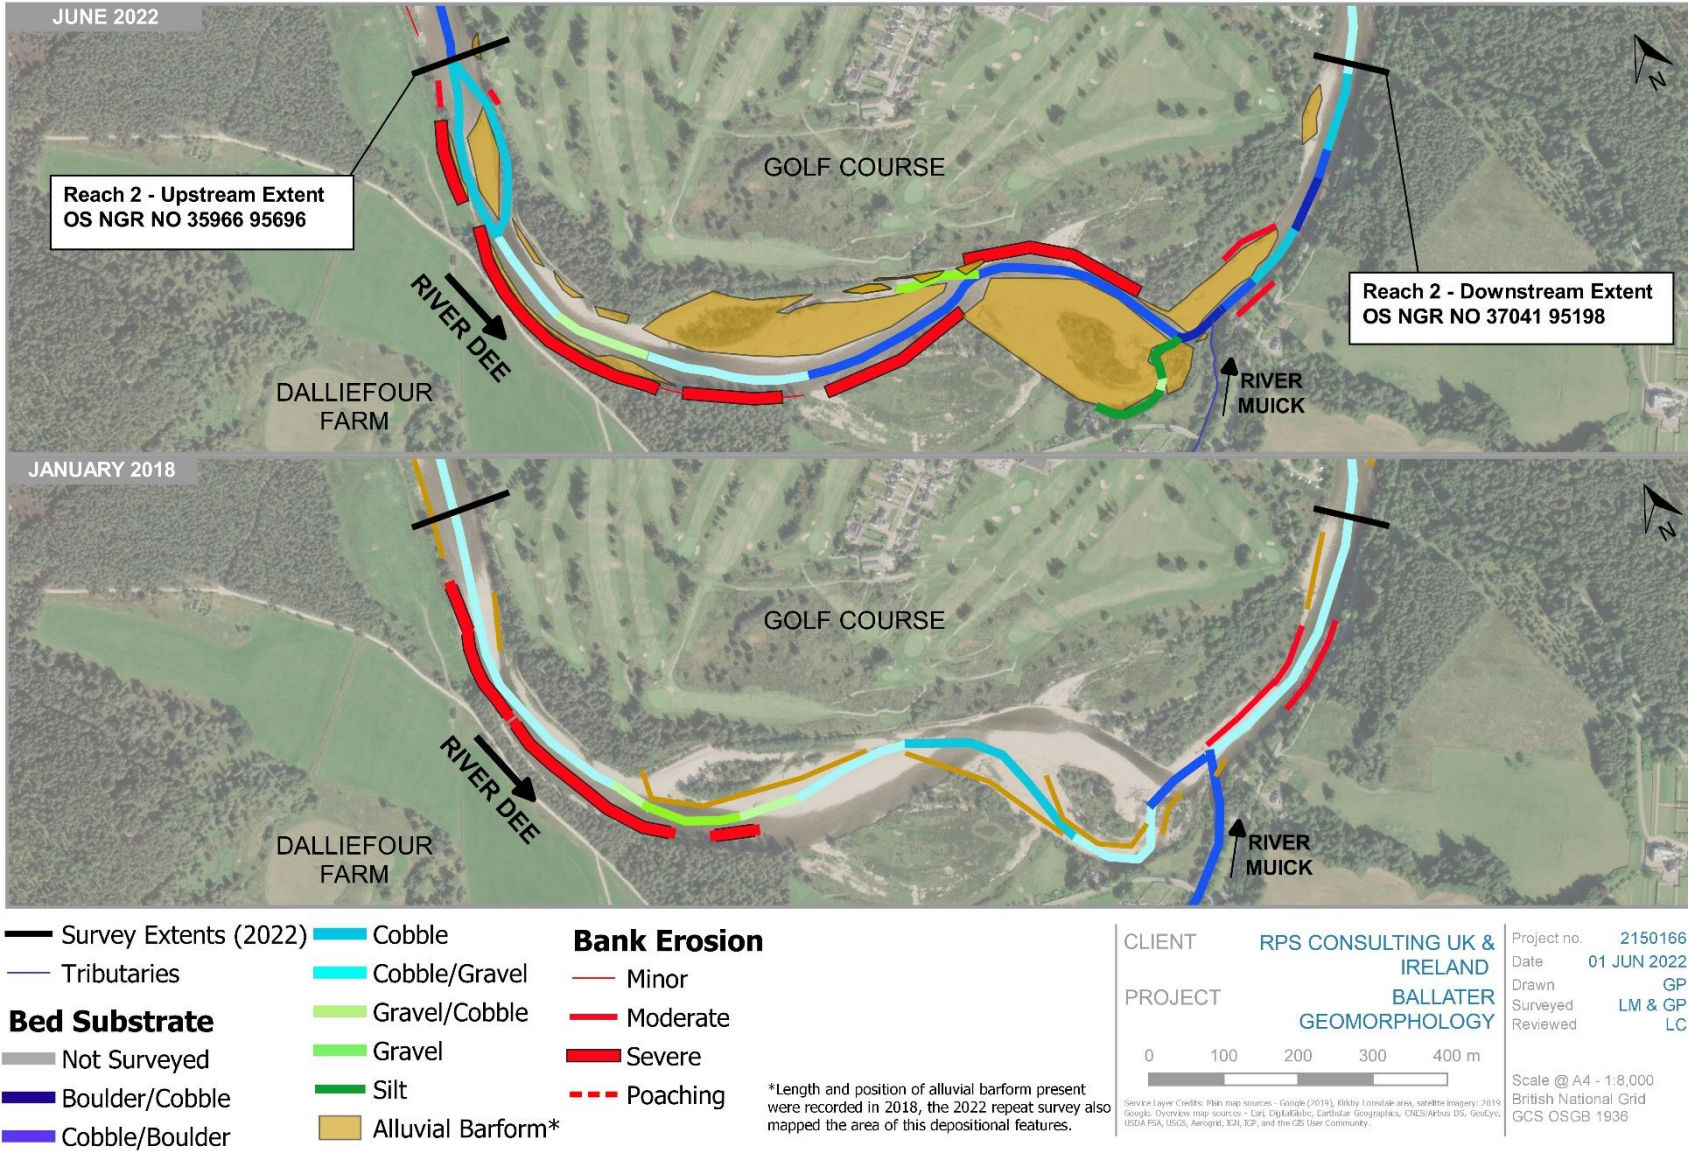
Figure 2.5 Sediment dynamics: Reach 2.

- Extensive planform change, with main channel shifting >150 m northwards in places, causing extensive erosion of left bank and footpath
- Complete lack of defined pools, suggesting all pools infilled
- General coarsening of bed substrate, now dominated by cobbles and boulders, with gravel restricted more to bar forms
- Previous course of mainstem Dee now forming backwater
- Extensive change in distribution of complex bar forms

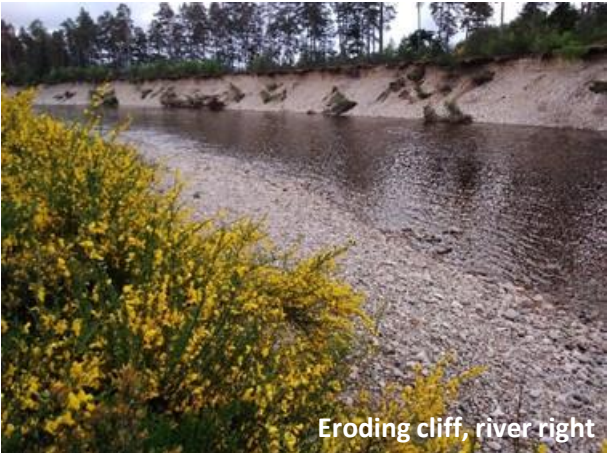
<p><b>Eroding cliff, river right</b></p>

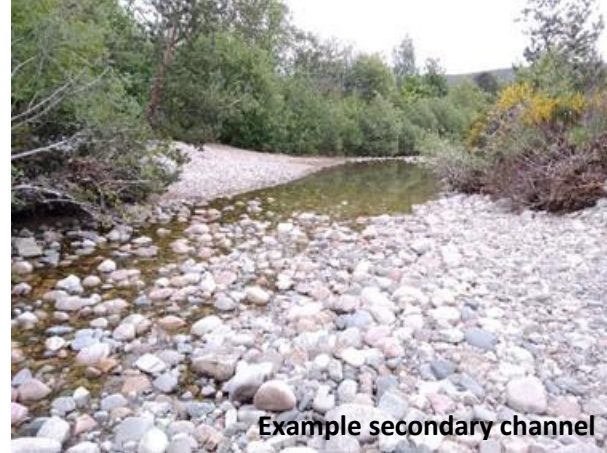
<p><b>Example secondary channel</b></p>

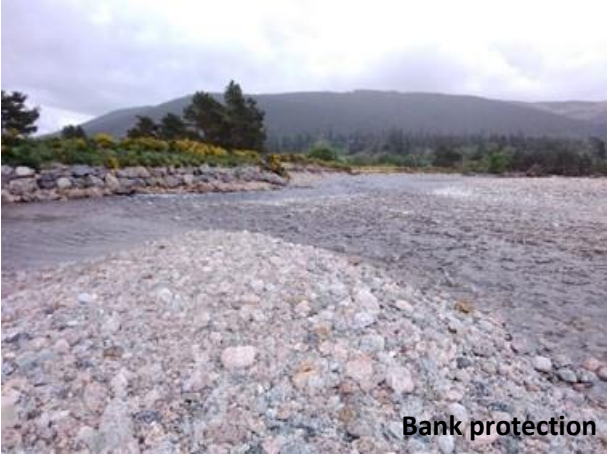
<p><b>Bank protection</b></p>

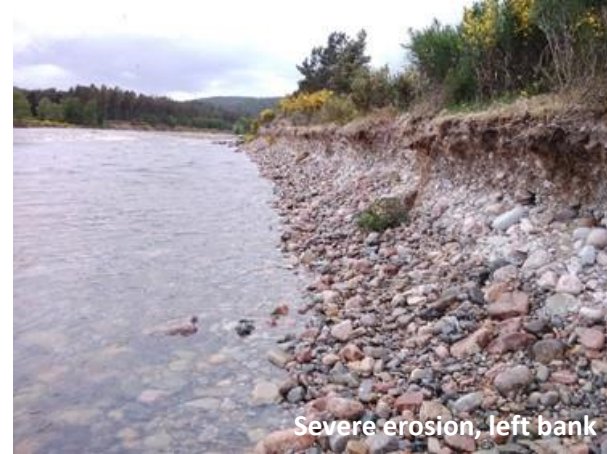
<p><b>Severe erosion, left bank</b></p>

- Large-scale avulsion of channel has caused severe bank erosion, affecting footpath; coarse material deposited across river left floodplain
- Large backwater formed along previous course of River Dee, silty substrate
- Extensive network of secondary channels on river left floodplain with sandy substrate and large wood common
- Much of bank/ floodplain area wooded outwith golf course

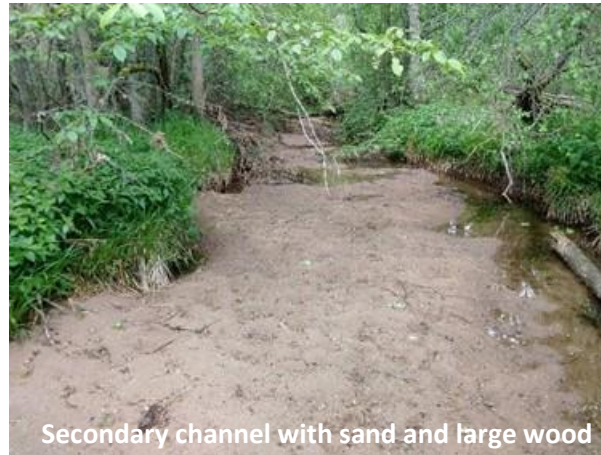
Secondary channel with sand and large wood

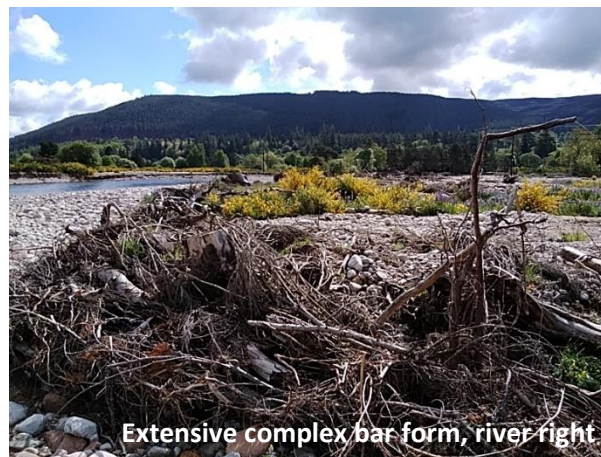
Extensive complex bar form, river right

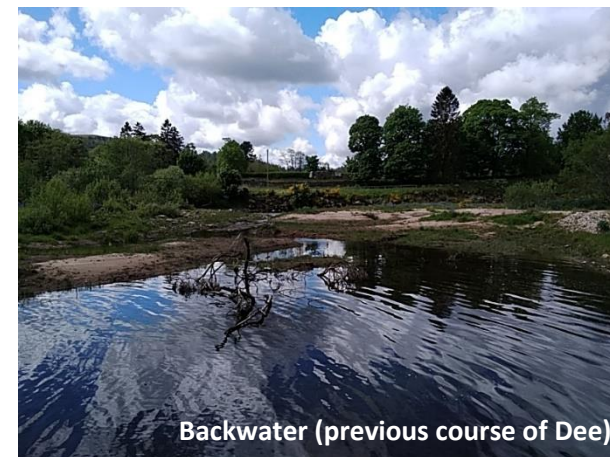
Backwater (previous course of Dee)

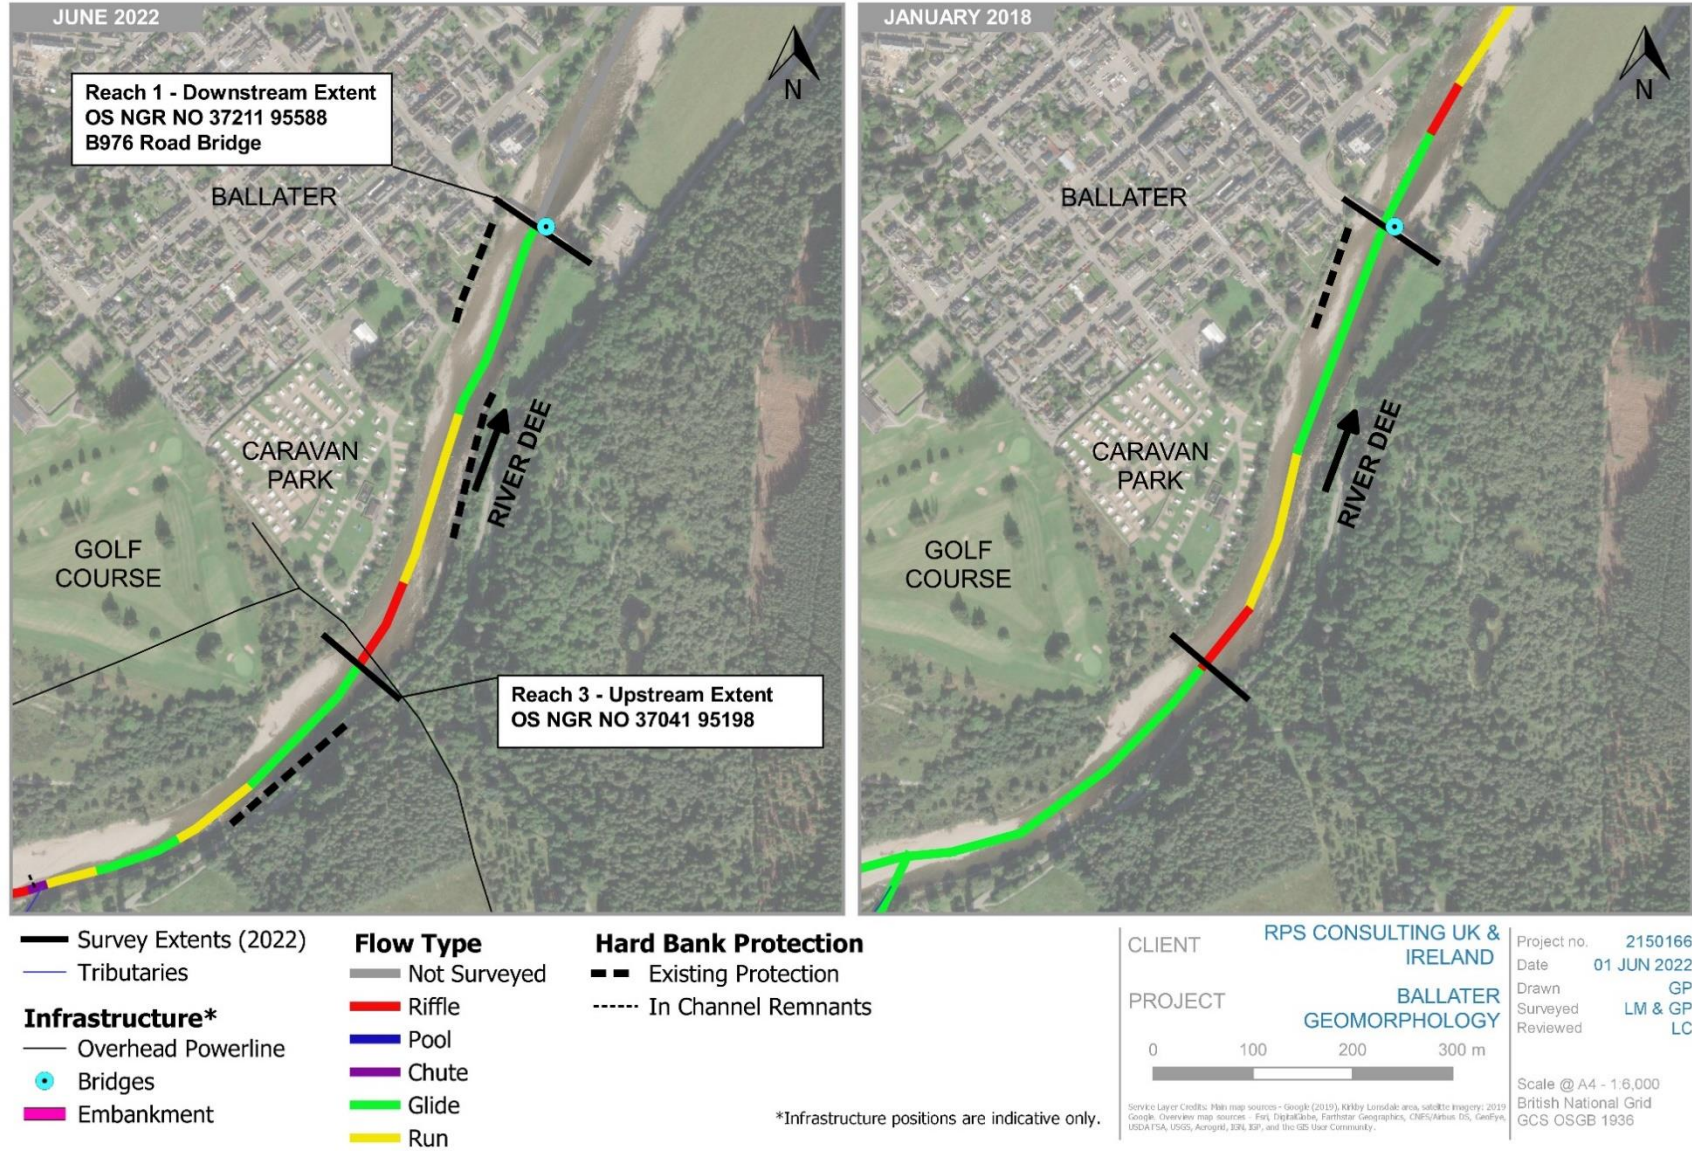
Figure 2.6 Morphological units and engineering pressures: Reach 3.

<b>River Dee at Ballater, Reach 3</b>	
<p><b>Dominant features</b></p> <ul style="list-style-type: none"><li>• Interspersed riffle, run and glide sections</li><li>• Banks generally stable and well vegetated with extensive tree cover, with little bank erosion</li><li>• Bank protection present locally</li><li>• Medial and lateral bar forms present, including vegetated island</li><li>• Bars and bed substrate dominated by cobbles and gravel in upper section and gravel downstream towards bridge</li><li>• Bed substrate generally active and clean</li><li>• Large wood generally absent except as trees in channel margin</li><li>• Channel more confined here, with steep wooded slope to river right providing constraint to lateral movement</li><li>• Caravan park and residential areas to river left</li><li>• No tributaries or drains here</li><li>• Bridge forms downstream boundary</li></ul>

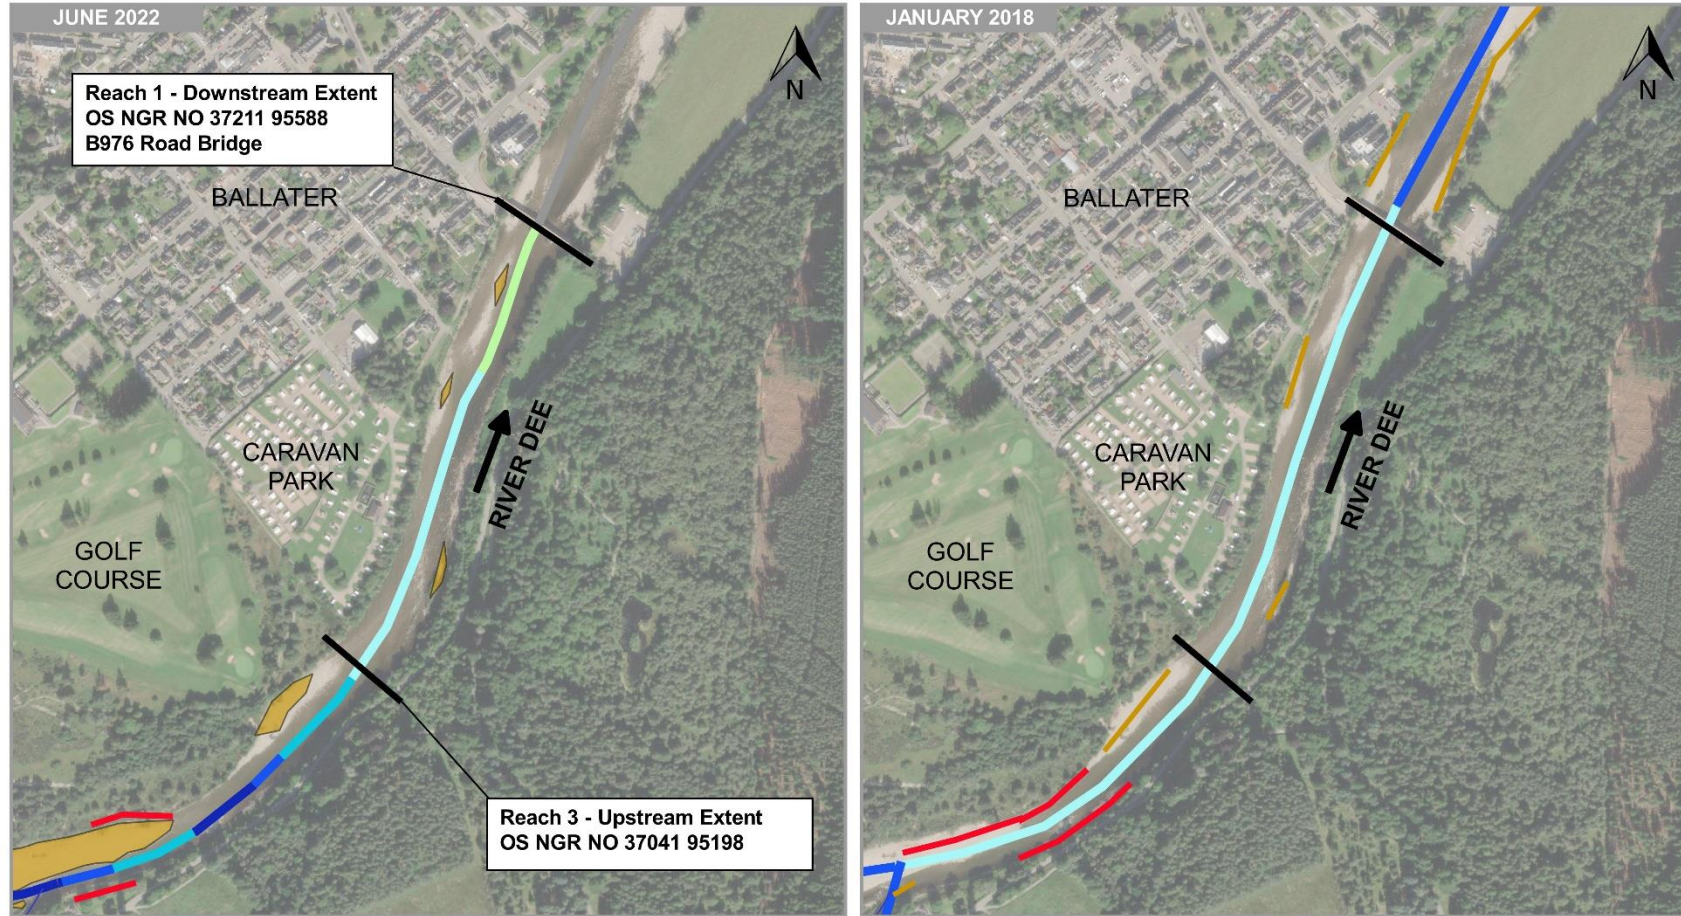
Figure 2.7 Sediment dynamics: Reach 3.

- No notable change in planform
- No notable change in morphological units
- General fining of bed substrate with gravel dominant in section upstream of bridge
- No notable change in alluvial bar forms

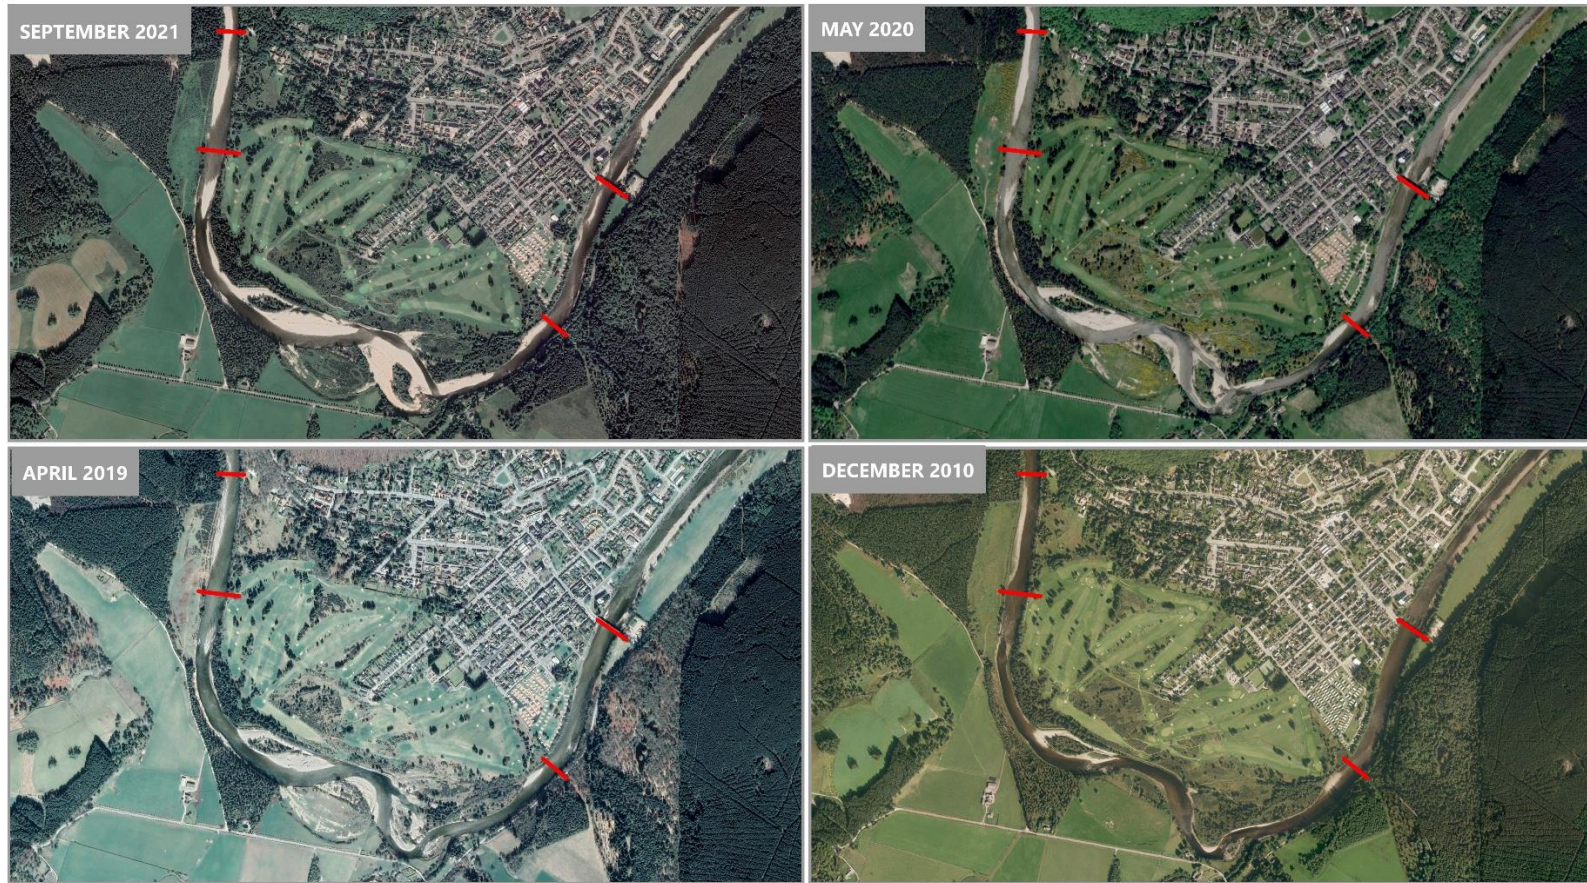
Figure 2.8 Aerial Imagery between 2010 and 2021, showing channel planform adjustment and evolution of alluvial barforms throughout the last decade.

- The sediment ‘pulse’ generated through Storm Frank has significantly altered the channel configuration in the vicinity of Ballater golf course, leading to a migration of the main stem of the River Dee;

- Where Storm Frank had locally increased cross-sectional area and lowered transport capacity (such as the area immediately upstream of the confluence with the River Muick), large alluvial deposits have developed in the period between fluvial audits.

- The development of these alluvial deposits has effectively cut-off the previous main flow route of the River Dee upstream of the Muick confluence, significantly altering the hydraulic patterns and shear stress observed at channel boundary along the left bank.

- This change in cross-sectional profile and channel hydraulics exacerbated erosional forces along the left bank of the Dee in the lower section of the embankment protecting the golf course and the town of Ballater.

1. Removal of dead trees to build up banks and decrease channel lateral migration
2. Re-excavate previous main-stem channel, diverting majority of flows from left bank/ golf course
3. Clear out channel on golf course outfall
4. Build up bund on golf course using Hesco barriers

- The suitability of Option 1 to decrease the rate of channel lateral migration in proximity to the golf course. This could contribute towards the natural reactivation of the previous primary

- The potential suitability of Option 2 to encourage the re-occupation of the previous main flow route. However, this intervention would require a robust detailed design process to provide evidence that newly dug main channel can be self-sustainable and will not perform as a sediment “sink” in the next high flow events.

- Some likely limitations to the long-term effectiveness of Option 3. Considering the grain diameter of sediment recently deposited in the area of woodland closer to the golf course it appears that, within the current channel configuration, relatively small events can deposit substantial volumes of fine material in these side channels. Therefore, the depositional character of this area can significantly limit the long-term effectiveness of this option.

- That Option 4 may provide a positive contribution to the desired 1 in 10 year standard of protection, with minimal impact to geomorphic processes. However, careful consideration will be necessary to ensure that final barrier configuration does produce the following negative impacts:

1. Barriers deflecting hydraulic forces during a high flow event and increasing shear stress and erosive potential in the River Dee.
  2. Potential for changes in nearby flood levels in proximity to golf course and caravan park. In particular, it is recommended that barrier installation is not completed prior to undergoing hydraulic modelling updates.
