ASSESSMENT OF THE RED BRAE COLLAPSE ON THE FLOODING MECHANISM OF 30TH DECEMBER 2015

RPS, August 2019

FINAL REPORT

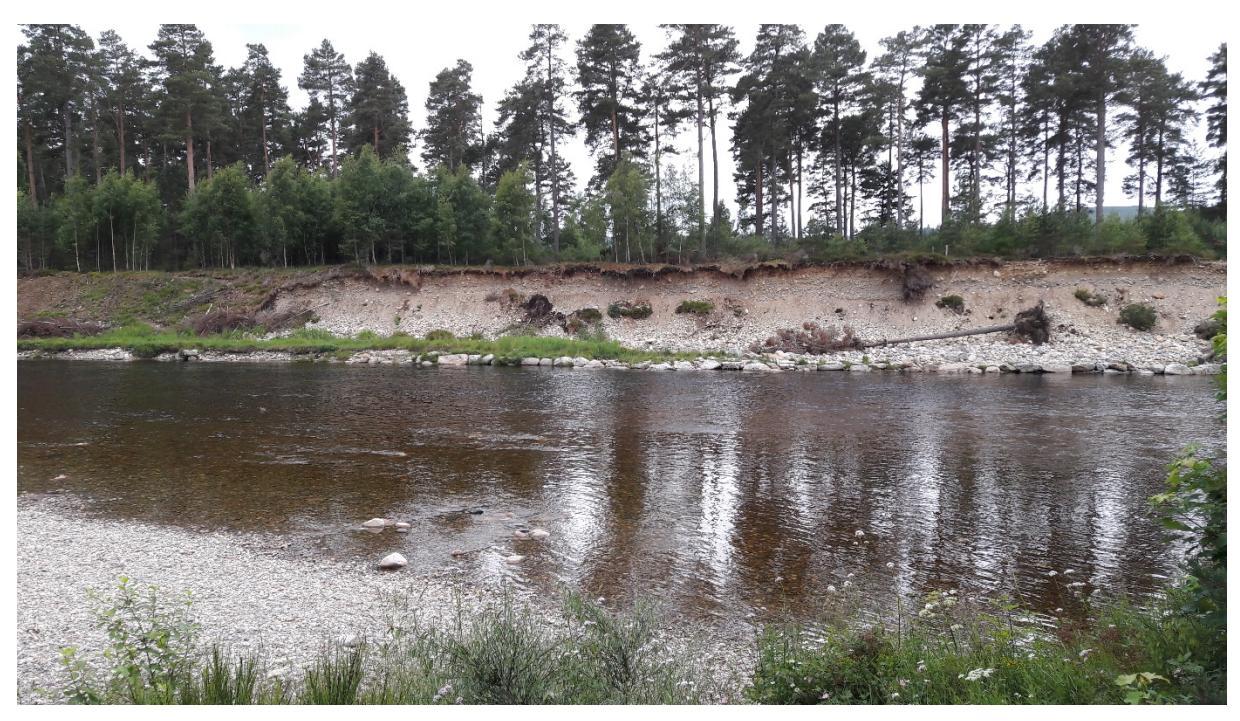
Figure 2 Photograph of the Red Brae, River Dee (taken at cross-section RD63).

The Red Brae is located along the right bank of the River Dee, on the opposite side of the river to Ballater Golf Course (see Figure 1). The Red Brae is characterised by steep slopes, with the top of bank approximately 8 to 10 metres above the river channel (see Figure 2). The channel in the vicinity of the Red Brae and surrounding area, is dominated by erosional processes, with scour 'leading to the failure of an extensive length of high alluvial river terrace' (cbec, 2018).

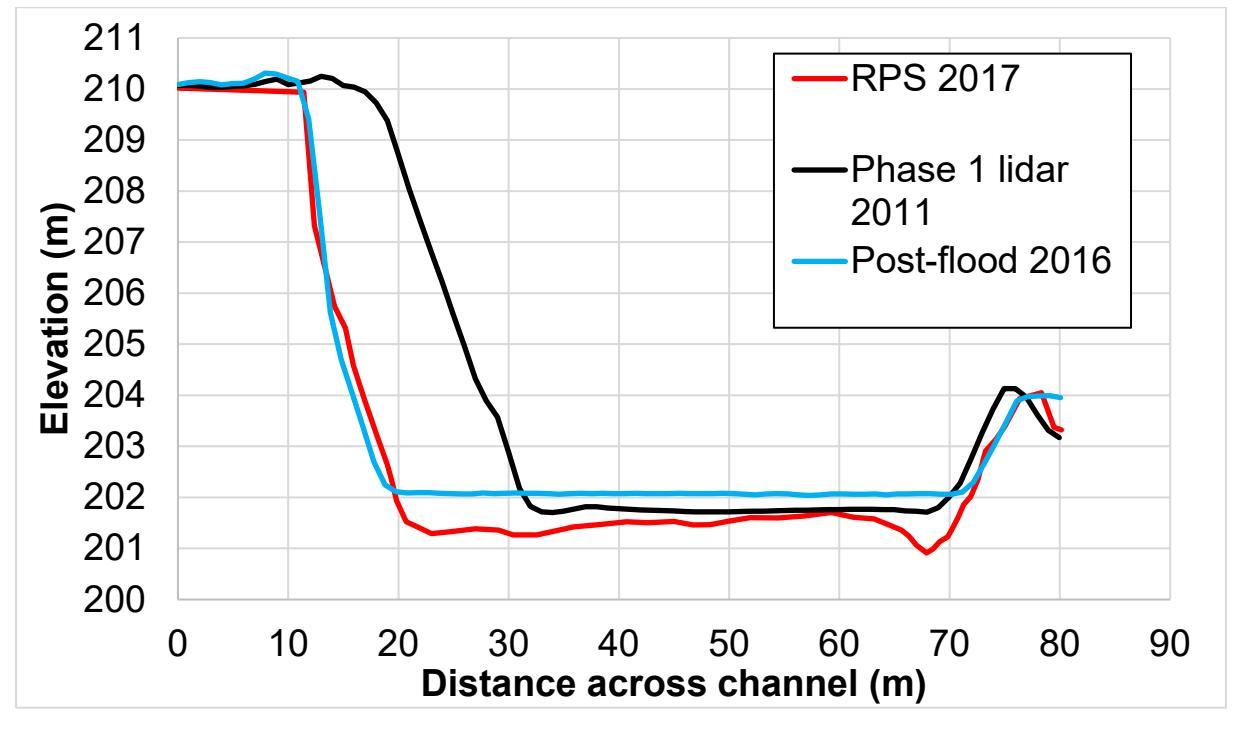
Figure 4 Comparison of River Dee cross-sections (RD63) at the Red Brae.

Figure 4 compares cross-sections that JHI extracted from LiDAR data recorded in 2011 and 2016 (black and blue lines respectively) at a representative point along the Red Brae (cross-section RD63). The right bank of the River Dee (Red Brae) is shown on the left of Figure 4. This shows that the Red Brae receded by approximately 13 metres at river level and by approximately 8 metres at the top of bank. Both of these cross-sections incorporated the river level when the LiDAR data was recorded. RPS undertook a topographical survey of the River Dee in the summer of 2017, as part of the Ballater Flood Protection Study. The relevant cross-section is shown in red in Figure 4, which is comparable to the other post-flood event cross-section (from the 2016 LiDAR). It should be noted that the 2017 cross-section incorporates the river bed level (and the not the river water level) at the time of the survey. Figure 4 also shows the width of the River Dee at cross-section RD63 changed from approximately 40 metres in 2011 to over 50 metres in 2016 and 2017.

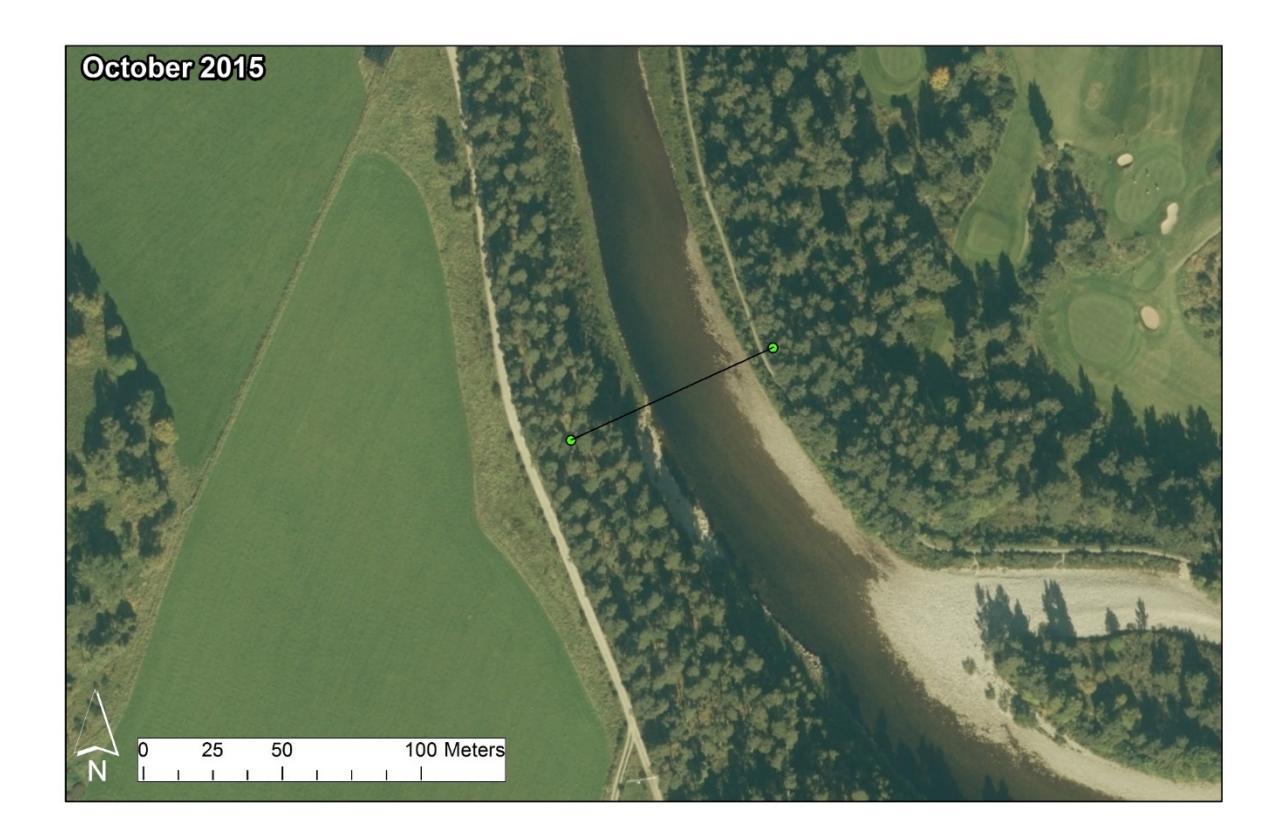
Figure 5 Aerial image of area where cross-section RD63 is located, before December 2015.

Figure 5 and Figure 6 show aerial images of the area where cross-section RD63 is located, and demonstrate how the channel has widened between October 2015 and April 2016 when the images were recorded. These images, in addition to the cross-sections in Figure 4, suggest that the changes in the channel geomorphology at this location occurred as a result of the 30th December 2015 flood event.

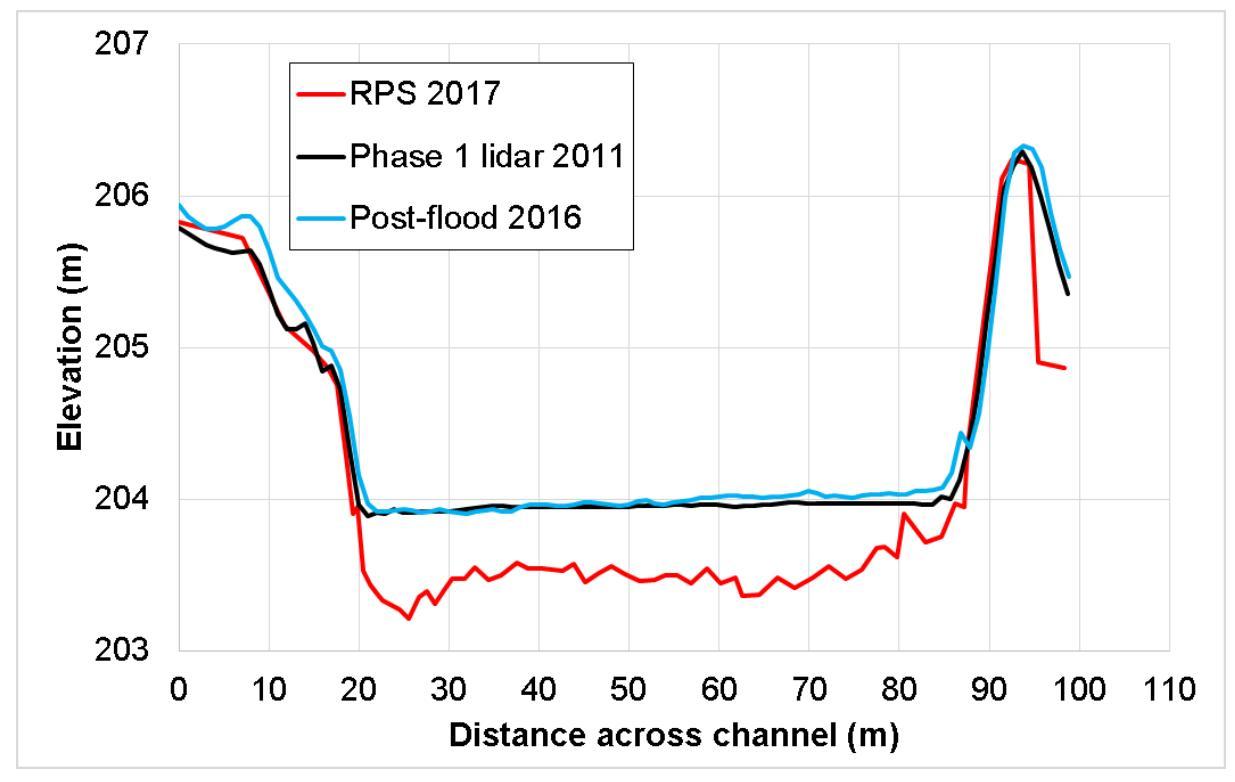
Figure 7 compares cross-sections that JHI extracted from LiDAR data recorded in 2011 and 2016 (black and blue lines respectively) at the point where a breach of the informal flood embankment occurred during the 30th December 2015 flood event (cross-section RD57). Figure 3 shows that this is located upstream of where the Red Brae is considered to be located, by approximately 300m. The right bank of the River Dee is shown on the left of Figure 7, and is less than 3m high (in comparison with over 8m at RD63). Both of these cross-sections incorporated the river level when the LiDAR data was recorded. The relevant cross-section recorded during the RPS 2017 survey is shown in red in Figure 7. It should be noted that the 2017 cross-section incorporates the river bed level (and the not the river water level) at the time of the survey. Figure 7 shows that there was an insignificant change in the river profile between 2011 and 2017, and therefore it is concluded that there was no collapse during the 30th December 2015 flood event at this location on the river.

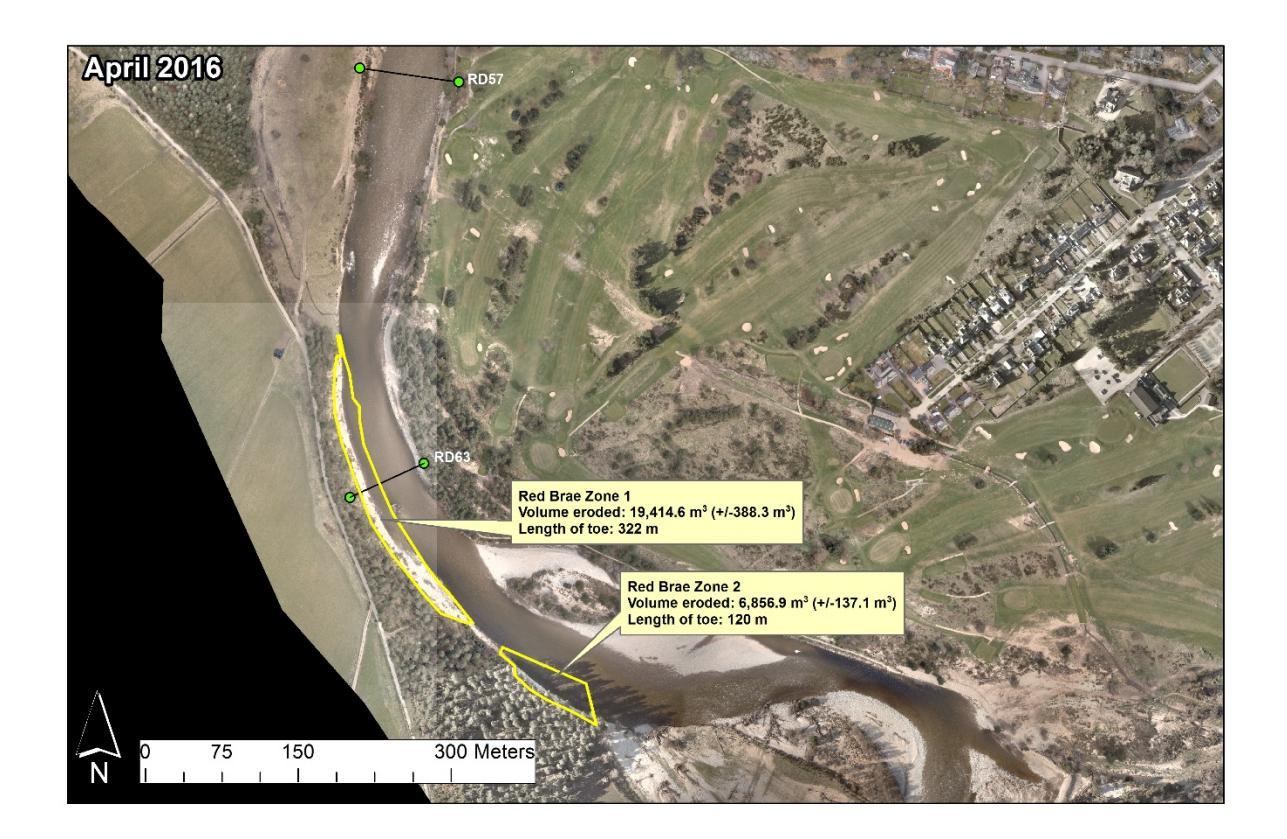
Figure 10 Estimated volume of eroded material at the Red Brae following December 2015

A more simplified assessment, based solely on the estimated dimensions of the Red Brae terrace (i.e. on average 8.5m tall along a length of 442m, having receded an average of 10m) then this equates to a total volume of 37,570m³ which potentially collapsed into the Dee. The two different methods produce significantly different estimated volumes of material, however, it can be said that they both support the case for a very large volume of material being eroded from the Red Brae in December 2015.

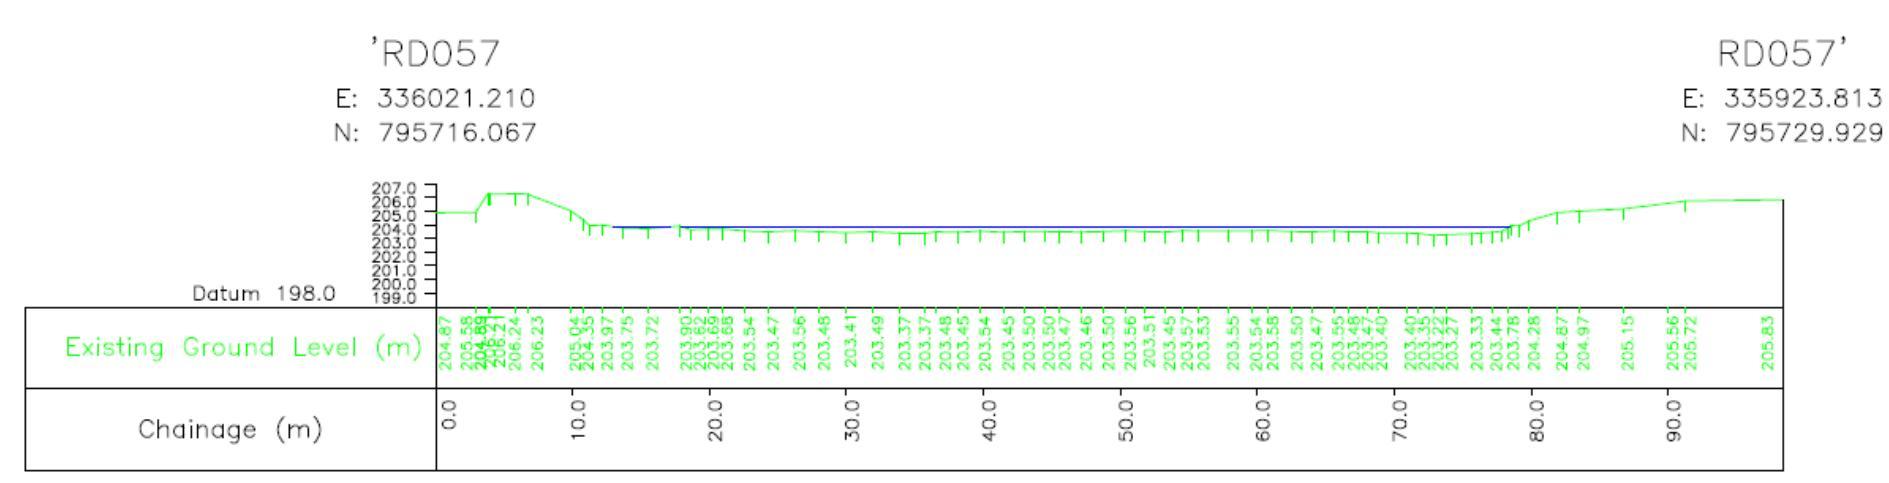
Figure 11 Cross-section RD57 recorded during the 2017 topographical survey

Figure 3 shows the reported location of the breach within the informal flood defence embankment. This is located close to the 14th tee of the Golf Course, between cross-sections RD57 and RD58 (Figure 11 and Figure 12 respectively), where the current height of the right bank above river level is much reduced in comparison to RD63 as shown in Figure 13 (and therefore the impact of collapse further diminished assuming a similar height of bank prior to December 2015). The height of the right bank above the recorded level at RD58 is approximately 2.5m. It is noted that the breach location is approximately 300 metres upstream of cross-section RD61 (which is considered to be the start of the Red Brae) meaning that the collapse would have had to produce a significant backwater effect in order to be the main contributing factor to the breach in the informal flood defence and the diversion of flows across the golf course.

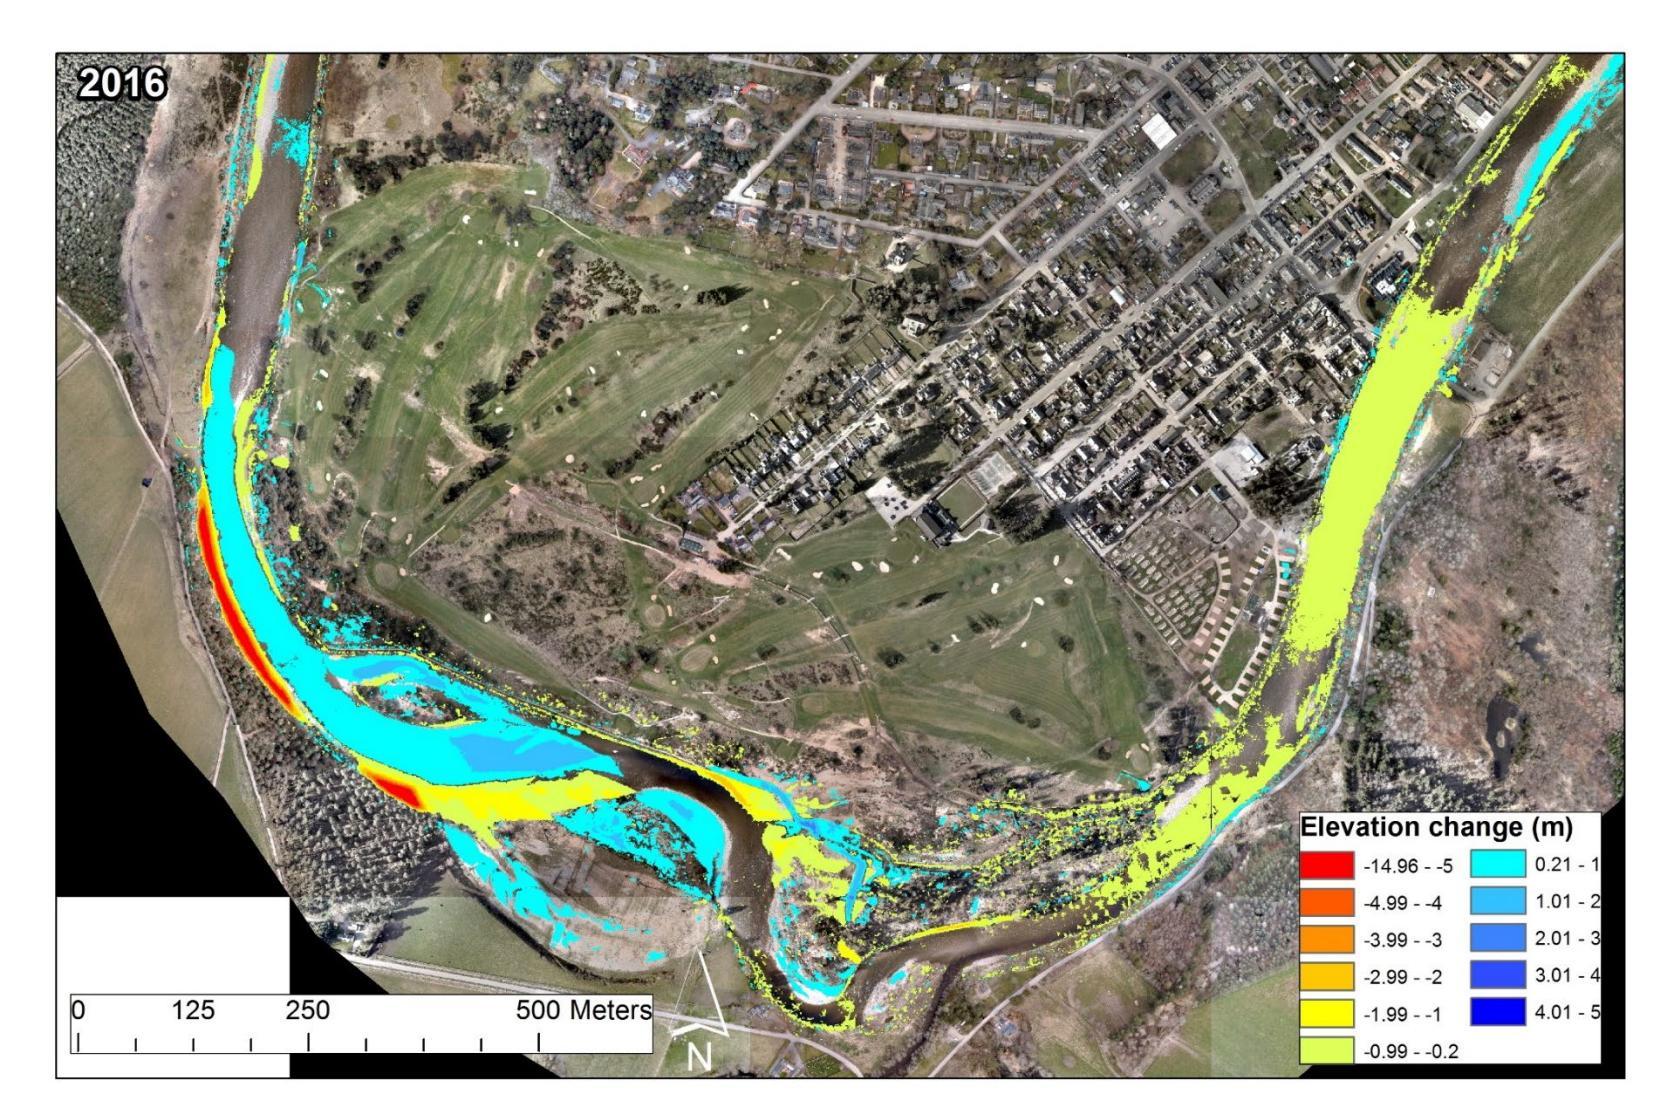
Digital elevation model of difference based on subtraction of the 2016 LIDAR elevation data by the 2011 LIDAR elevation data. Yellow, orange and red colours highlight erosion (i.e. surface lowering) and the blue colours show deposition (surface raising). Only changes greater than 0.2 m are shown due to error in the LIDAR data. Note that erosion or deposition changes within the wetted areas of river channel are not considered reliable.
