**BALLATER FLOOD PROTECTION SCHEME
GEOMORPHIC PROCESS MODEL AND REVIEW OF MORPHOLOGICAL IMPACTS**

FINAL REPORT

**Prepared for
RPS
and
Aberdeenshire Council**

**Prepared by
cbec eco-engineering UK Ltd**

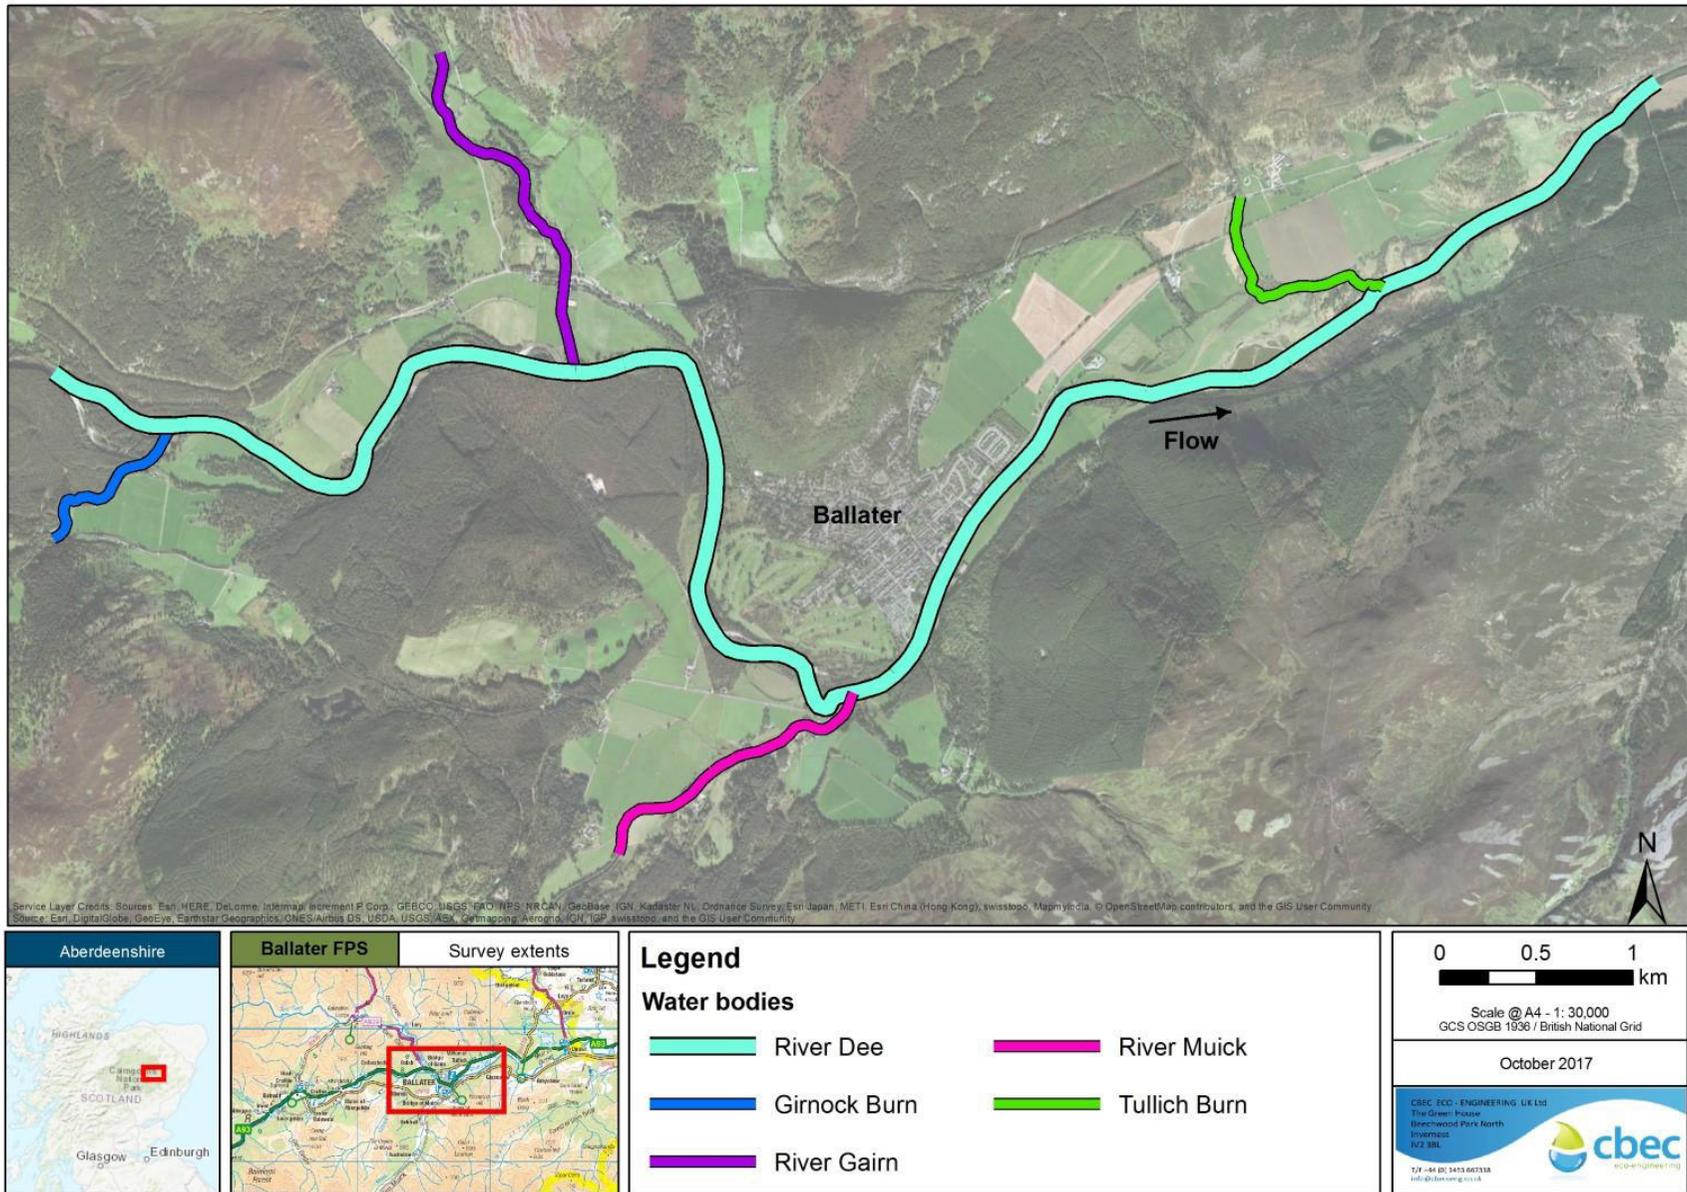
Figure 2.1 Surveyed extents of River Dee mainstem and main tributaries.

The fluvial audit assessment continuously characterised physical conditions along a ~12 km section of the main-stem River Dee, from OS NGR NO 32682 96518 (upstream) to NO 41064 98167, (approximately 3.8 km downstream of Ballater). In addition, sections of four tributaries were surveyed to their confluences with the Dee; Girnock Burn from NO 32580 95745, River Gairn from NO 34541 98325, River Muick from NO 35525 94155 and Tullich Burn from NO 38736 97494. The survey extents are shown in Figure 2.1.

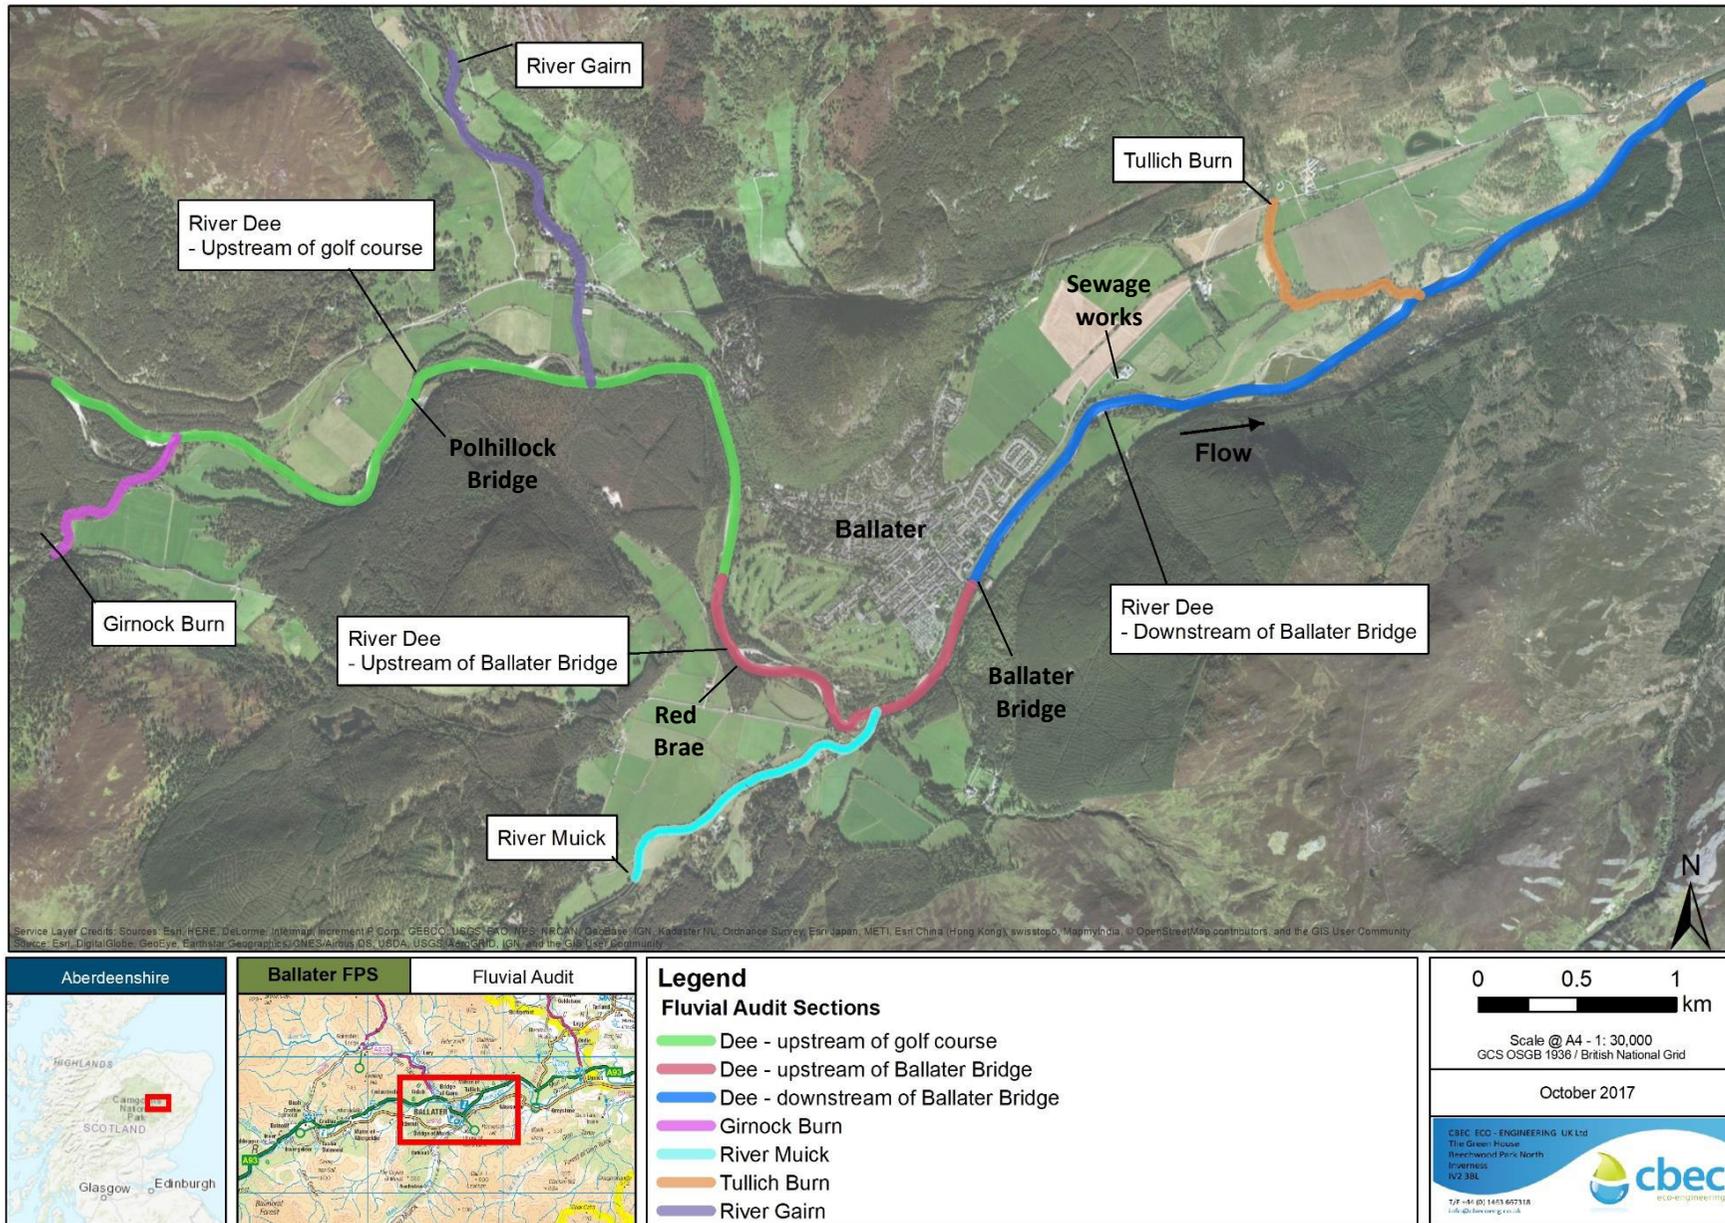
Figure 2.2 Fluvial Audit summary sections and key features.

These sections are illustrated in **Figure 2.2**, with survey data provided in **Figure 2.3** and **Figure 2.4**.

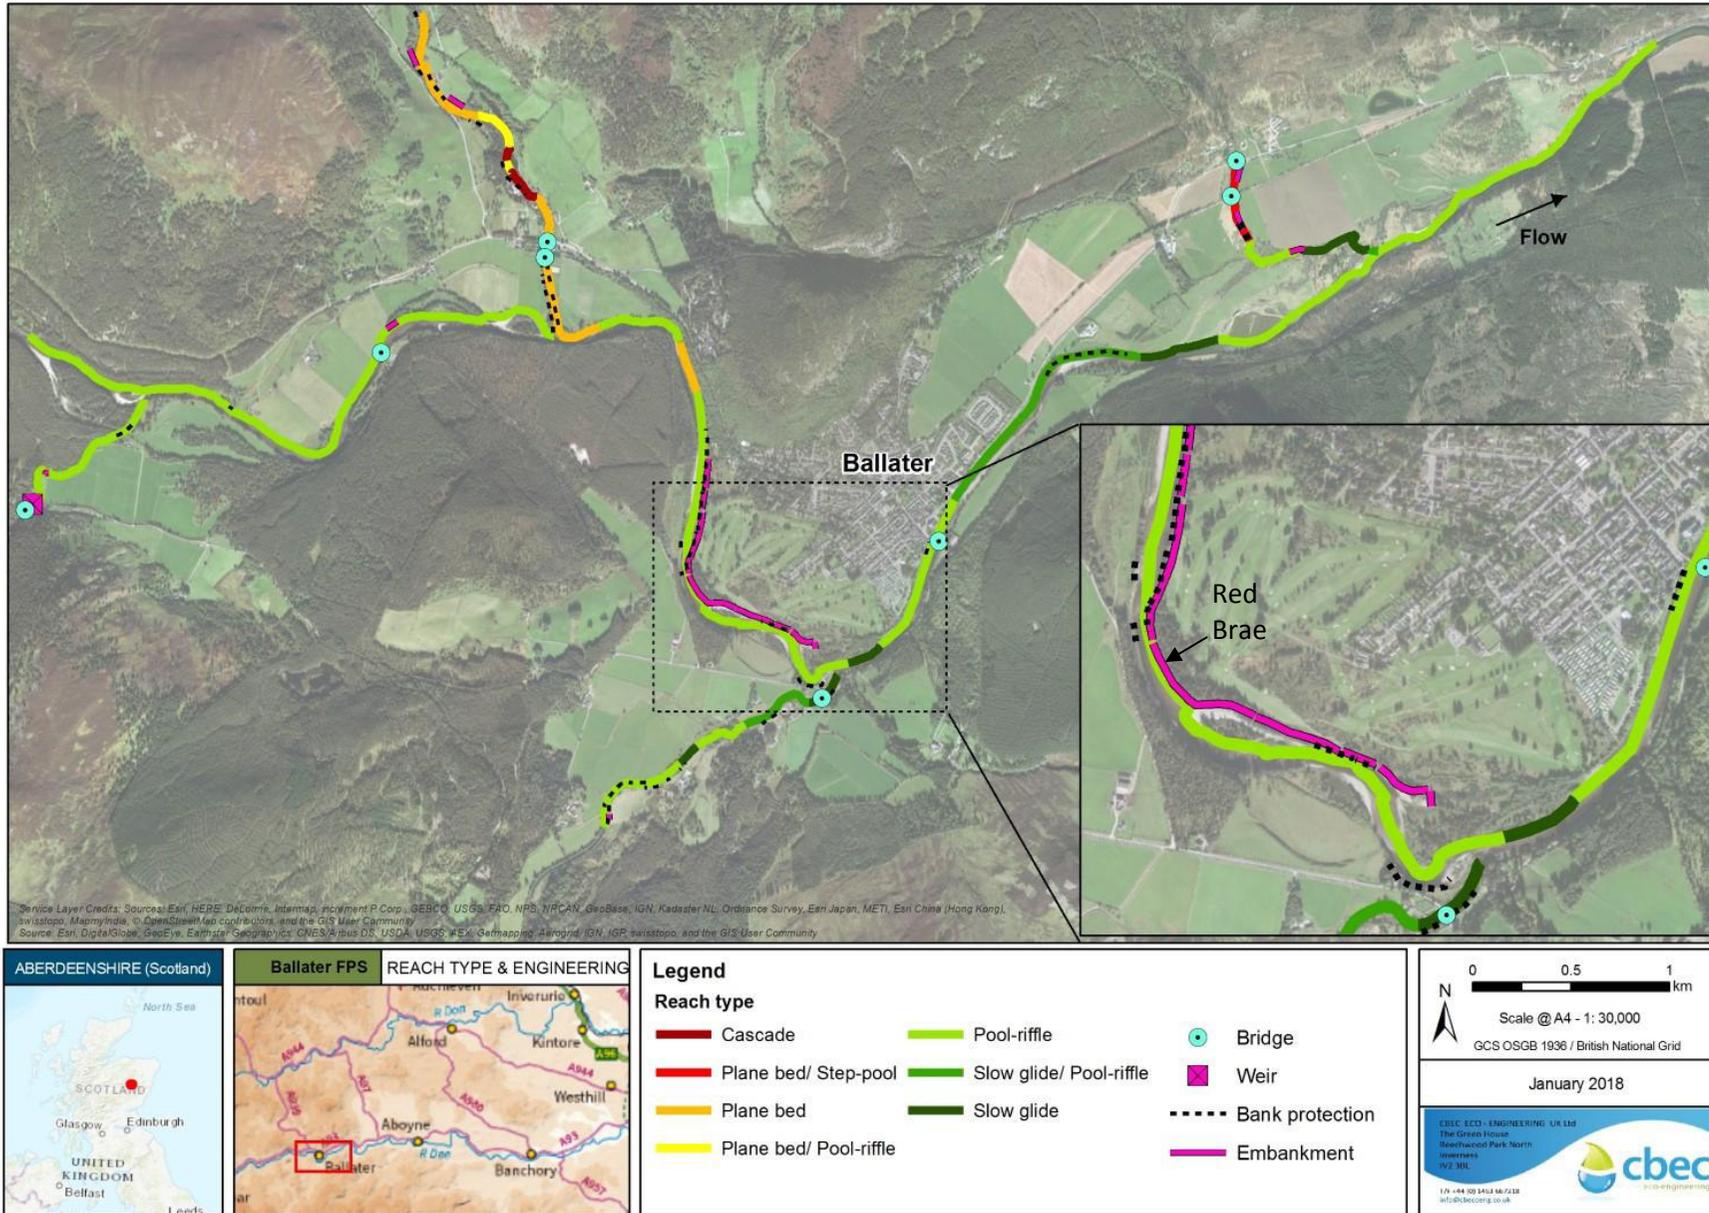
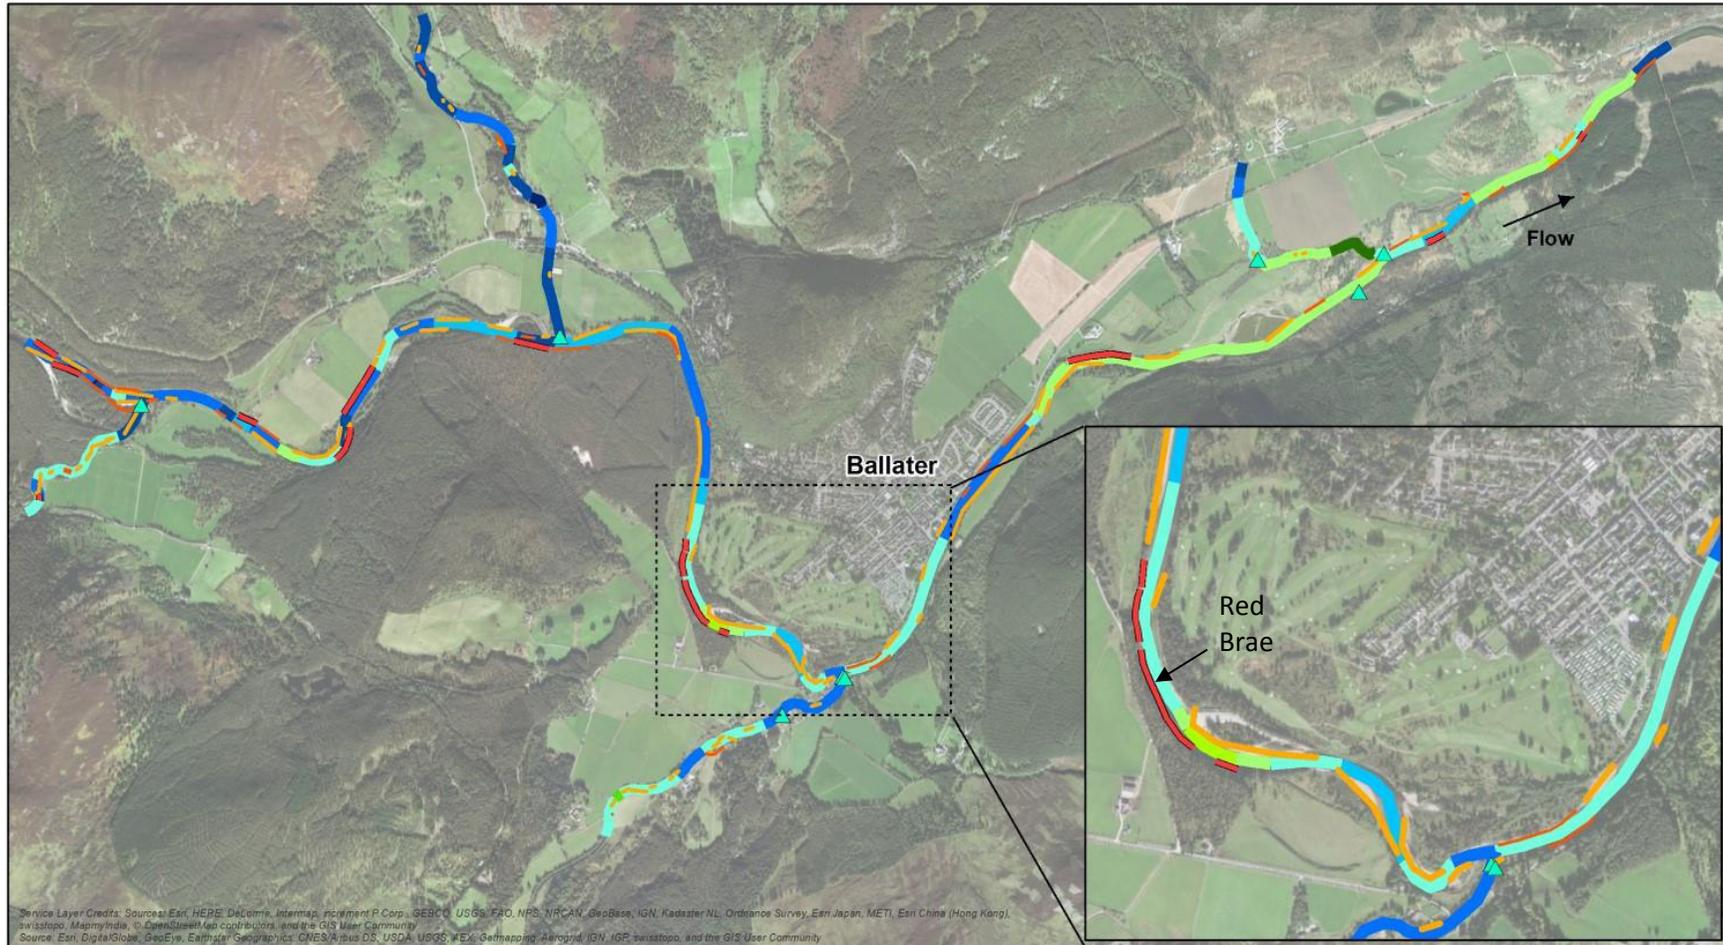
Figure 2.3 Reach type and engineering pressures

SUBSTRATE	
	Cobble/gravel
	Gravel/cobble
	Gravel
	Sand/cobble
	Silt
	Bedrock
	Boulder/cobble
	Cobble/boulder
	Cobble
	Tributary
	Alluvial barform
Bank erosion	
	Severe
	moderate

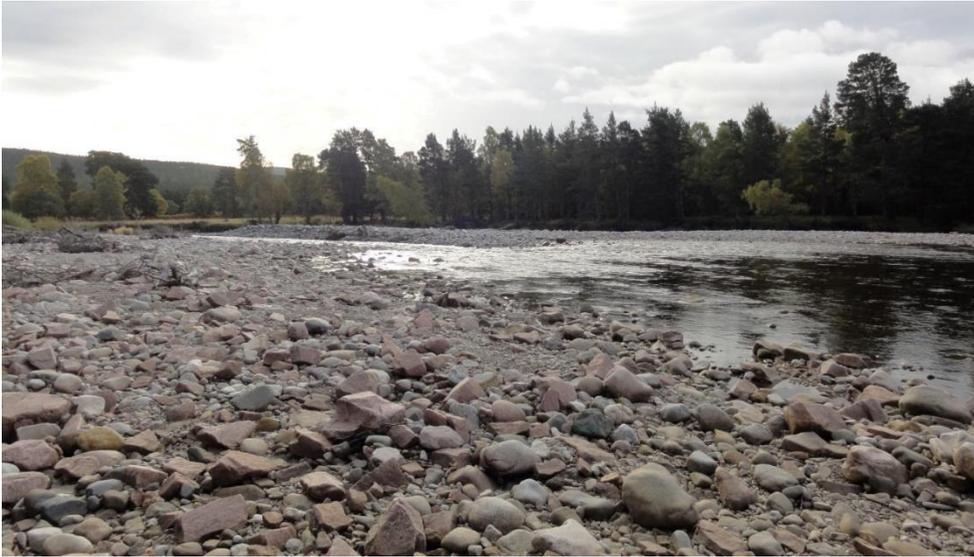
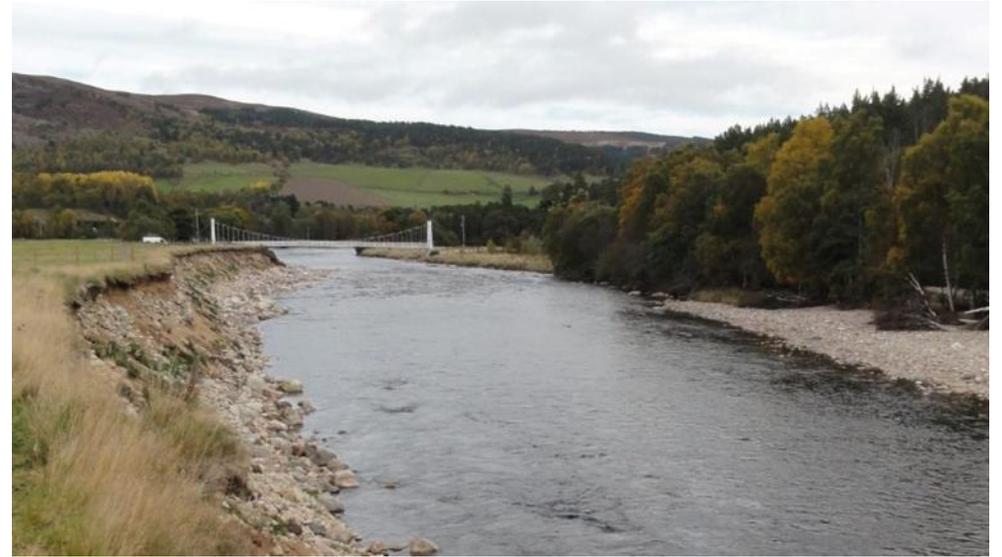
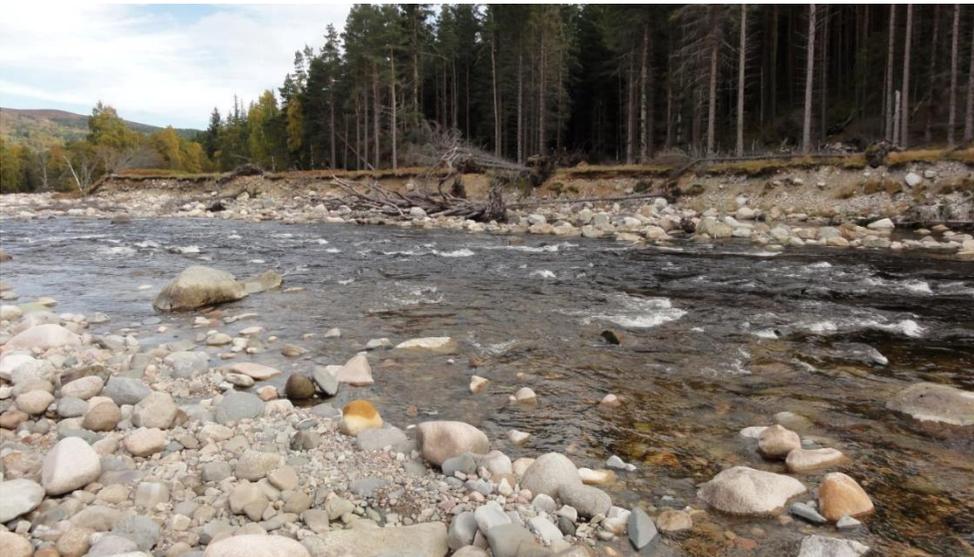
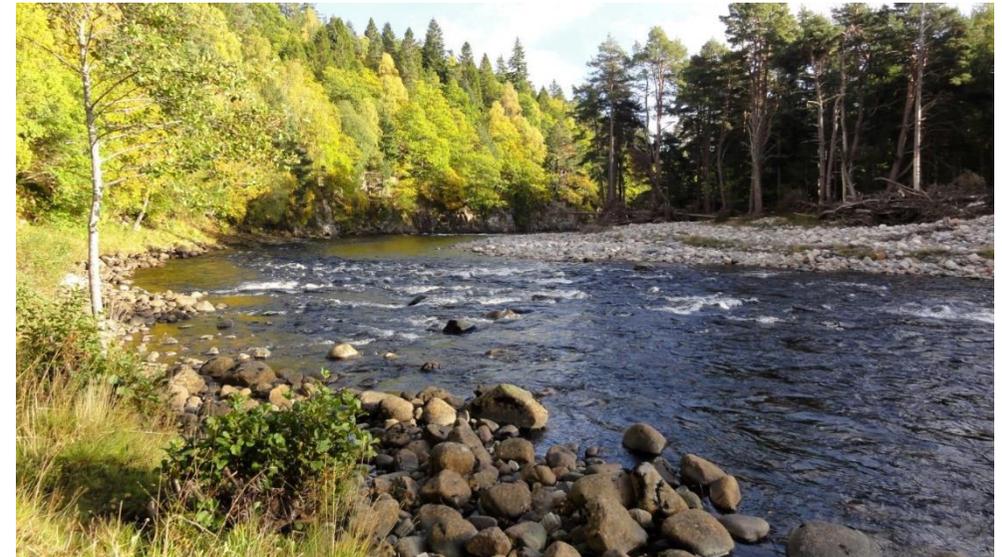
Figure 2.5 Survey photos from mainstem River Dee (upstream of Ballater Golf Course). Top left: significant deposition at upstream extent of reach, bottom left: severe erosion on right bank upstream of Polhilllock Bridge, top right: extensive erosion along left bank upstream of Polhilllock Bridge, bottom right: section of naturally confined river corridor downstream of River Gairn confluence).

At the upstream limit of this section (in the vicinity of the confluence with the Girnock Burn), historic evidence of a relatively short wandering section was recorded. Analysis of the available time-series of historic maps (starting with OS One Inch-1897) has highlighted a tendency towards decrease in planform sinuosity during the pre-Storm Frank period, with evidence of stabilisation of bars/ mid-channel islands, and a progressive shift towards a morphology dominated by a single-thread channel flowing in proximity to the northern bank (likely associated with recovery from geomorphic instability generated during the Muckle Spate event). However, the magnitude of the Storm Frank event exceeded local thresholds for geomorphic change, resulting in both severe erosion of the boundary materials (bed and banks) in the main channel and partial reactivation of historic channels, leading to localised severe aggradation. This has produced both a reconfiguration of channel geometry and a significant increase in availability of unstable erodible sediment following the Storm Frank event. Importantly, these changes are likely to have resulted in a localised decrease in threshold for geomorphic change, with the potential to lead to significant future adjustment of channel geometry and mobilisation of sediments during subsequent smaller flood events.

While subsequent patterns of channel adjustment and sediment transport through this section will be largely dictated by the relationship between the rates of vegetation colonisation/ depositional feature stabilisation and the frequency/ magnitude of future flood events, the observed changes in channel geometry and availability of transportable material are likely to have produced a temporary adjustment (lowering) of thresholds for geomorphic change. When coupled with the forecasted evolution in rainfall patterns for this area of Scotland (with an increase in frequency and magnitude of heavy rainfall events), a period of geomorphic instability and rapid adjustment of channel form can reasonably be expected for this section of the main-stem River Dee.

Considering this increase in the supply of materials with the potential for mobilisation during flood events and the predicted lowering of thresholds for geomorphic change, it is considered that this area of the main-stem River Dee has the capacity to supply significant volumes of sediment to downstream reaches during subsequent flood events. In addition, a localised increase in valley confinement coupled with a decrease in sinuosity was recorded in the reach immediately downstream (i.e. between the confluence with the River Gairn and Ballater golf course). It is, therefore, considered that 'efficient' sediment transport through the lower section of this area of the River Dee is likely to result in a potential for increase in supply of sediment to the reach immediately upstream of Ballater.

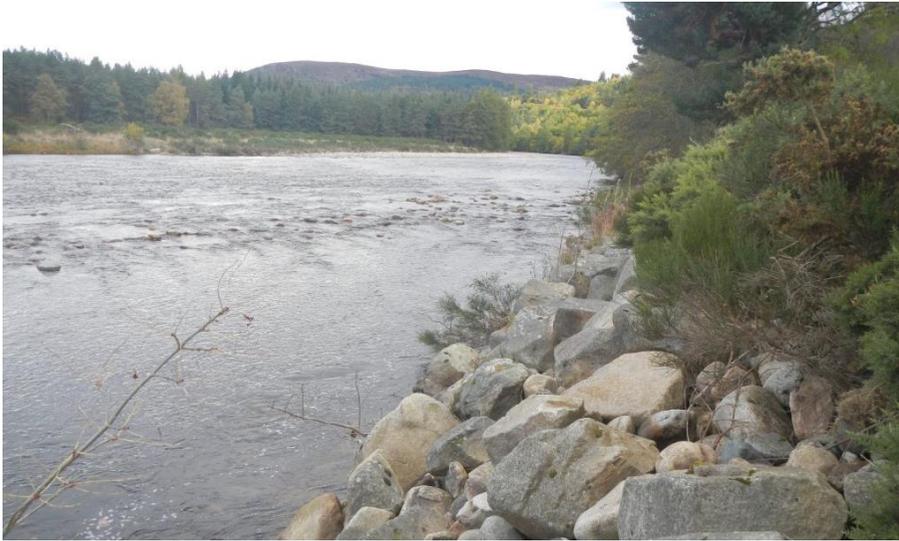
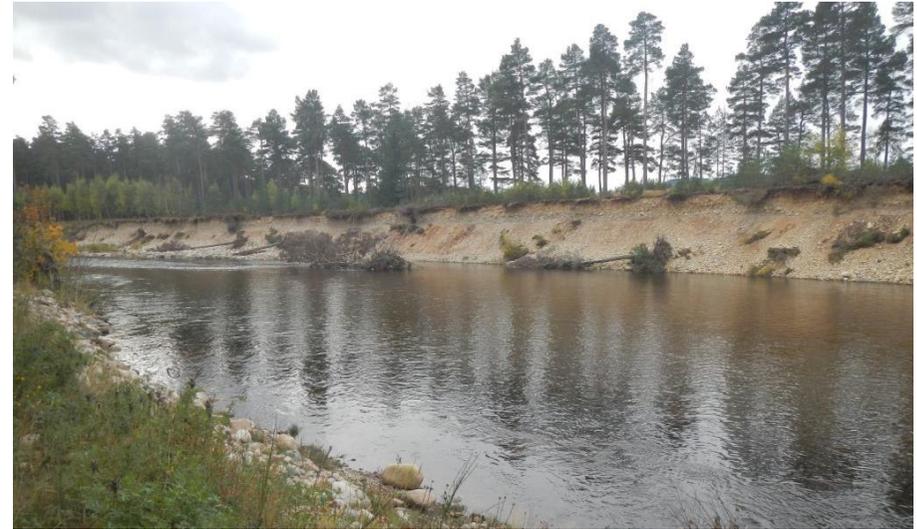
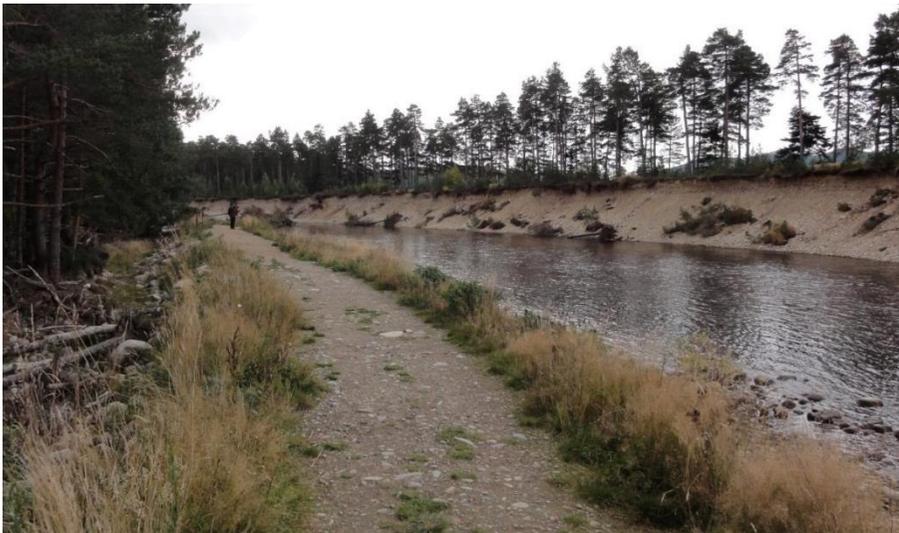
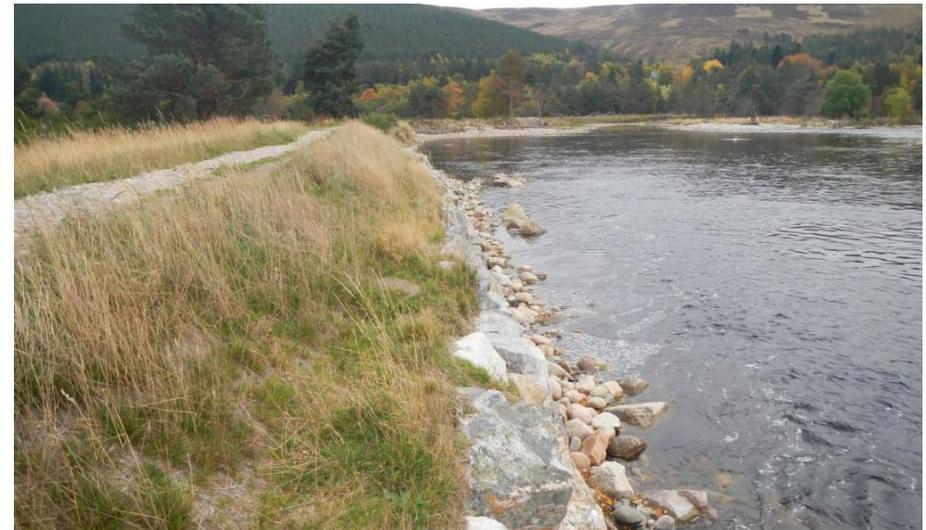
Figure 2.6 Survey photos from mainstem River Dee (between Ballater Golf Course and Ballater Bridge). Top left: rip rap bank protection on left bank (view upstream), bottom left: significant river terrace erosion at Red Brae (right bank), top right: Additional view of eroded right bank, bottom right: boulder rip rap in left bank.

The historical evolution of channel form of the River Dee (between 1866 – 1972) is assessed in detail in an extensive review of the geomorphological character of the system (Cheltenham and Gloucester College, 2000). The study indicates that this particular section of the Dee has seen significant erosion in the Red Brae locality throughout this period. It also identified this specific area as being a major source of potential future input to the Dee system. SEPA's 2017 review corroborates this, and estimates that the bank has eroded/ retreated by up to 20 m in a five year period between 2011 and 2016, with Storm Frank being responsible for a significant proportion of this.

Importantly, Storm Frank has significantly disturbed depositional features that had, for the century preceding this event, been characterised by progressive stabilisation. As a result, it is anticipated that thresholds for geomorphic change will have experienced a temporary lowering, following the disturbance associated with the Storm Frank event. Field observations from cbec's fluvial audit and SEPA's geomorphology team corroborate this hypothesis, with areas of severe bank erosion and localised deposition being observed without flows of bankfull or higher having occurred over the period between Storm Frank (December 2015) and the date of the fluvial audit (October 2017).

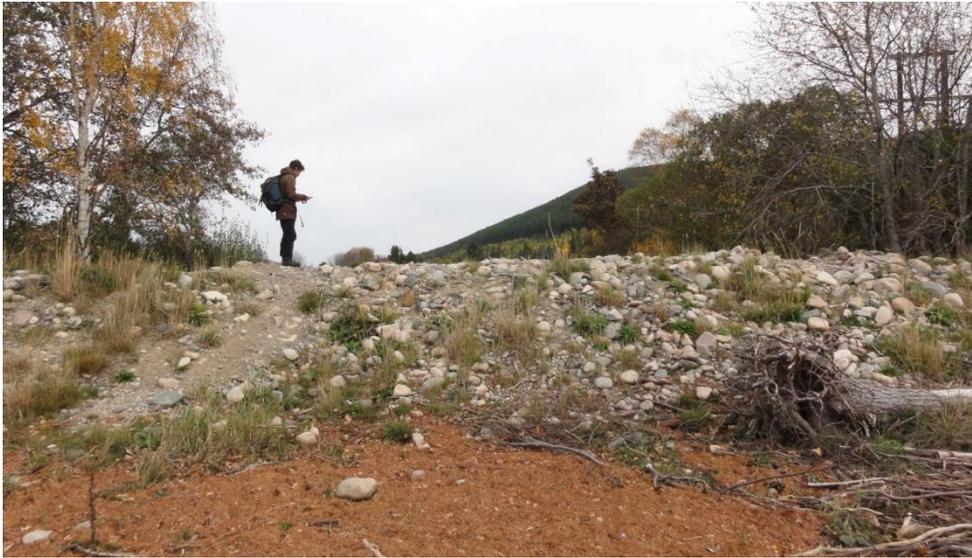
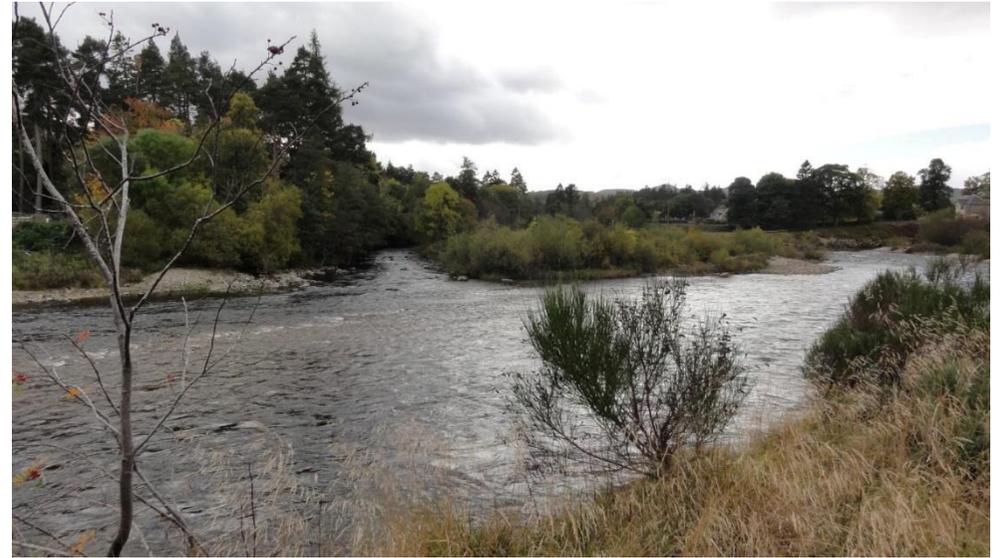
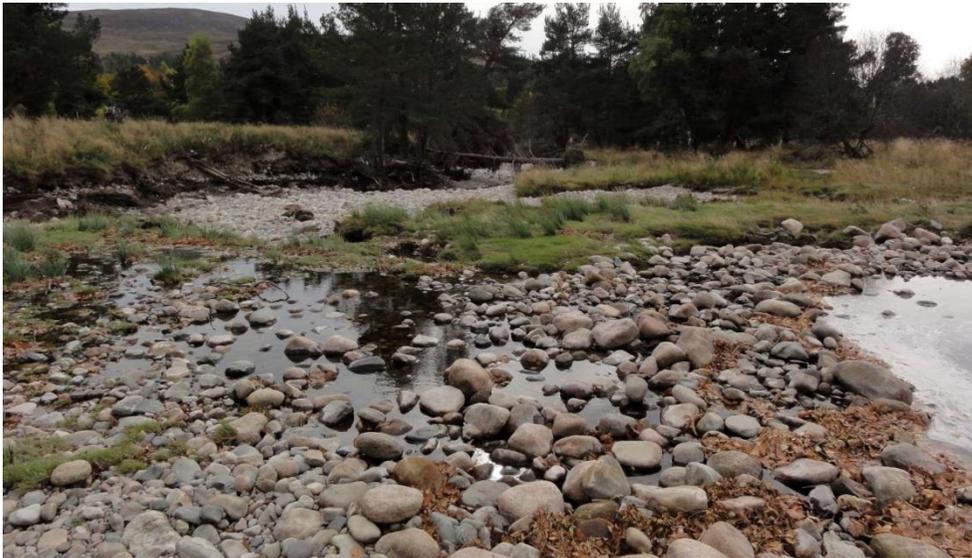
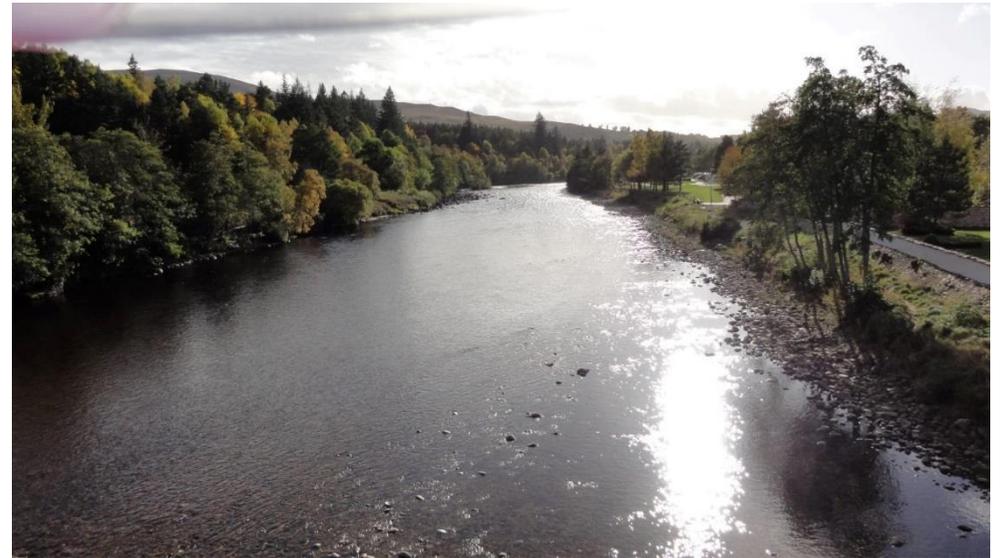
Figure 2.7 Survey photos from mainstem River Dee (between Ballater Golf Course and Ballater Bridge) continued. Top left: repaired embankment breach on left bank by golf course, bottom left: paleochannel within left bank, top right: River Muick confluence (view from left bank), bottom right: view upstream from Ballater Bridge.

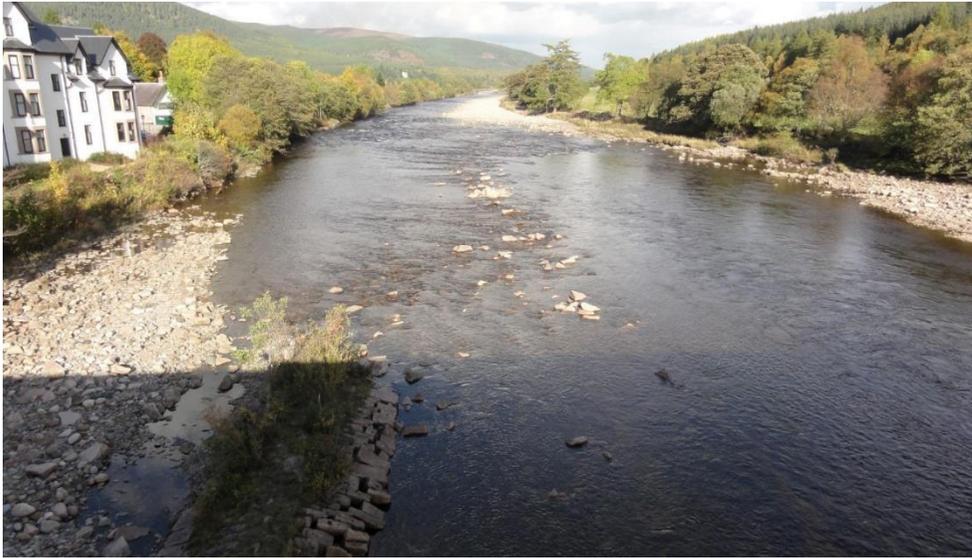
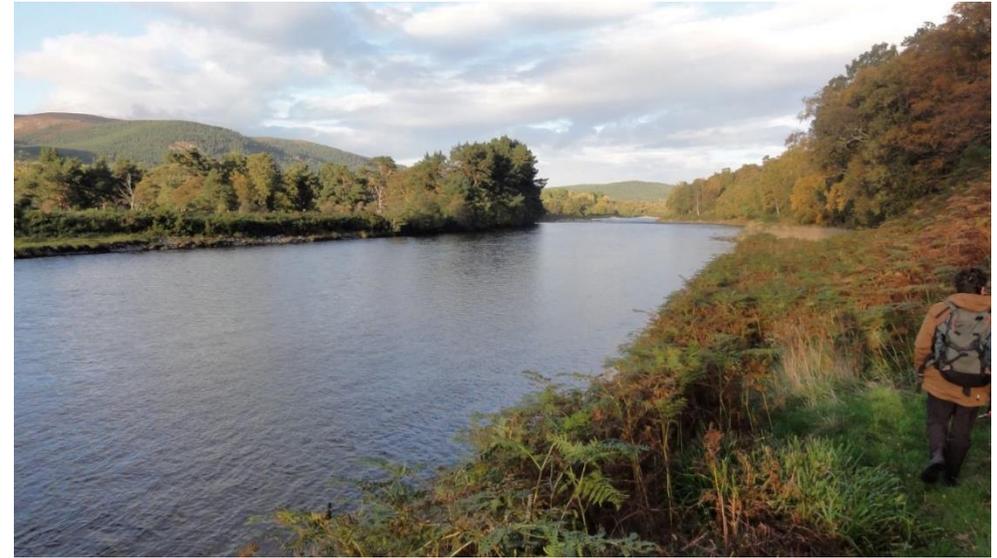
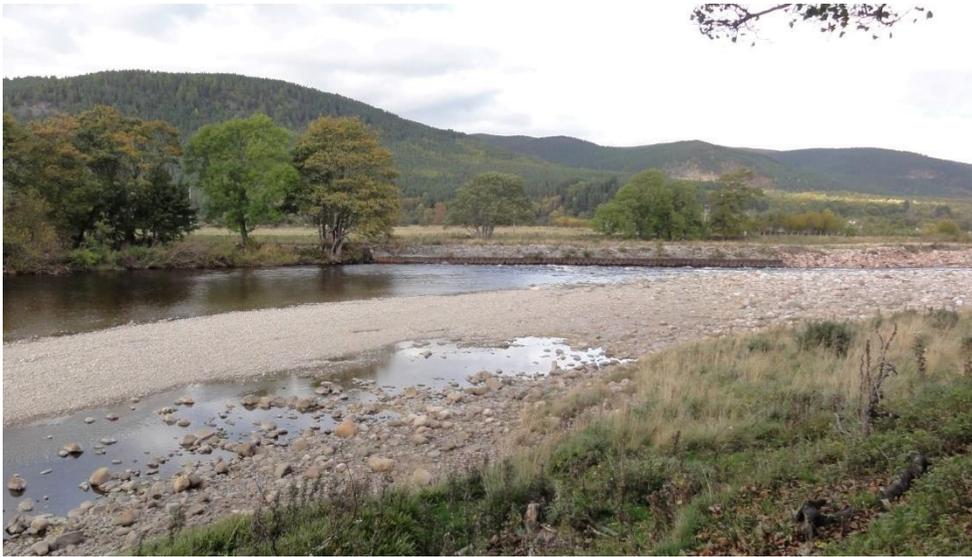
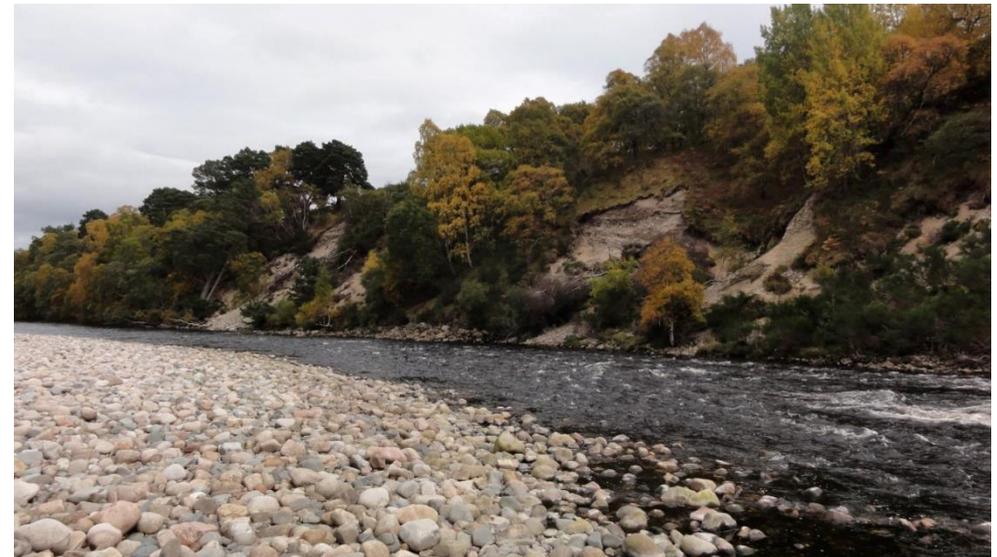
Figure 2.8 Survey photos from mainstem River Dee (downstream from Ballater Bridge). Top left: view downstream from Ballater bridge, bottom left: deposition (right bank) and bank protection by sewage works (left bank), top right: view downstream showing single thread channel, bottom right: significant hillslope coupling (right bank)

During very large flood events such as Storm Frank, changes to floodplain geometry/ roughness tend to be the governing control over patterns of erosion and deposition. In one localised section of this reach (the meander bend by the sewage works located immediately downstream of Ballater), the left bank failed during the storm, causing a significant amount of water to enter the floodplain. In this section of channel, an increase in the channel's erosional capacity is evident. This is manifested in high shear stress at the location where channel geometry constrains flow towards the left bank

This appears to be the only area within this section of the study site to experience notable change during the flood; the failure of the left bank was coupled with an increase in size of the adjacent point bar on the right bank (Matheson, pers. comm). Severe erosion on this left bank was recorded during the survey, alongside extensive hard bank protection (some of which appeared damaged). The point bar, consisting largely of imbricated coarse cobble and boulder material, shows little sign of colonisation by vegetation, suggesting at least partial inundation and turnover of sediment across the feature since Storm Frank.

Further downstream (in proximity to the confluence with the Tullich Burn), the main-stem River Dee exhibited evidence of dynamic geomorphic adjustment. Similarly to the processes observed upstream in the vicinity of the Girnock Burn confluence, the Storm Frank event has resulted in significant aggradation of secondary channels, the formation of large depositional bar features and locally increased erosion of river terraces. Whilst these geomorphic responses are considered consistent with the expected response for the reach type recorded at this location, it will likely be important for this section to be included within any future hydraulic model, to assess the contribution of this stretch of channel to flood risk within Ballater.

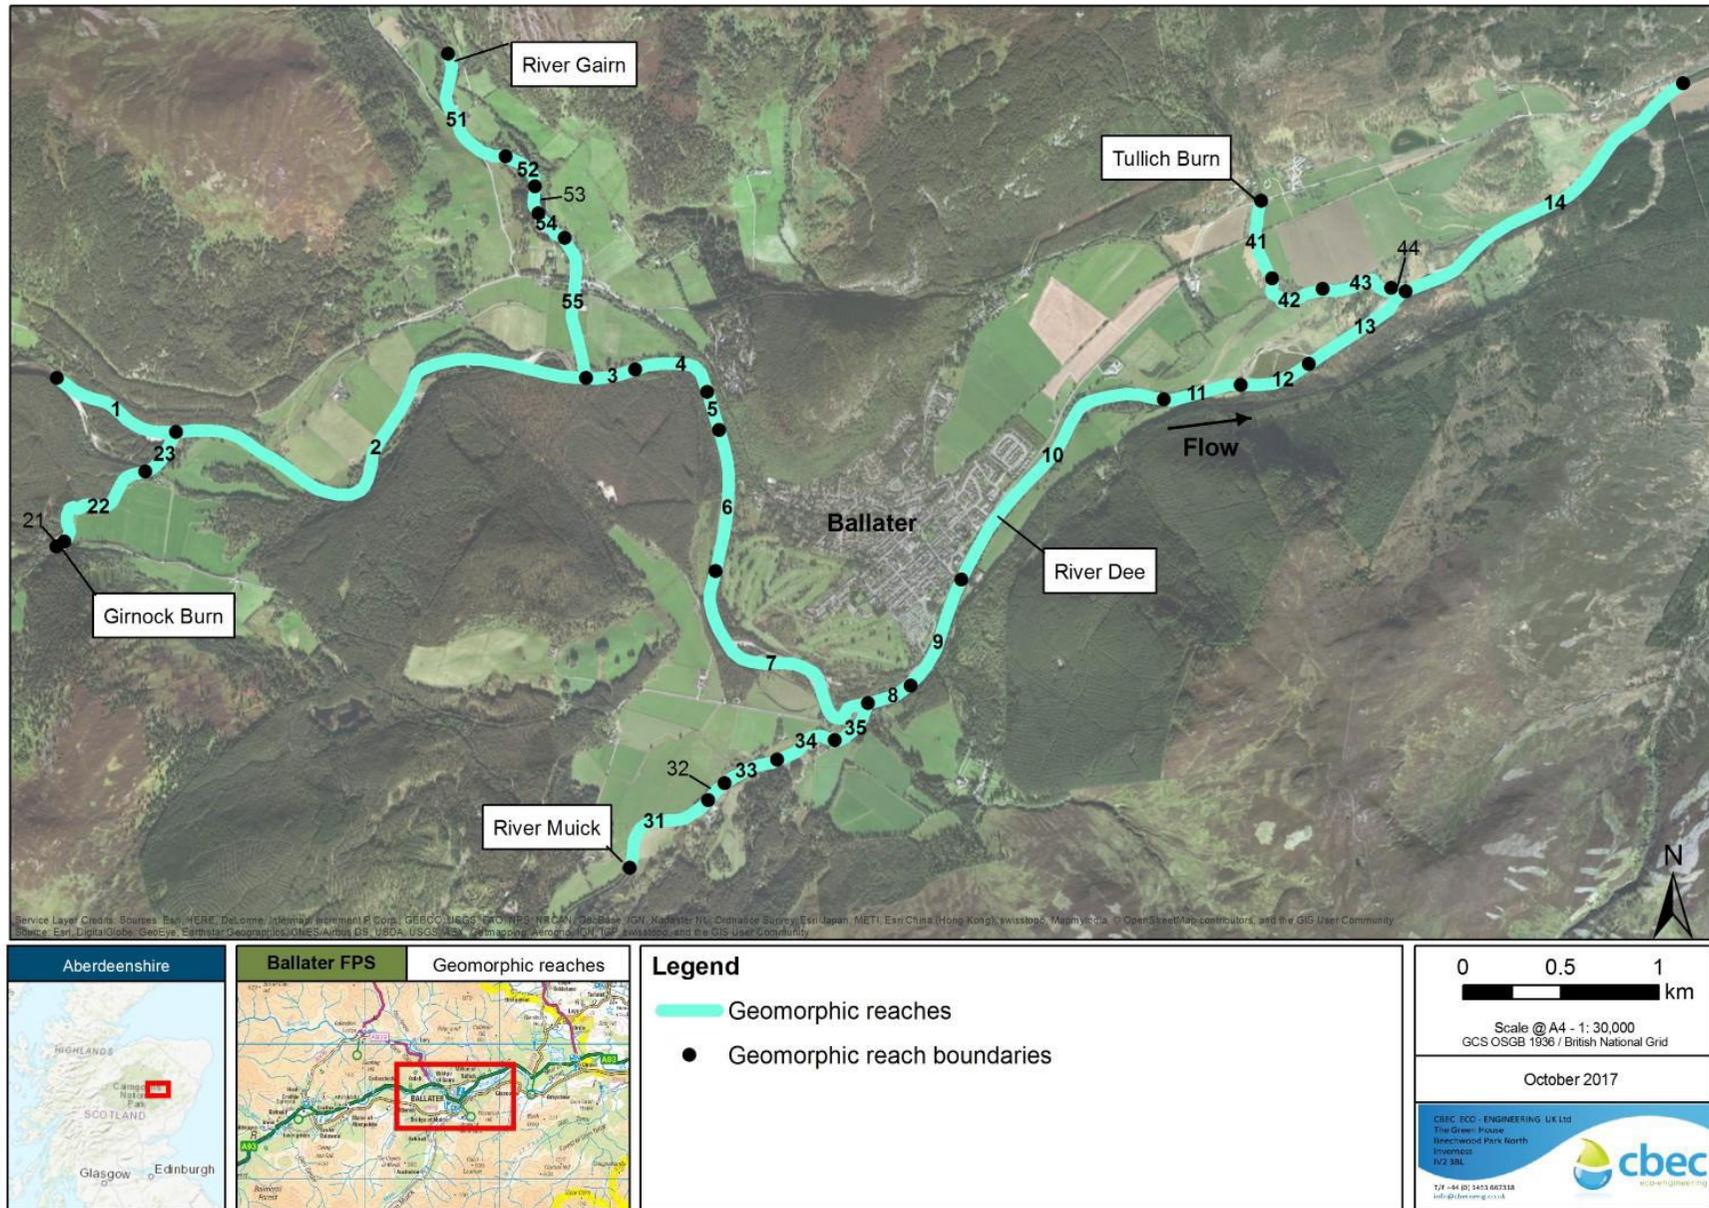
Figure 3.1 Delineated geomorphic sub-reaches.

Sub-reach boundaries were identified using all available, relevant information, including the fluvial audit data, maps and aerial photographs. Sub-reaches were between 48 m and 2594 m in length, with a mean length of 570 m; 31 sub-reaches were identified in total (**Figure 3.1**). The number and lengths of sub-reaches were determined to be at a spatial scale that allowed appropriate interpretation and resolution of geomorphic variables for the objectives of the project, while being manageable in terms of the data analysis process.
