**BALLATER FLOOD PROTECTION SCHEME
GEOMORPHIC PROCESS MODEL AND REVIEW OF MORPHOLOGICAL IMPACTS**

FINAL REPORT

**Prepared for
RPS
and
Aberdeenshire Council**

**Prepared by
cbec eco-engineering UK Ltd**

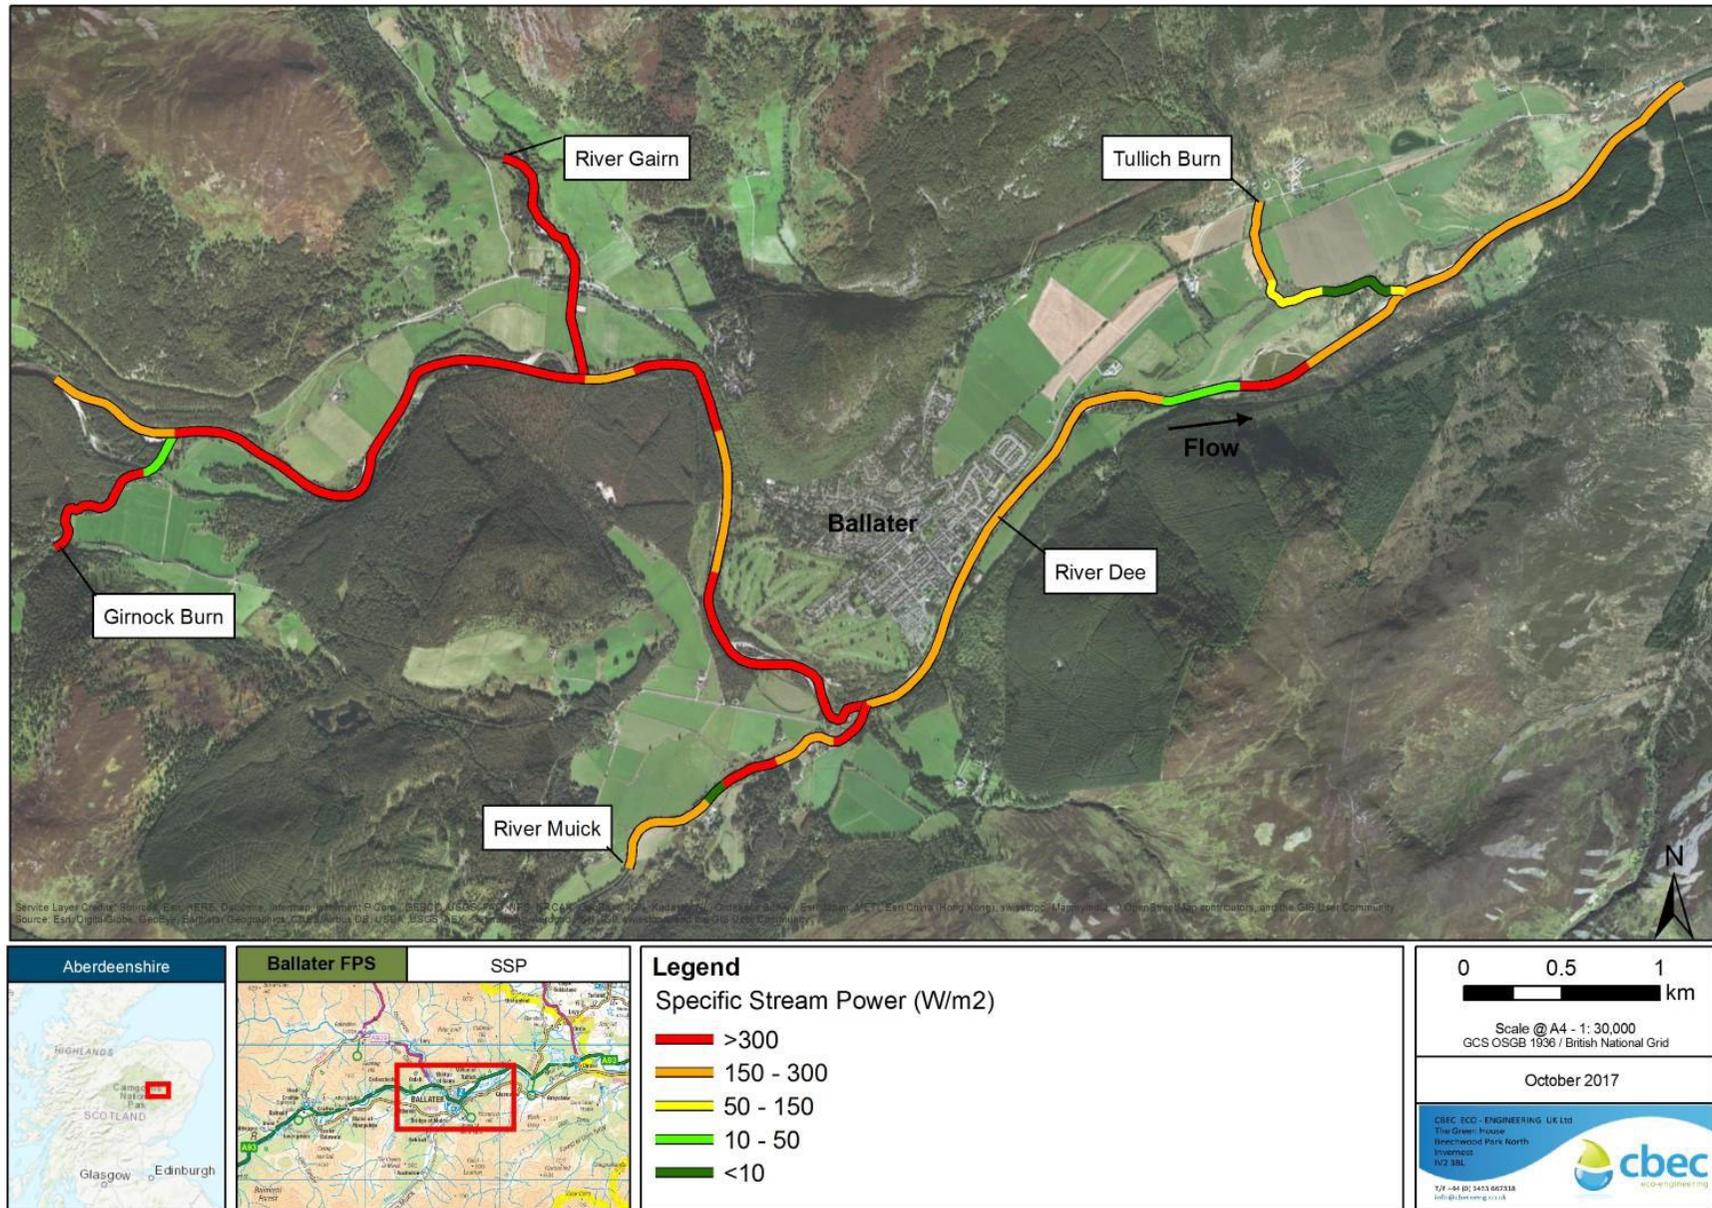
Figure 3.2 Specific Stream Power (SSP) by sub-reach.

Specific stream power shows moderate variations through the study area. On the mainstem Dee, the highest sub-reach specific stream power, 593.6 Wm^{-2} , was found downstream of the River Gairn confluence. This high stream power was a result of the increase in discharge coming from the River Gairn, together with an increase in channel slope and significant increase in confinement as the channel enters an area dominated by bedrock channel boundaries. A stream power of this magnitude is typically found in steep, high energy rivers with confined channels, cobble/gravel bed material and high sediment transport capacity (Nanson and Croke, 1992).

The four tributaries included within the study display varying patterns of specific stream power. Sub-reach 54 on the River Gairn displayed the highest value of specific stream power recorded during the surveys, of 1019 Wm^{-2} . This reflects a confined, high gradient sub-reach dominated by bedrock, with a bedrock 'chute' through which flow is further constricted. Downstream, a reduction in specific stream power is observed due to a widening of the river corridor (sub-reach 55).

On both the Girnock and Tullich Burns, specific stream power generally reduces with distance downstream. As both burns approach their confluence with the Dee, specific stream power reduces significantly (both record values of $<100 \text{ Wm}^{-2}$ for the majority of their downstream extents, most likely attributable to backwater effect (as was observed during the fluvial audit).

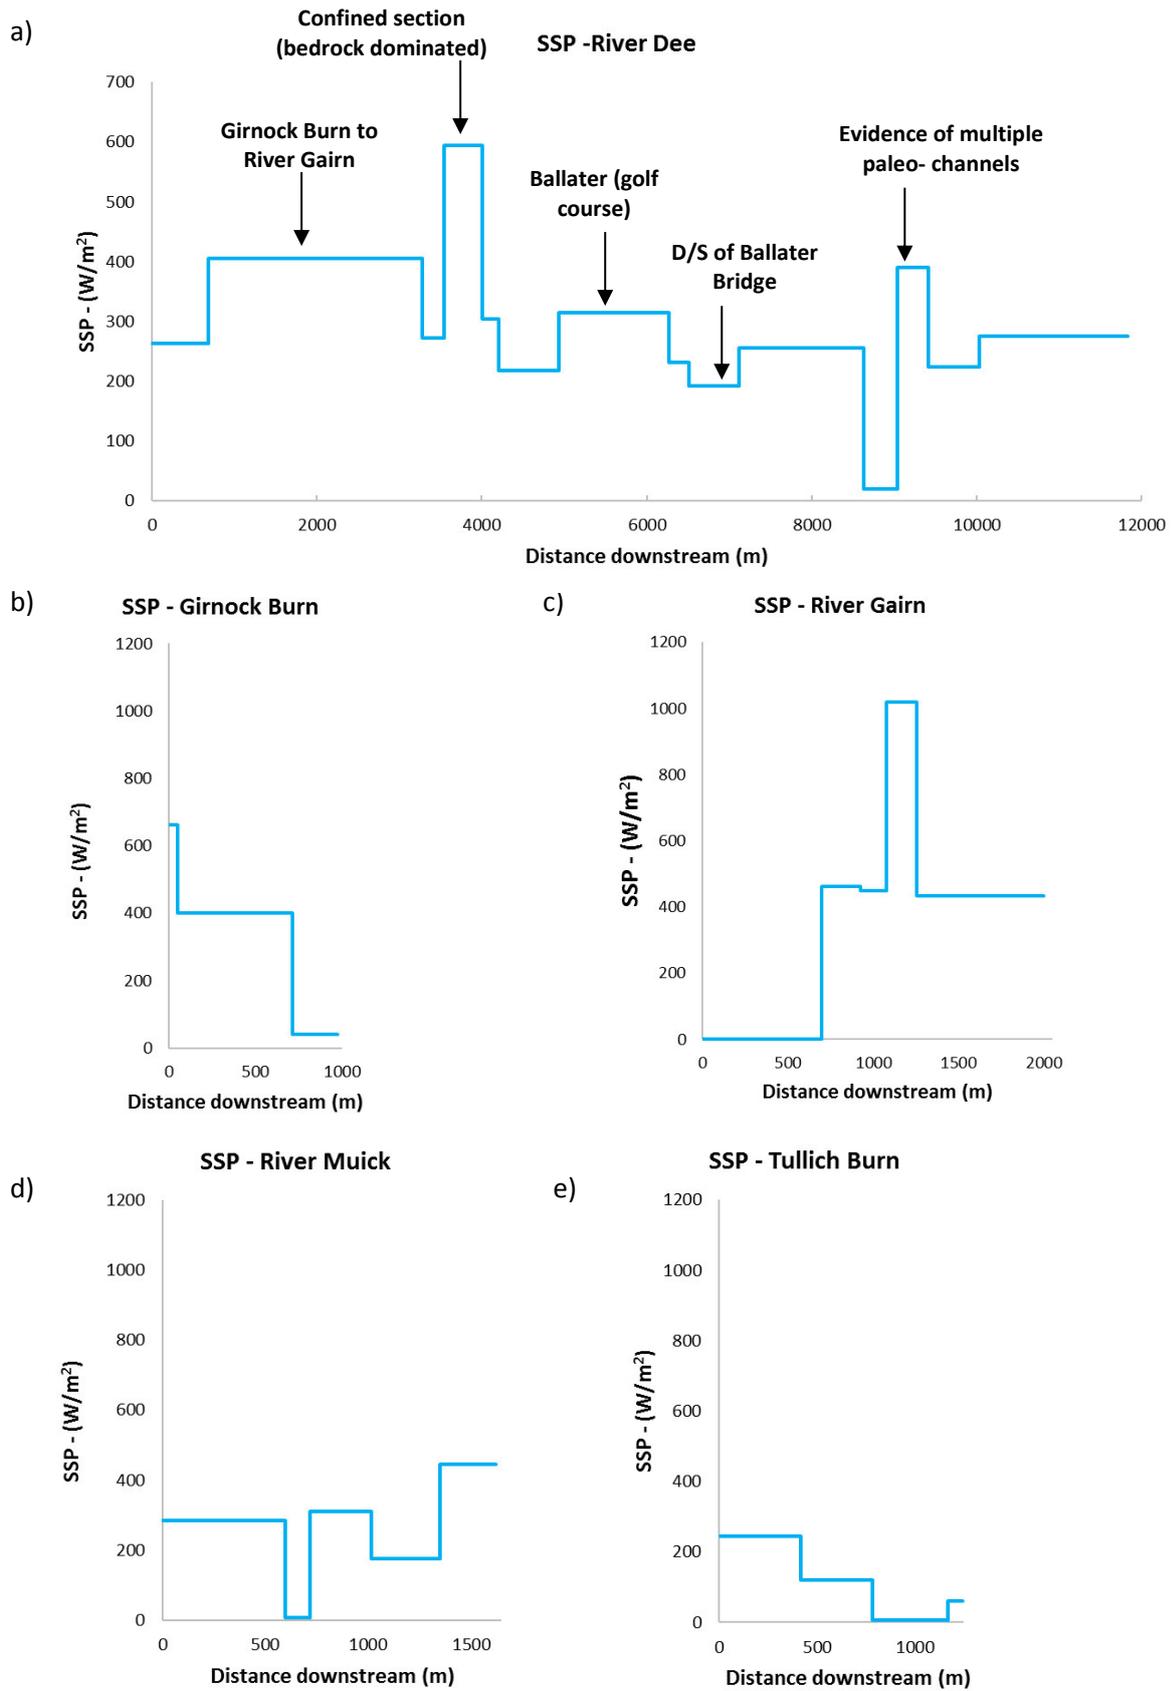
Figure 3.3 Downstream variation in specific stream power for a) River Dee, b) Girnock Burn, c) River Gairn, d) River Muick and e) Tullich Burn. (Note: Dee plot is shown on smaller index scale than tributaries)

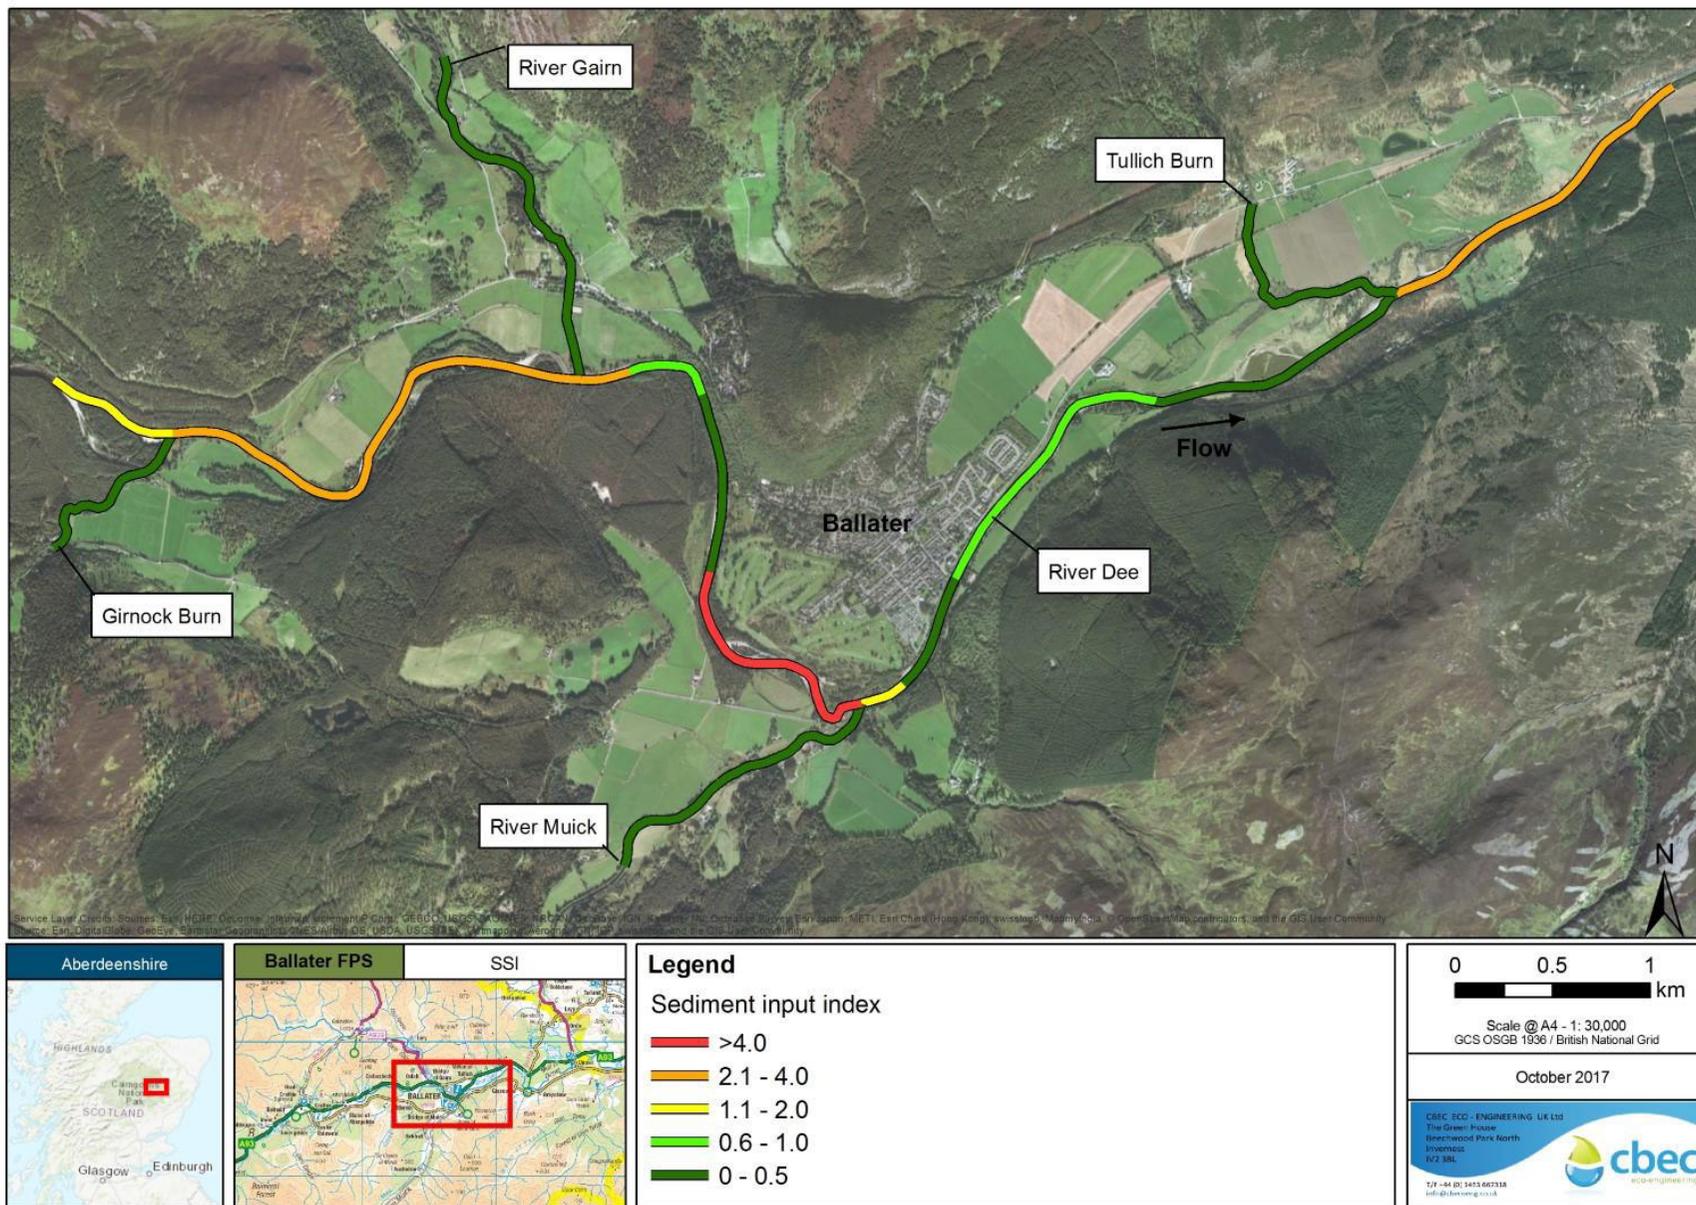
Figure 3.4 Sediment input index by sub-reach.

The sediment input index calculated for each sub-reach is shown in map format in **Figure 3.4** and plotted as Sediment input index vs. distance downstream in **Figure 3.5**.

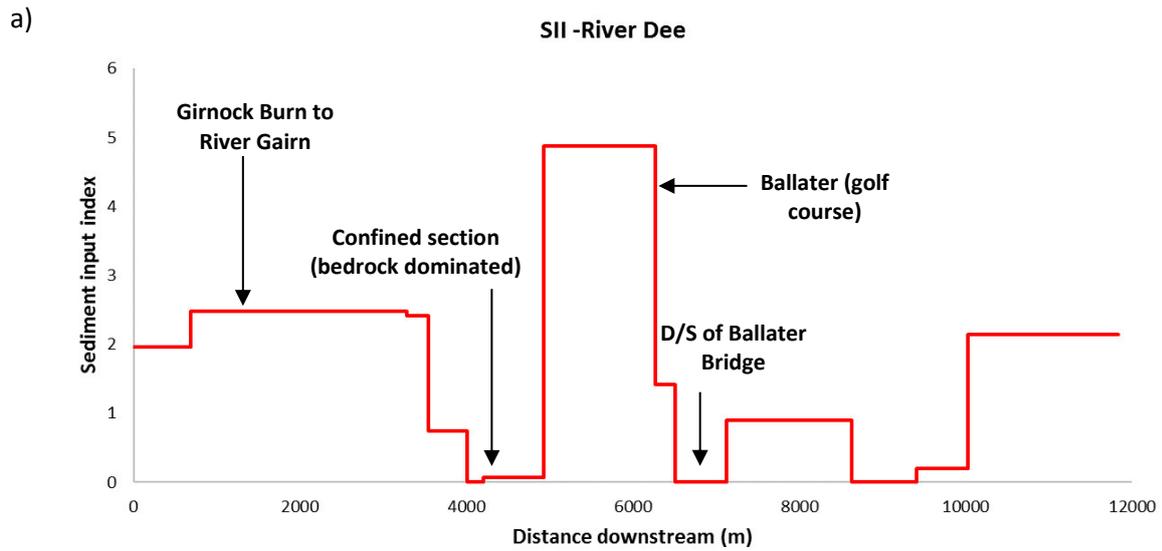
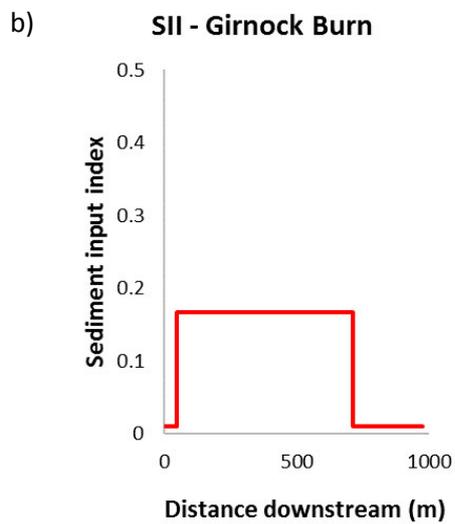
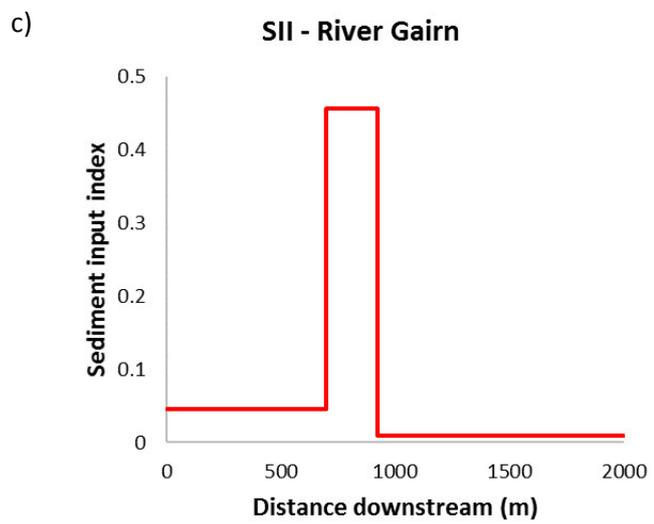
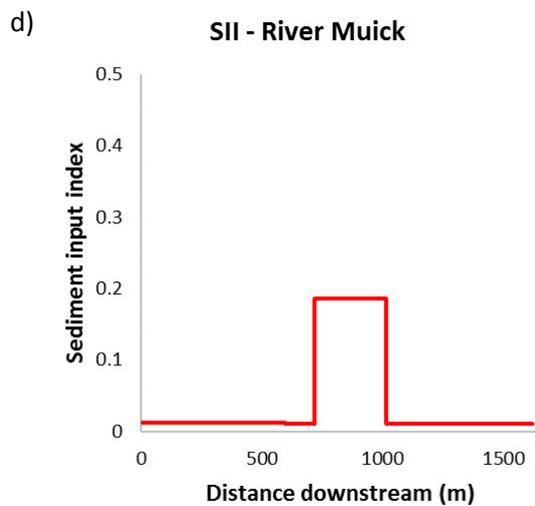
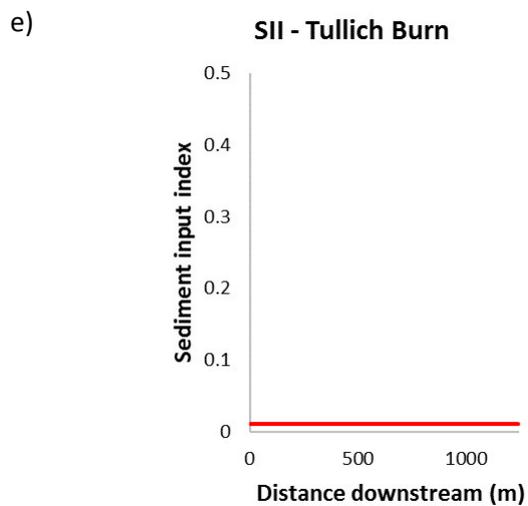
Figure 3.5 Downstream variation in sediment supply for a) River Dee, b) Girnock Burn, c) River Gairn, d) River Muick and e) Tullich Burn. (Note: Dee plot is shown on larger index scale than tributaries)

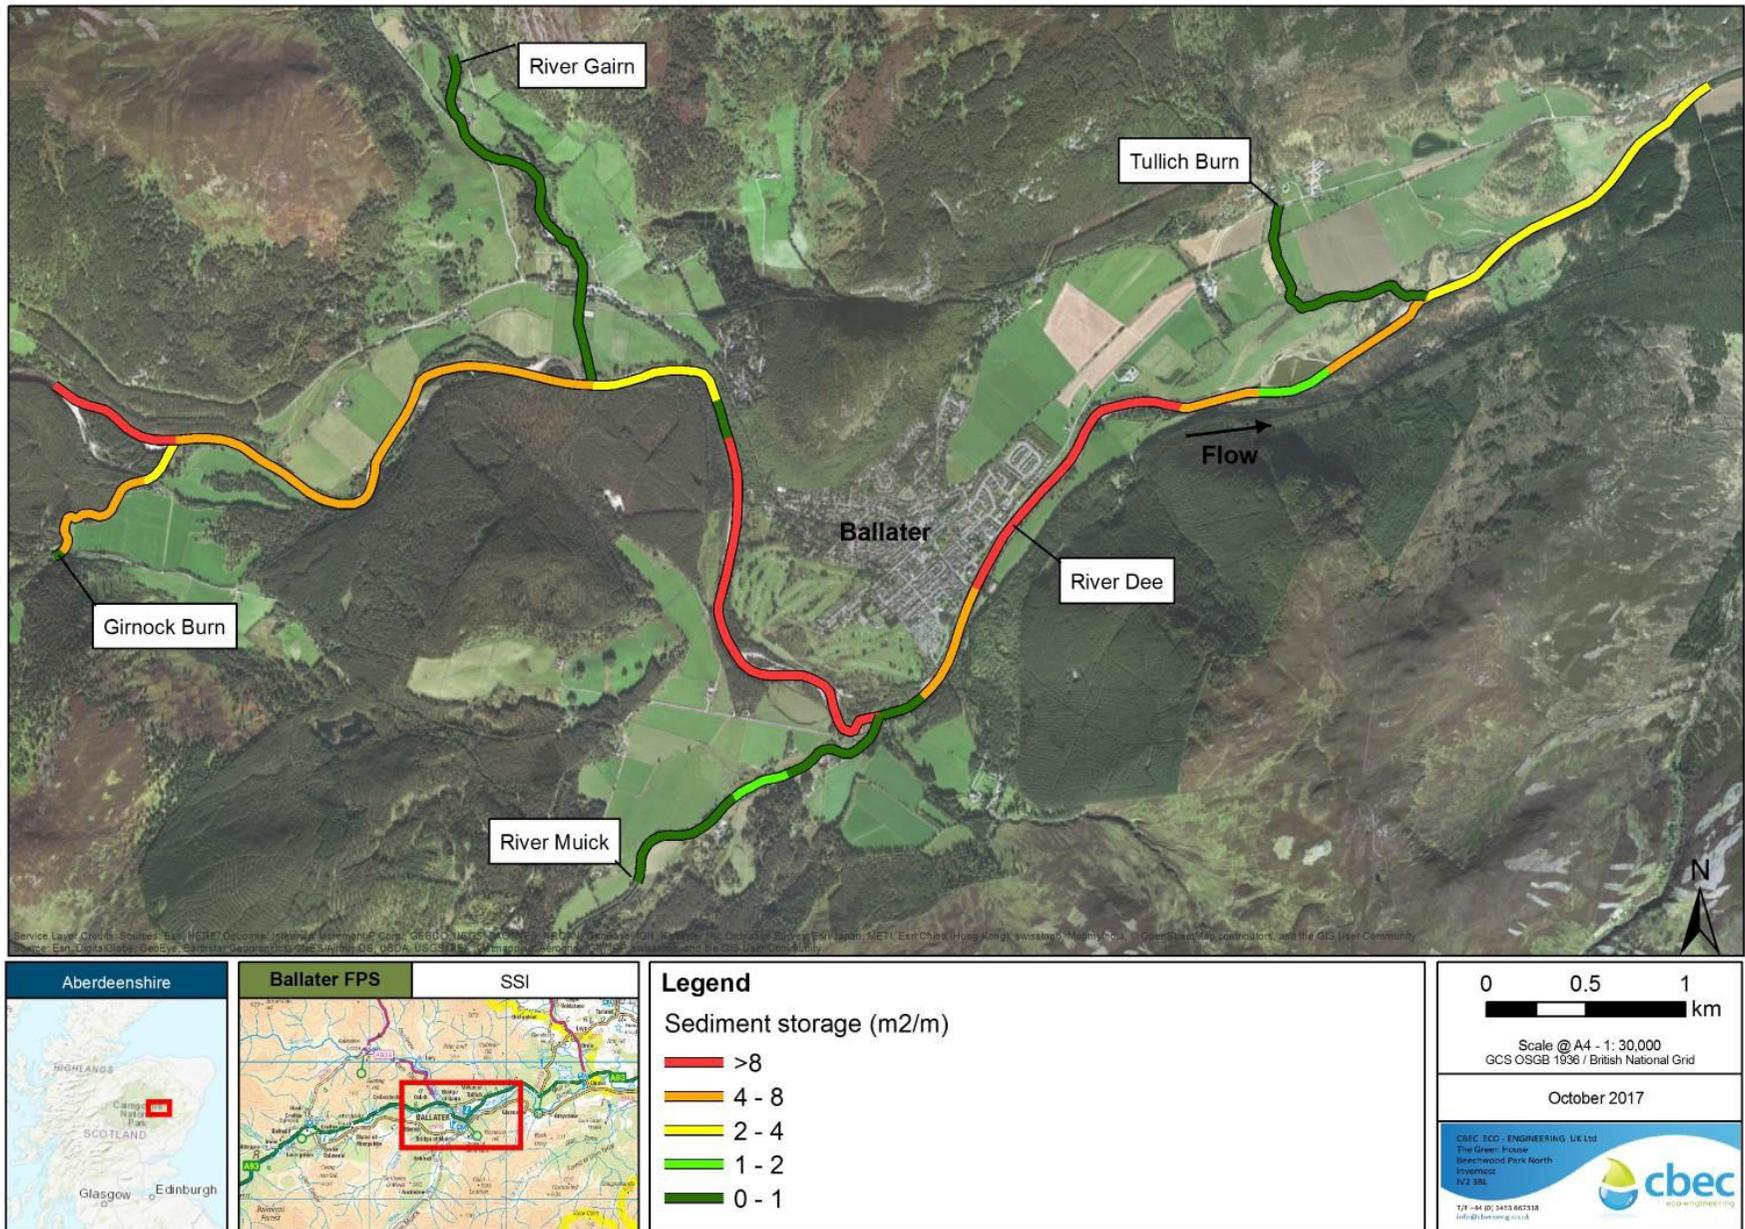
Figure 3.6 Sediment storage index by sub-reach.

Compared to the depositional areas on the River Dee, the associated tributaries each recorded minor levels of sediment storage. That said, small gravel and/ or cobble bar features were evident in certain stretches of the Girnock Burn, River Muick and Tullich Burn. The River Gairn deposited sediment was coarser in nature and, whilst some flood deposition (specifically cobble and boulder-sized material) was evident during the field surveys, there was generally only minor evidence of well-formed alluvial bar features (owing to the gradient of the channel throughout).

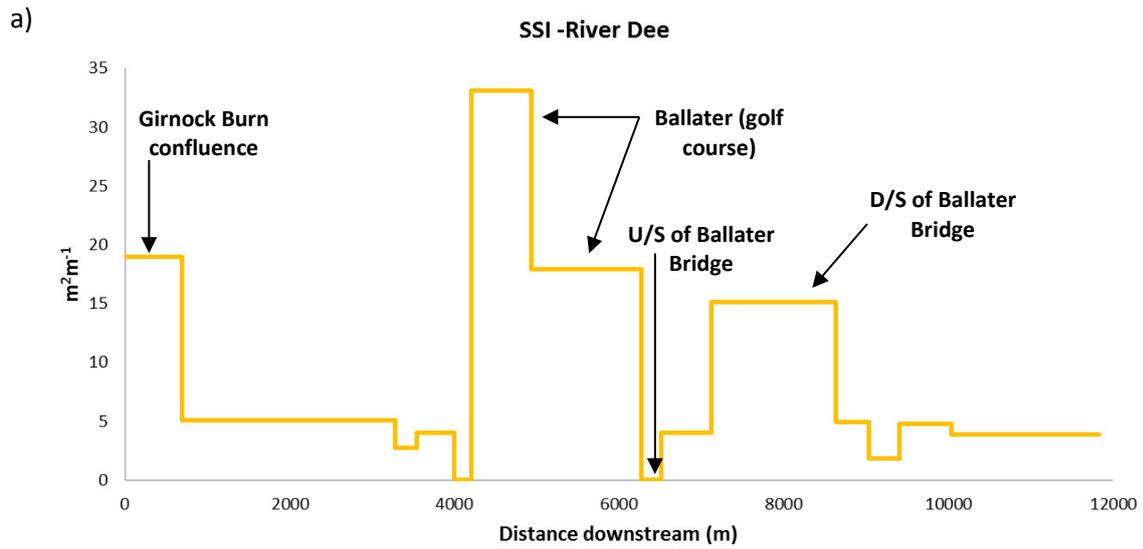
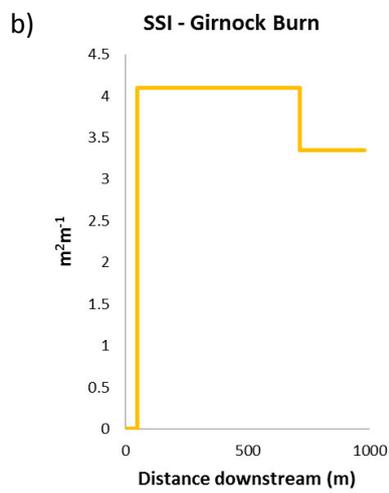
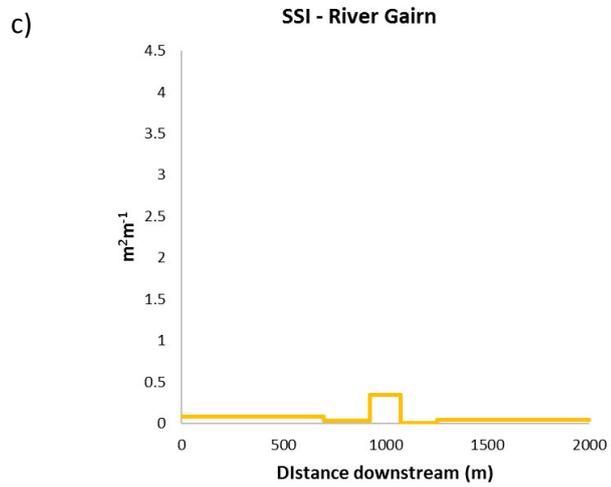
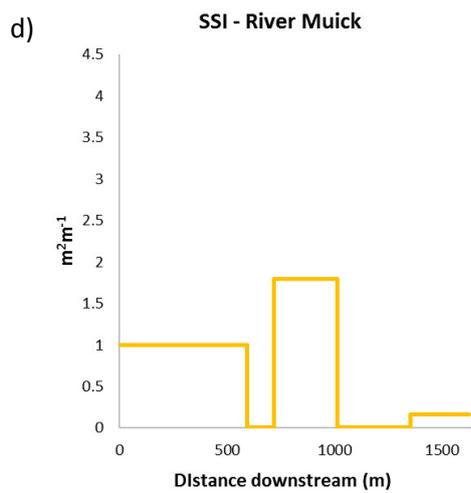
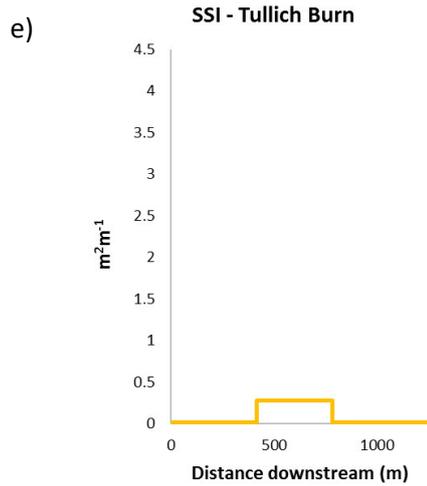
Figure 3.7 Downstream variation in sediment storage for a) River Dee, b) Girnock Burn, c) River Gairn, d) River Muick and e) Tullich Burn. (Note: Dee plot is shown on larger index scale than tributaries).

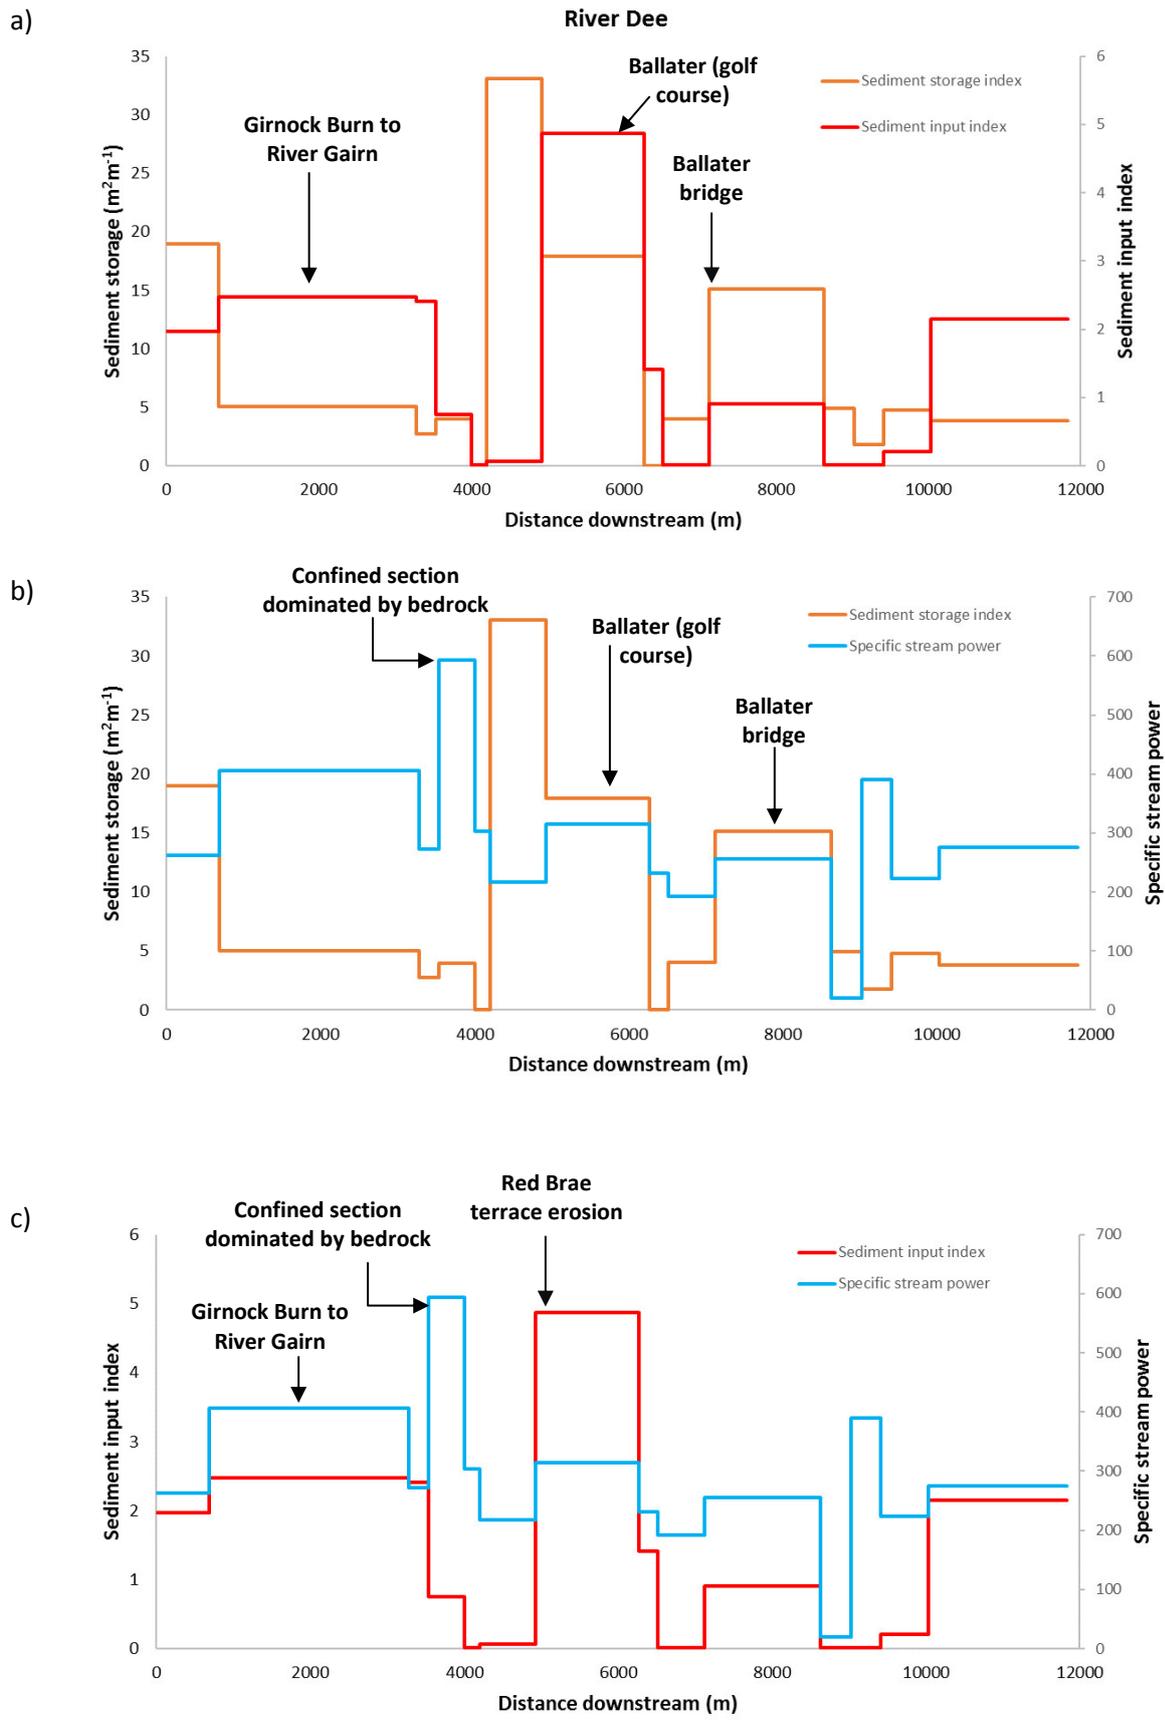
Towards the end of the River Dee mainstem surveyed extent (sub-reach 14), an increase in sediment input (mainly from increased bank erosion, as well as minor input from the Tullich Burn, coincides with a relatively high specific stream power, and a subsequent decrease in sediment storage (**Figure 3.8**).

Figure 3.8 River Dee spatial patterns of a) sediment storage and sediment input b) sediment storage and specific stream power, and c) sediment input and specific stream power.

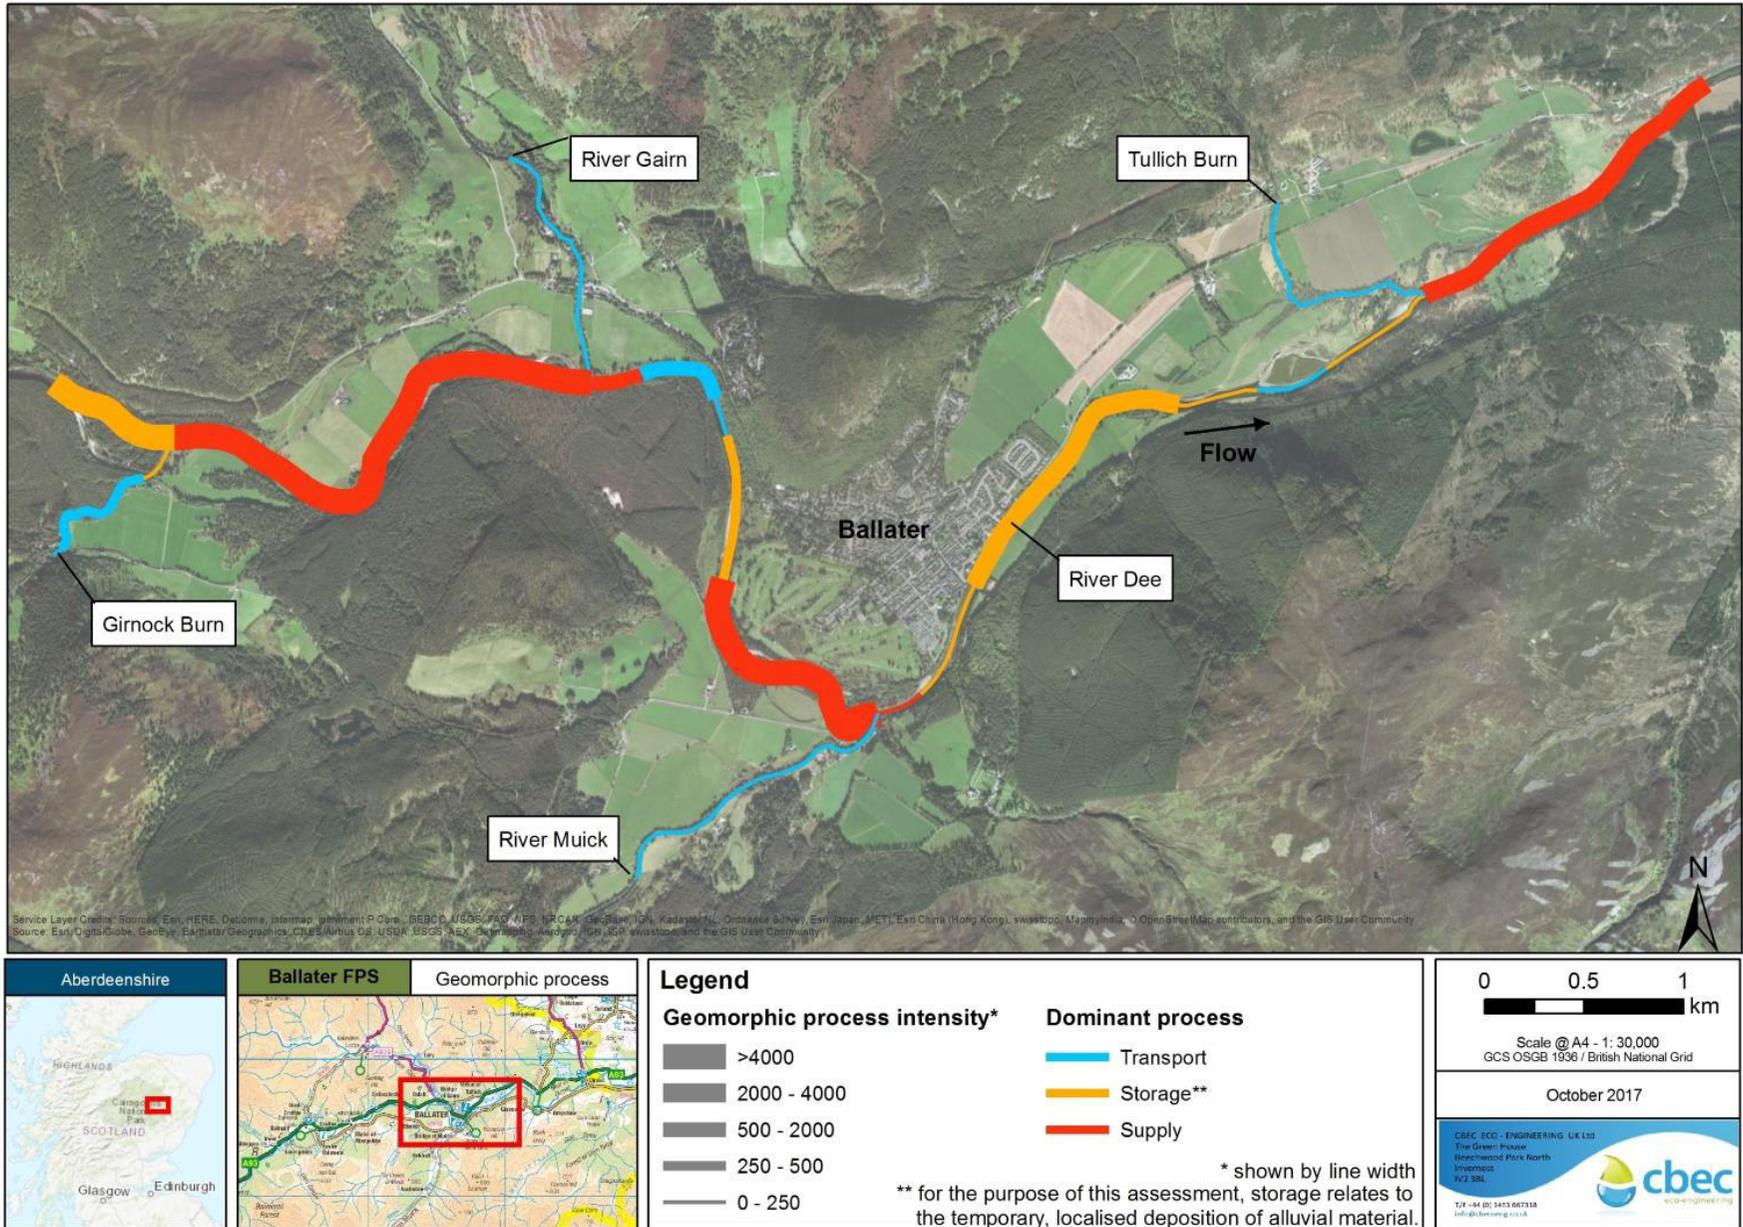
Figure 3.9 Geomorphic process regime

Geomorphic process intensity, or dynamic behaviour, provides an indication of the likely sensitivity of the system to change (e.g. during a large-scale flood event), as well as the sensitivity of the system to modifications. Engineering or land use modifications on dynamic reaches are likely to have a greater impact on geomorphology than those on less dynamic, more stable sub-reaches, because of the greater propensity of the channel to react in the more dynamic reaches. The level of dynamic behaviour of each sub-reach is, therefore, an important factor in determining its restoration priority, in conjunction with the degree of engineering and land use pressures, as described below. In addition, understanding of the dominant process in a reach is important for assessing the likely impacts of engineering and land use pressures, as well as determining the geomorphic response to restoration interventions and allowing suitable restoration options to be developed.

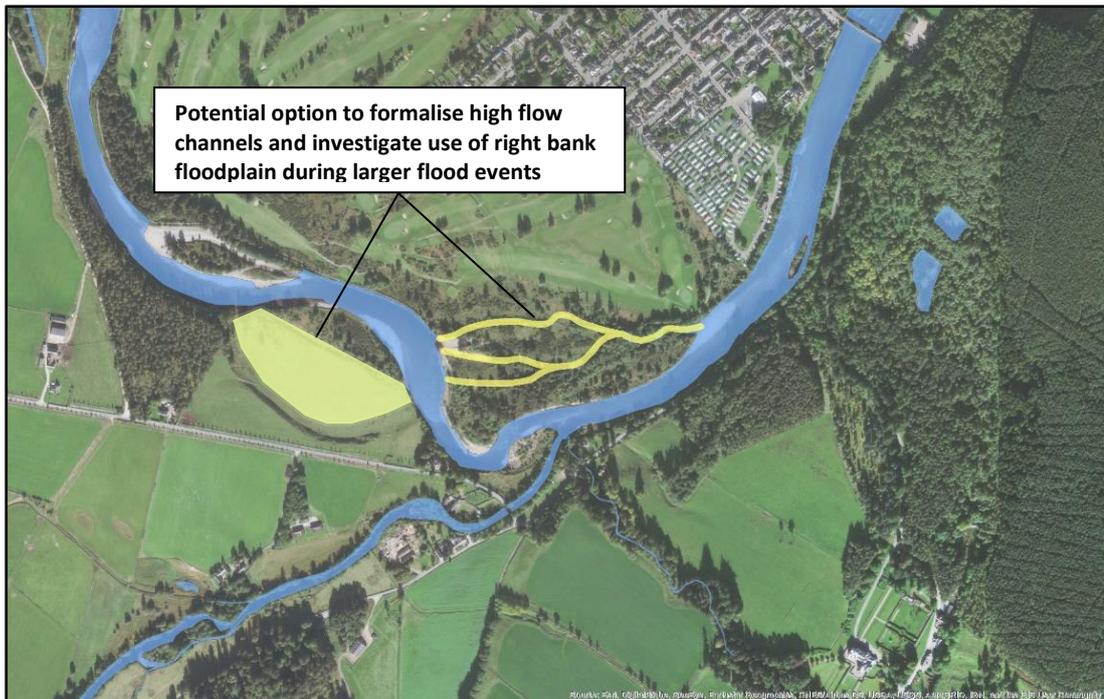
Figure 4.1 Indicative location of potential high flow/ partially reactivated paleo-channels

- The 90° embankment present in the left bank upstream of the confluence with the River Muick, is deemed to potentially result in an increase in water levels in the vicinity of Ballater golf course. While connectivity with the floodplain is currently limited at this location by the presence of the embankment, both cbec and SEPA have recorded instances of recent erosion of fluvial deposits along the left bank where the channel appears to tend towards reoccupying paleo-channels present in this section of floodplain. There is also potential opportunity to utilise a section of the opposite bank, in an area of former channel alignment. It is recommended that the option to formalise existing paleo-channels and investigate the right bank floodplain at this location is included for discussion during the development of the flood protection scheme (**Figure 4.1**). In broad terms, these high flow channels/ areas should be designed to inundate below bankfull flow and have sufficient capacity to mitigate flood risk immediately upstream of this area. However, the design of these channels should be carefully assessed using morphodynamic modelling tools to ensure their geometry minimises the risk of aggradation following flood events. Additionally, it is important to ensure that no significant increase in risk is posed to local infrastructure, or downstream areas such as Ballater bridge, through the increased flow capacity.

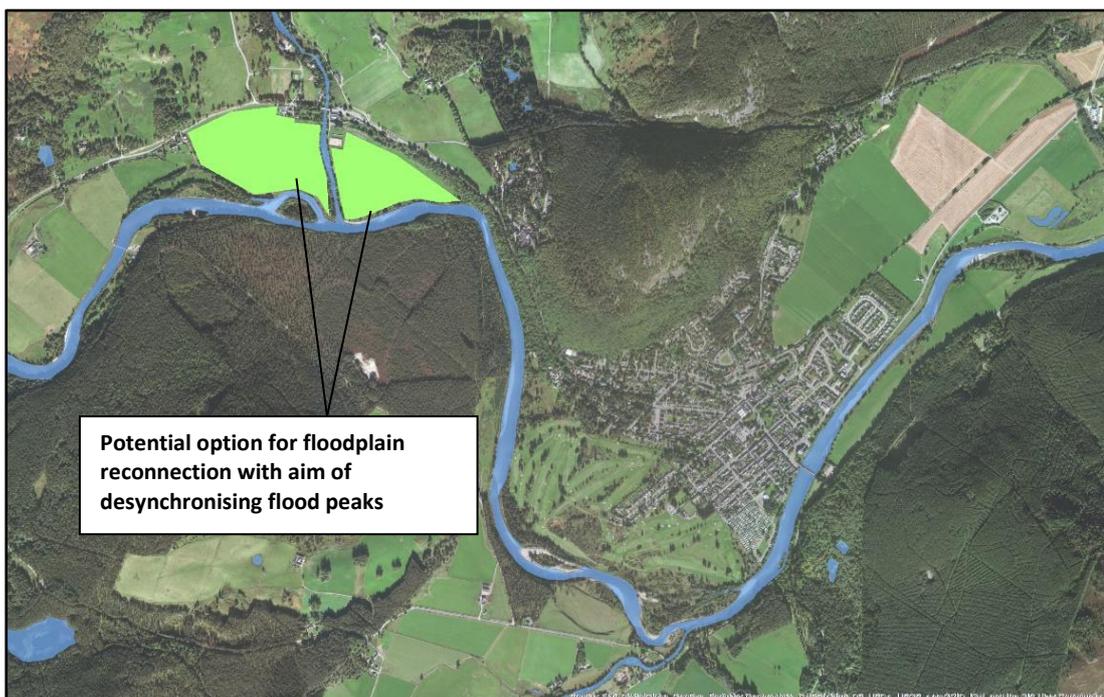
Figure 4.2 Indicative location of potential floodplain reconnection

- An additional option to complement the proposed flood protection measures has been identified in the vicinity of the River Gairn confluence. Given the relatively high contribution of this waterbody to the hydrology of the Dee system (the River Gairn contributes with 22.24% to the total catchment area at the point of confluence), there may be a benefit to investigating options for desynchronising flood peaks by reconnecting sections of the floodplain (Figure 4.2). During the fluvial audit, a wide area of floodplain with no residential or commercial properties along the left bank has been identified. Promoting a hydrological study of duration and timing of flood peaks in both the Gairn and the Dee and utilising hydraulic modelling tools to investigate flood patterns, may highlight a potential option to install set-back embankments that retain flood water within this area. However, the feasibility and potential benefits of this measure can only be accurately assessed with further, detailed investigations.

- The left bank floodplain immediately upstream of the River Gairn confluence, offers a potential opportunity for the installation of set-back embankments, to retain water within this area during flood events, as a form of Natural Flood Management.
