ASSESSMENT OF THE RED BRAE COLLAPSE ON THE FLOODING MECHANISM OF 30TH DECEMBER 2015

RPS, August 2019

FINAL REPORT

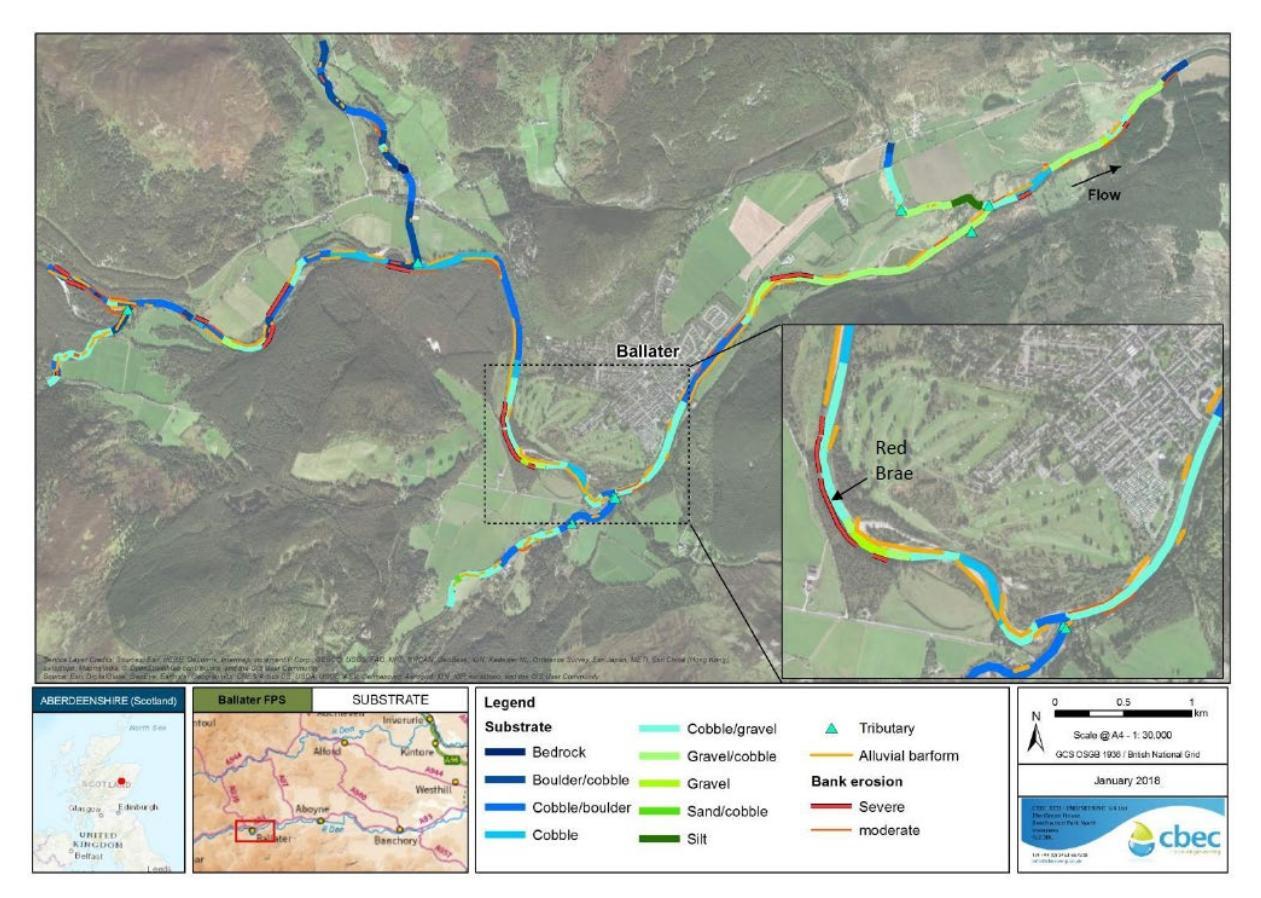
The Red Brae is located along the right bank of the River Dee, on the opposite side of the river to Ballater Golf Course (see Figure 1). The Red Brae is characterised by steep slopes, with the top of bank approximately 8 to 10 metres above the river channel (see Figure 2). The channel in the vicinity of the Red Brae and surrounding area, is dominated by erosional processes, with scour 'leading to the failure of an extensive length of high alluvial river terrace' (cbec, 2018).

Figure 1Location of Red Brae, Ballater and identification of sediment dynamics (BallaterFlood Protection Scheme, Geomorphic Process Model and Review of Morphological Impacts.cbec eco-engineering, January 2018).

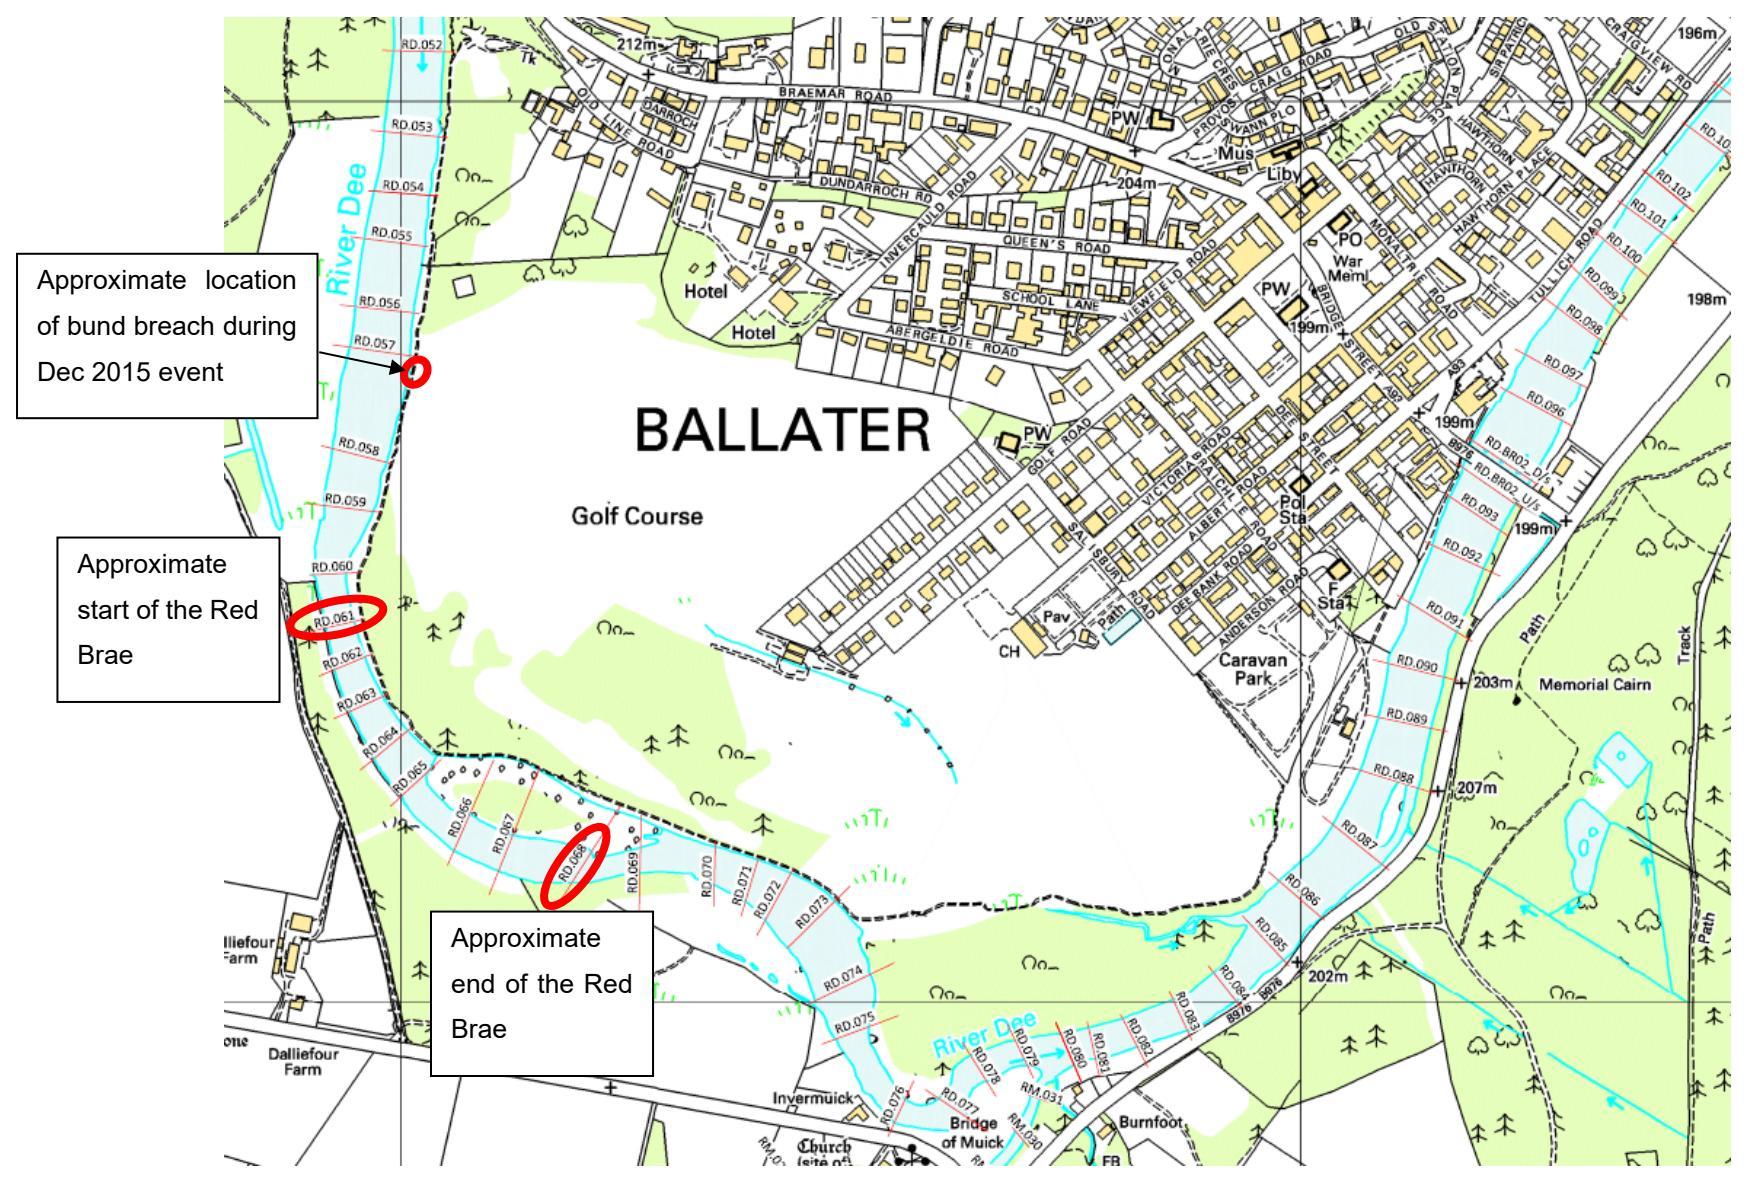
RPS undertook a topographical survey of the River Dee in the summer of 2017, as part of the Ballater Flood Protection Study. The location of the cross-sections recorded during this survey is shown in Figure 3. A review of this survey data shows that the most upstream cross-section with a significantly high right bank (in comparison to the left bank) is RD61 with the most downstream cross-section being RD68 (Figure 3). This indicates that the length of the reach known as the Red Brae is over 400 metres.

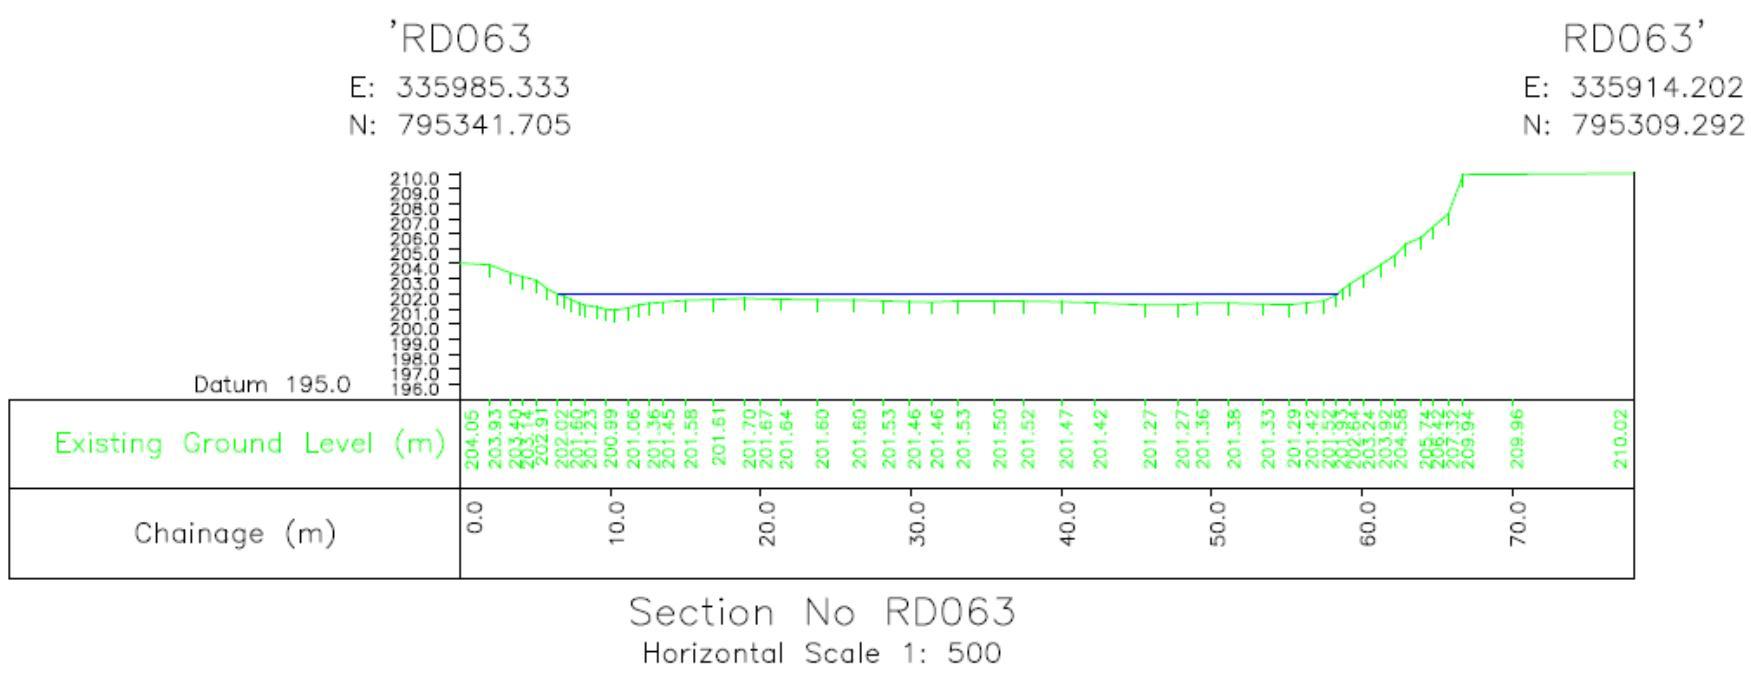
Figure 13 Cross-section RD63 recorded during the 2017 topographical survey (ref: Figure 2)

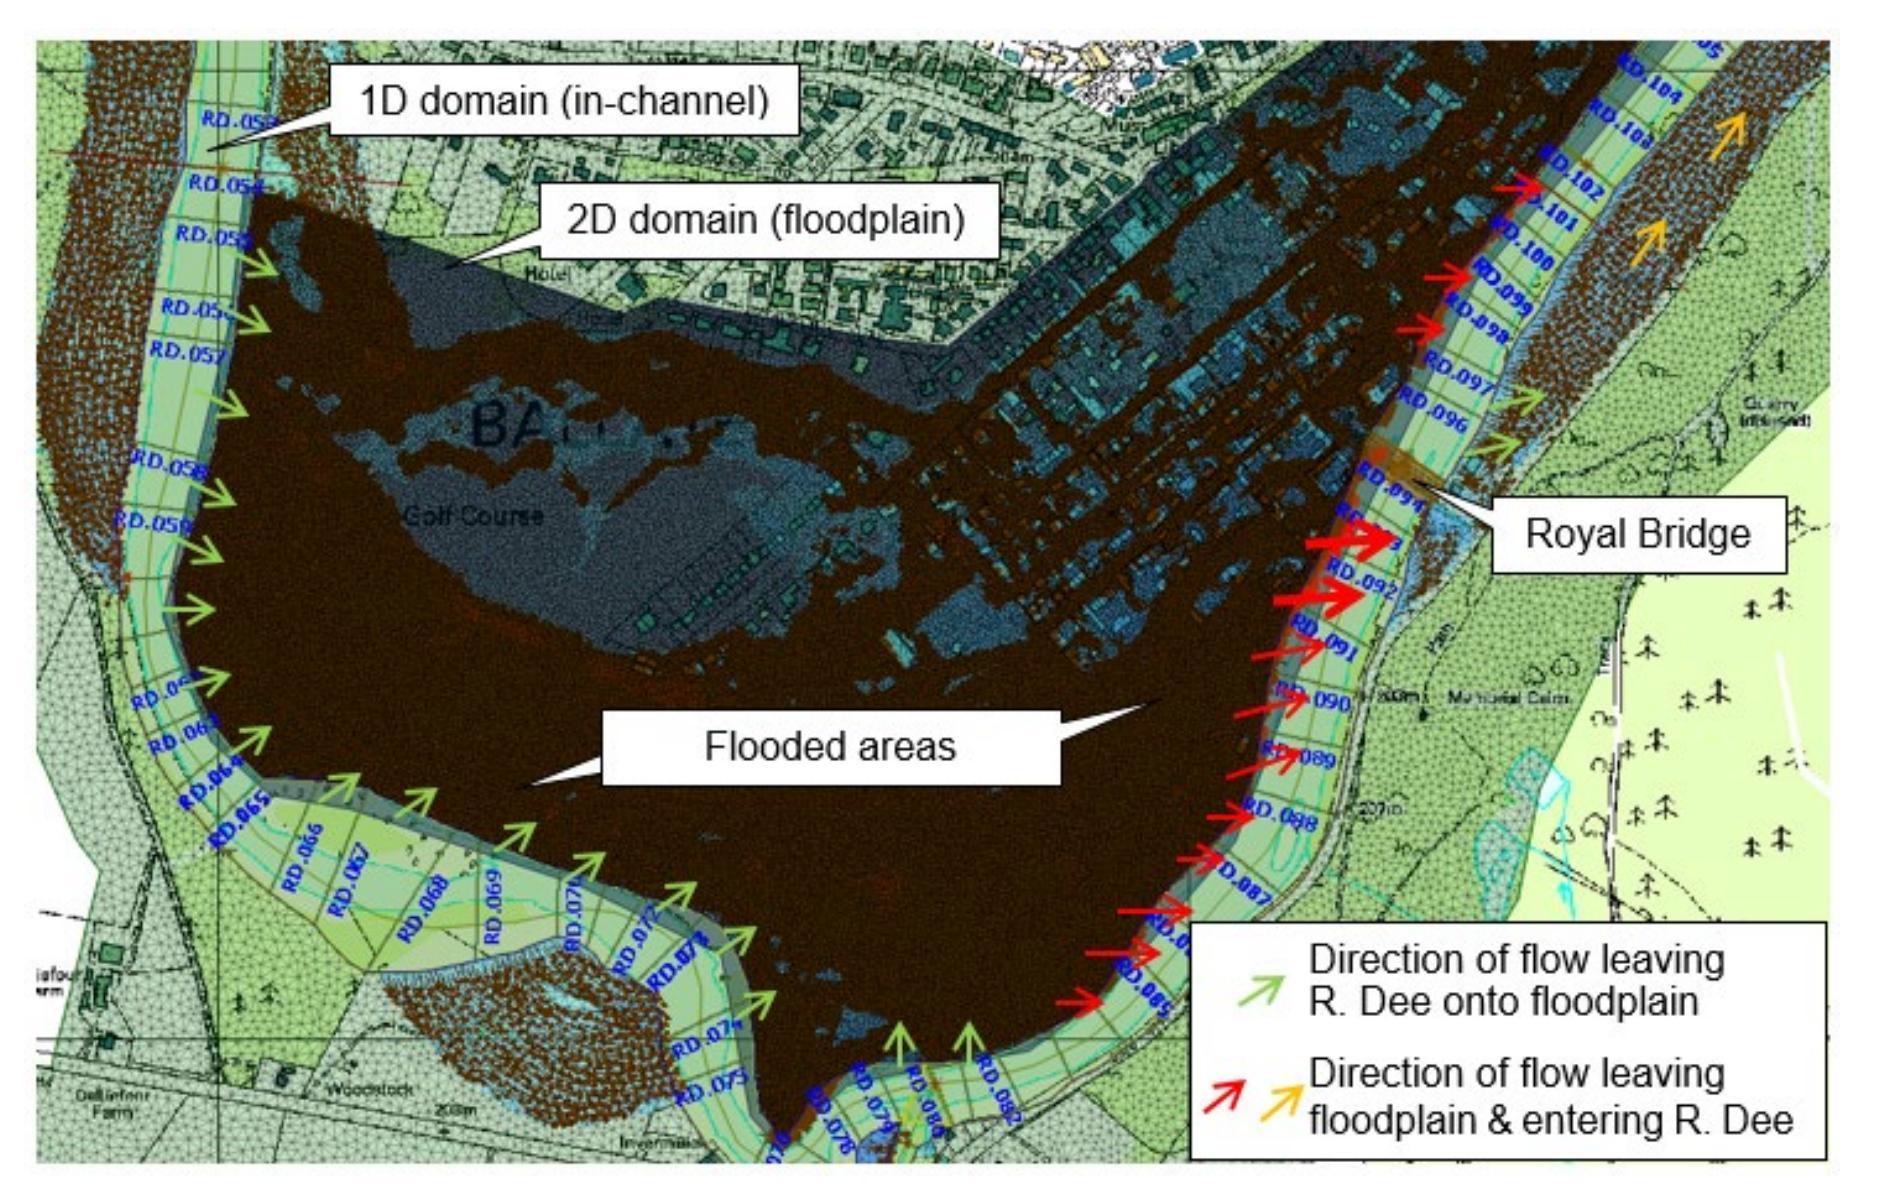
It should be noted that the Ballater FPS Feasibility Report does reflect the flow direction that has been described by the BFG i.e. that flood water flowed across the golf course from the River Dee at the 14th tee of Ballater Golf Club. Figure 3.28 in the Feasibility Report (which is shown in Figure 14 below) shows that the hydraulic model used in the study, which was constructed based on the 2017 survey information, simulates flow leaving the main channel and entering the floodplain from cross-section RD54 (which is located just upstream of the 14th tee) to cross-section RD82. This shows that the flood water from the River Dee flows naturally from the river towards the golf course (and the informal flood defence) and is not dependent on a collapse of the Red Brae causing a restriction in the channel (as this was not included in the model). It should also be stated that even if the breach did not occur, a similar flooding mechanism would have occurred in any case, as the informal flood defence was determined to have a standard of protection of 20% AEP (1 in 5 year return period), as during the simulated 1 in 10 year return period the bund was overtopped (Hydraulics Report, Section 3.6.2). On 30th December 2015, the peak flood levels were significantly higher than the crest of the informal flood defence, meaning that the embankment would have been overtopped even if the breach hadn't occurred.

Figure 14 also shows water flowing from the floodplain into the River Dee upstream of the Royal Bridge. This is in agreement with the comment from the BFG in the Ballater Eagle 'that the Golf Club flood waters were flowing towards rejoining the main channel and NOT escaping from it'.

Figure 14 Overview of the interaction of flows between the River Dee and its floodplain, during a 0.5% AEP (1 in 200 year) flood event.
