BALLATER ADDITIONAL FLOOD STUDY

Defence Condition Inspection

IBE1982_Rp001
D01
30 March 2022

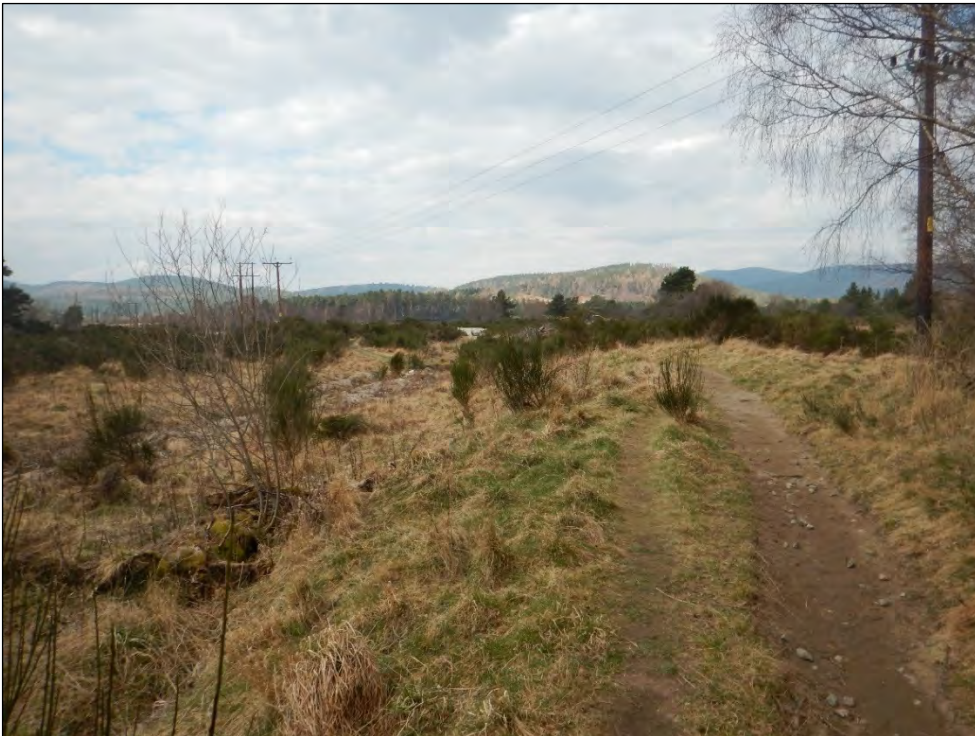
Plate 6 View of riverside path along southern boundary of the Golf Course (2022)

Beyond the Caravan Park the riverside path extends westwards along the River Dee through an area of rough land at the southern boundary of the Golf Course, on slightly raised ground as shown in [Plate 6](#).

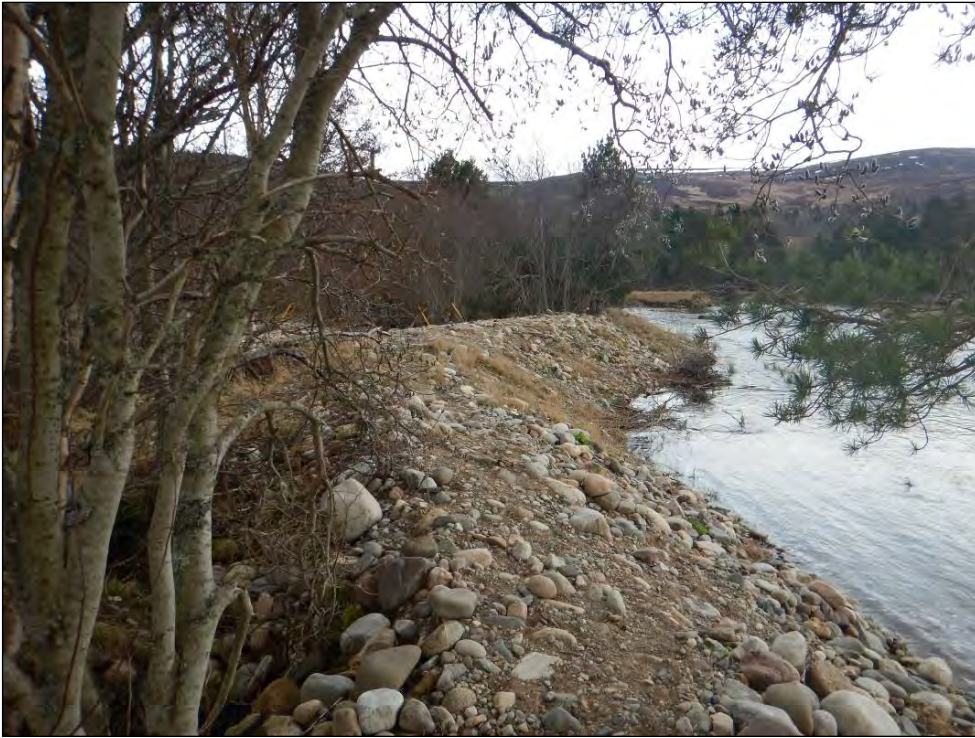
Plate 9 **Embankment at south end of Golf Course looking SE (2018)**

During the 2018 inspection a flood defence embankment was encountered at Grid Reference 36549,95086, see [Plate 7](#), extending upstream along the bank of the River Dee until circa grid reference 36049,95965. In 2018 the embankment between 36617,95012 and 36465,95159 was observed to be constructed of riverbed material and the observed lack of significant vegetative cover indicated this to be of relatively recent construction. The embankment in this area stood between 1.5 and 2m above the ground behind with a crest width of 2-3m. This section of the Ballater flood defences was assessed to be in **Fair** to **Poor** condition in 2018 on account of the steep faces of the embankment and the lack of significant stabilising vegetation.

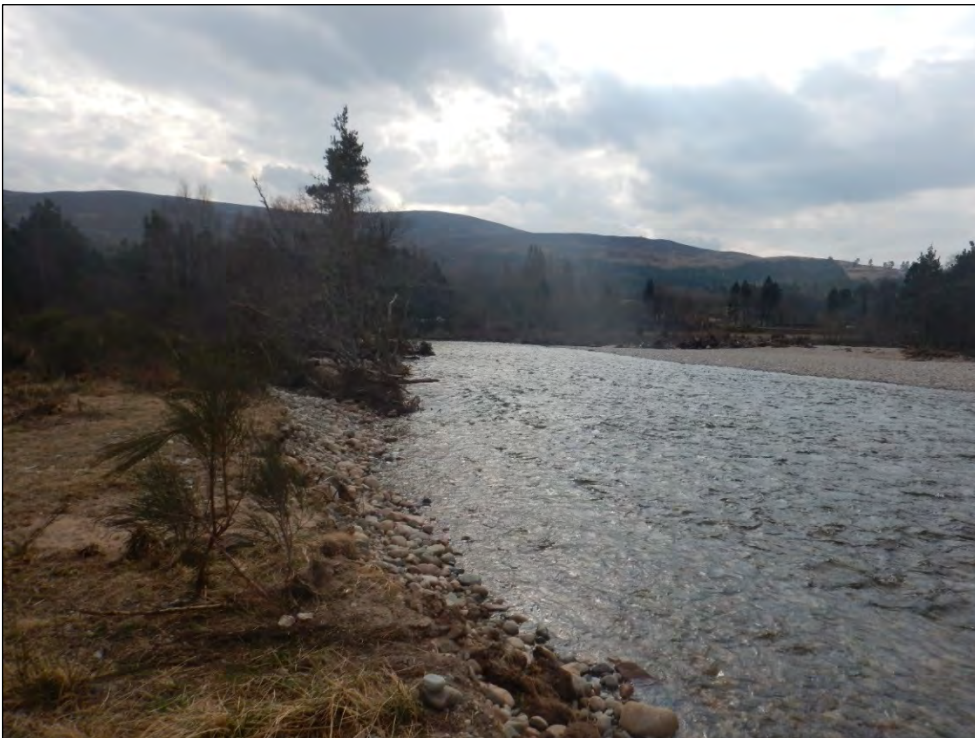
Plate 10 **View south from point at which path meets river (2022)**

During the 2022 inspection there was no evidence of this embankment, and the riverbank was encountered at 36595,95092, see [Plate 8](#), i.e. approximately 45m east of where it was in 2018. [Plate 9](#) and [Plate 10](#) show the view south from the point at which the path met the river in 2019 and 2022 respectively, and again it is noticeable that there is now no raised embankment. The change in the river course in this area is further illustrated in [Plate 11](#) and [Plate 12](#) which show the route of the main river channel to have switched from right (west, Glen Muick) side to the left (east, Ballater) side.

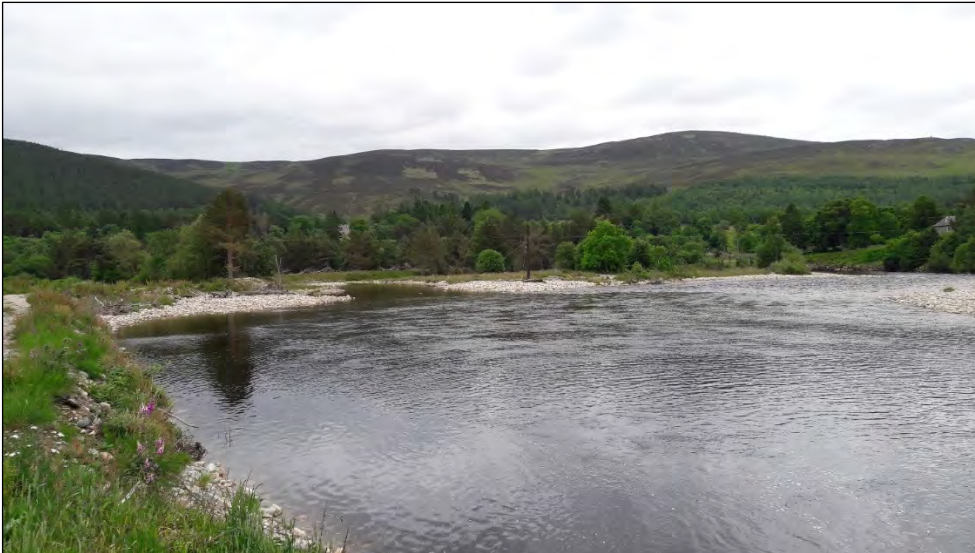
Plate 11 **General View of River Upstream of Confluence with the Muick (2018)**

It was obvious from the 2022 site visit that the main flow channel of the River Dee had migrated from the Glenmuick side to the Ballater side in the area around the confluence with the River Muick, see [Plate 11](#) and [Plate 12](#). This change in flow path has been associated with infilling of the former flow channel with riverine gravel and sand, to the extent that the feature formerly known as the Manse Pool on the Glenmuick side no longer exists, [Plate 55](#) and [Plate 56](#).

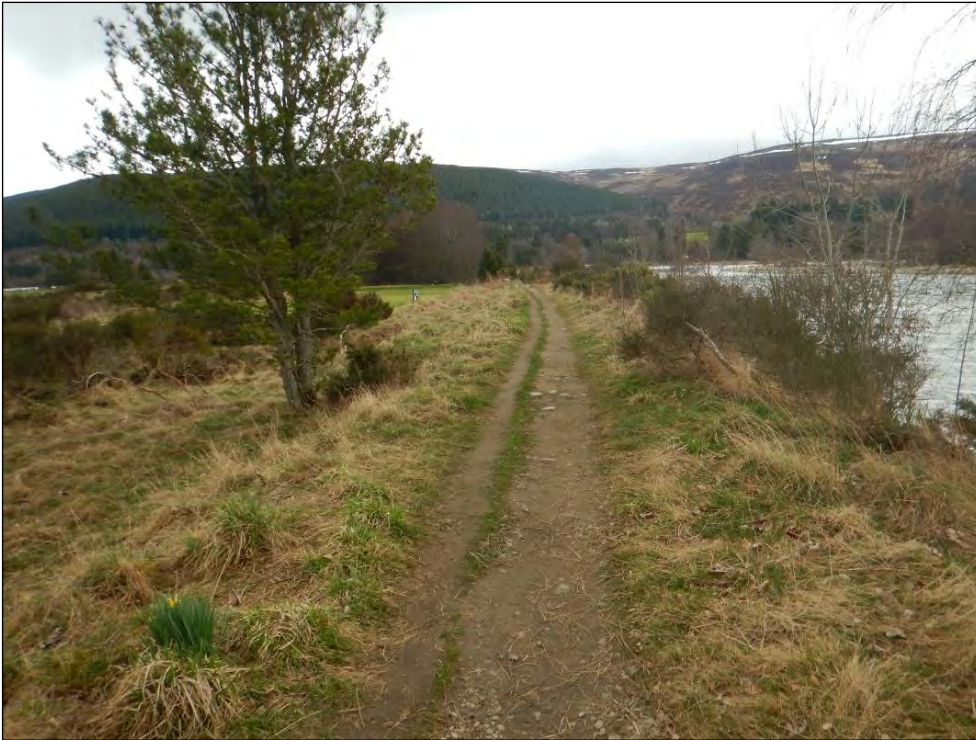
Plate 17 Typical view of embankment beyond Golf Road (2018)

Continuing westwards the 2018 inspection noted the embankment to remain in **Good** condition, [Plate 17](#) and [Plate 18](#), until approximately 36133,95261 where the river side face was observed to be partially eroded, [Plate 19](#). This was considered to most likely be due to pedestrian activity given the very localised nature of the erosion although it is possible that it was the result of the removal of a large tree and root system during recent floods. Similar images from 2022 are presented in [Plate 20](#) to [Plate 22](#) which show very little observable change from the images recorded in 2018 with the same area of damage still being visible.

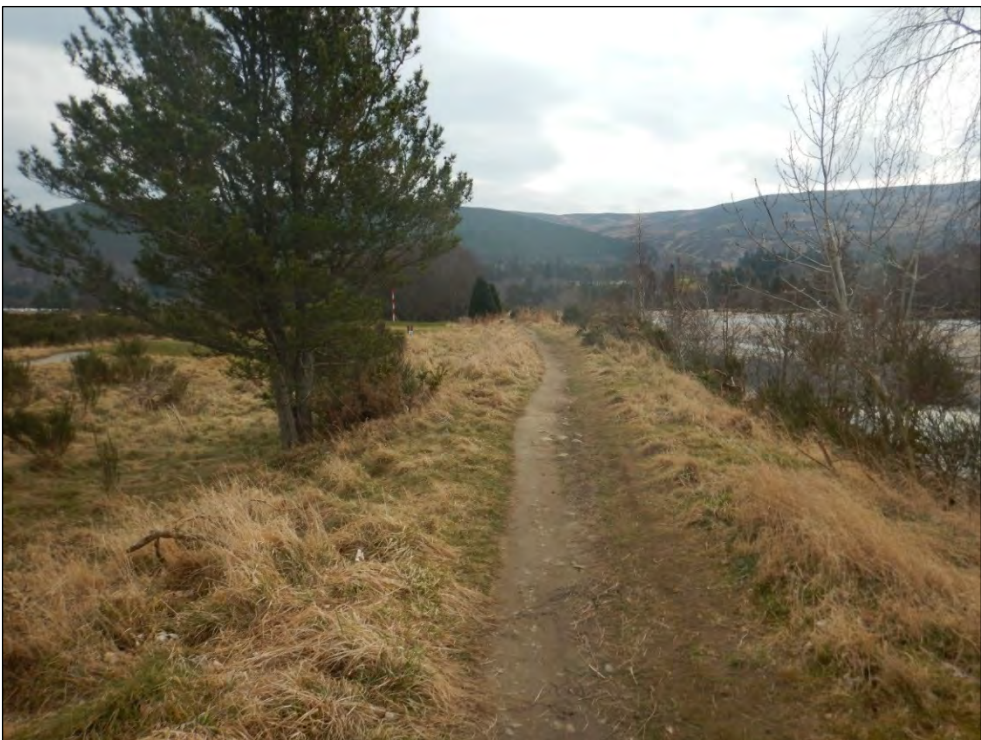
Plate 20 Typical view of embankment beyond Golf Road (2022)

This section of the embankment has a relatively low height (1-1.5m) and good crest width (circa 3m). Again, the embankment appears to have been formed from typical river/ glacial deposits with evidence of cobble visible amongst the vegetative cover. Generally, this section of the embankment is in **Good** condition, however, the damaged section was assessed as being in **Poor** structural condition due to the exposure of the core material.

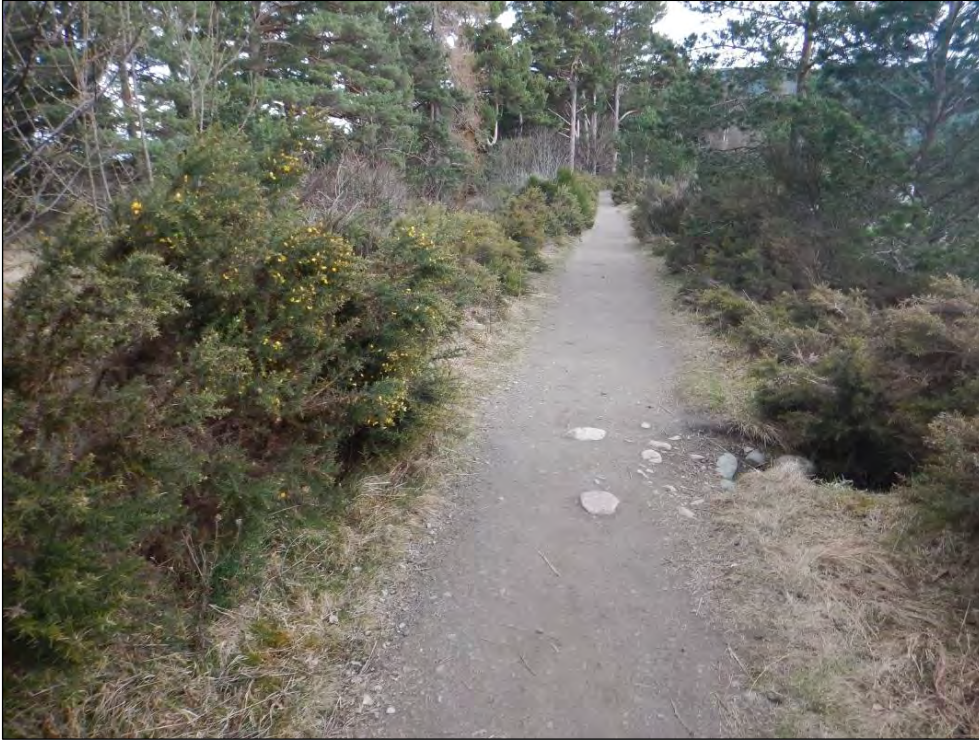
Plate 23 Pathway on embankment crest (2018)

The embankment continues in a similar form with extensive vegetation, including mature trees evident until circa 36000,95275 as shown in [Plate 23](#) and [Plate 25](#). Similar images from 2022 are presented in [Plate 24](#) and [Plate 26](#) which show little change in the nature or condition of the embankment.

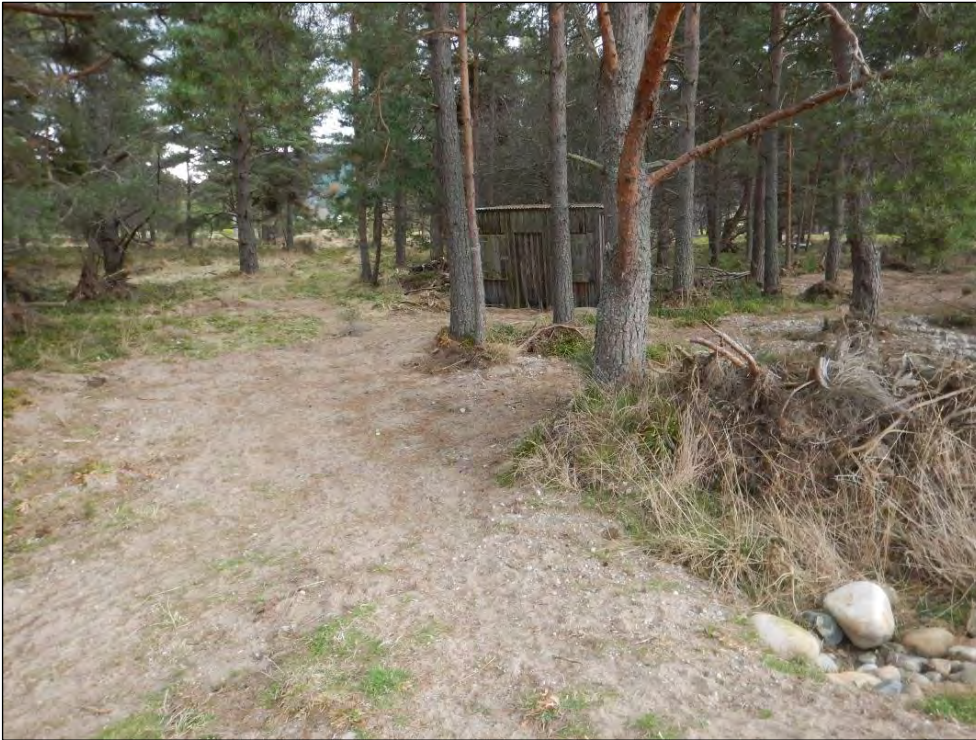
Plate 31 Riverine deposits behind embankment, including former fisherman's hut (2018)

Beyond 35005,05316 the embankment appeared to have been recently re-constructed using sand and gravel at the time of the 2018 inspection as shown in [Plate 27](#) and [Plate 29](#). These works appeared to be in response to the previous embankment having been over-topped as evidenced by the present of riverine detritus and debris scattered amongst the forest area behind, see [Plate 31](#). Equivalent images from 2022 are presented

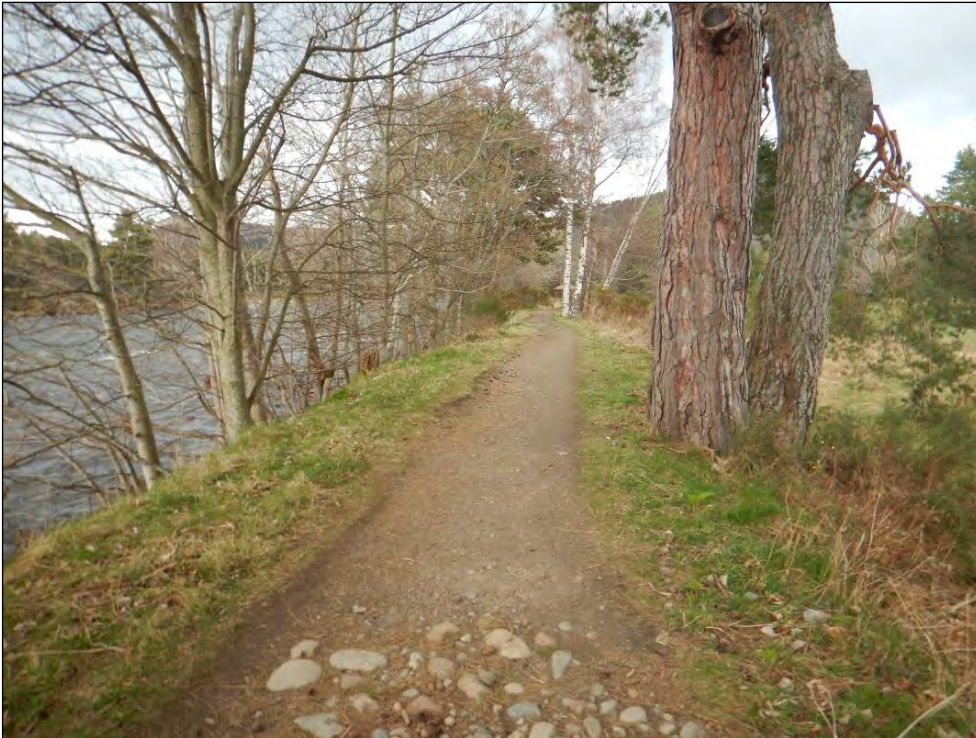
Plate 32 Typical view of embankment south of the 14th Tee (2018)

The repairs/ re-profiling of the embankment continued with some brief interruption to circa 35958,95482 beyond which it reverted to a similar vegetated form to previous sections although in this area there was more exposed cobble noted on the river side, [Plate 32](#) and [Plate 34](#). It was not obvious from the visual inspection if this was the remnants of a deliberate attempt to armour the exposed face of the embankment or simply the results of selective erosion having removed much of the finer material, however the embankment appeared relatively stable as evidenced by the presence of mature trees growing out of the river facing slope. Similar images from 2022 are presented in [Plate 33](#) and [Plate 35](#) and show little change from those taken in 2018 apart from an increase in vegetation cover.

This section of the embankment was assessed to be in **Good** condition at the time of both site inspections.

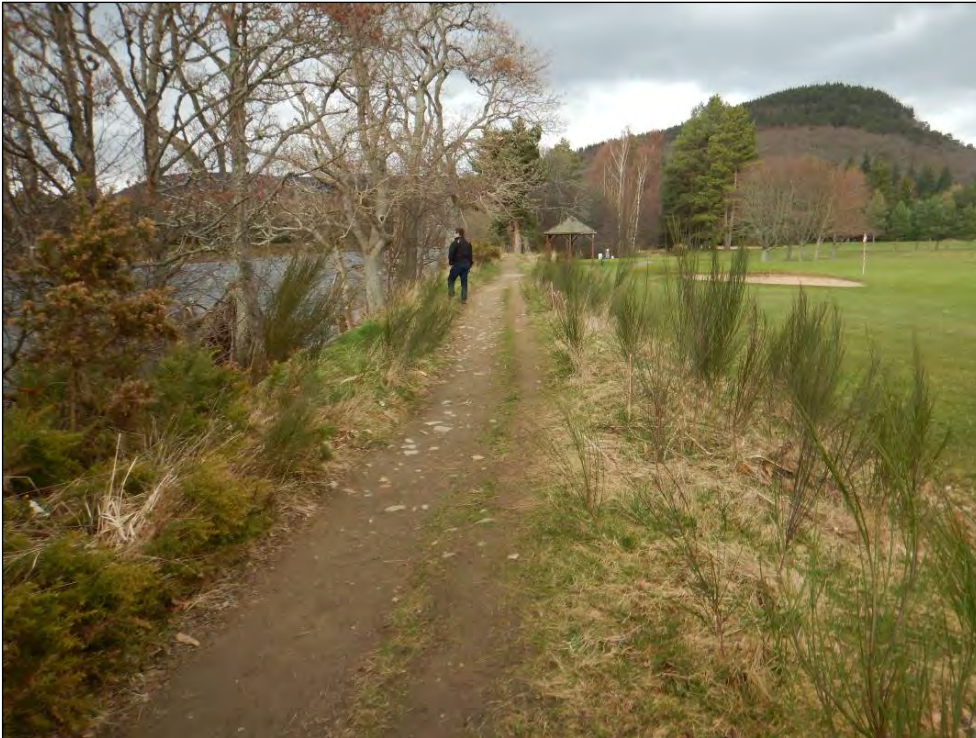
Plate 36 View of embankment approaching 14th Tee (2018)

The embankment continues in this form, [Plate 36](#) and [Plate 37](#), until the 14th Tee, where again little discernible difference was noted between the 2018 and 2022 inspections.

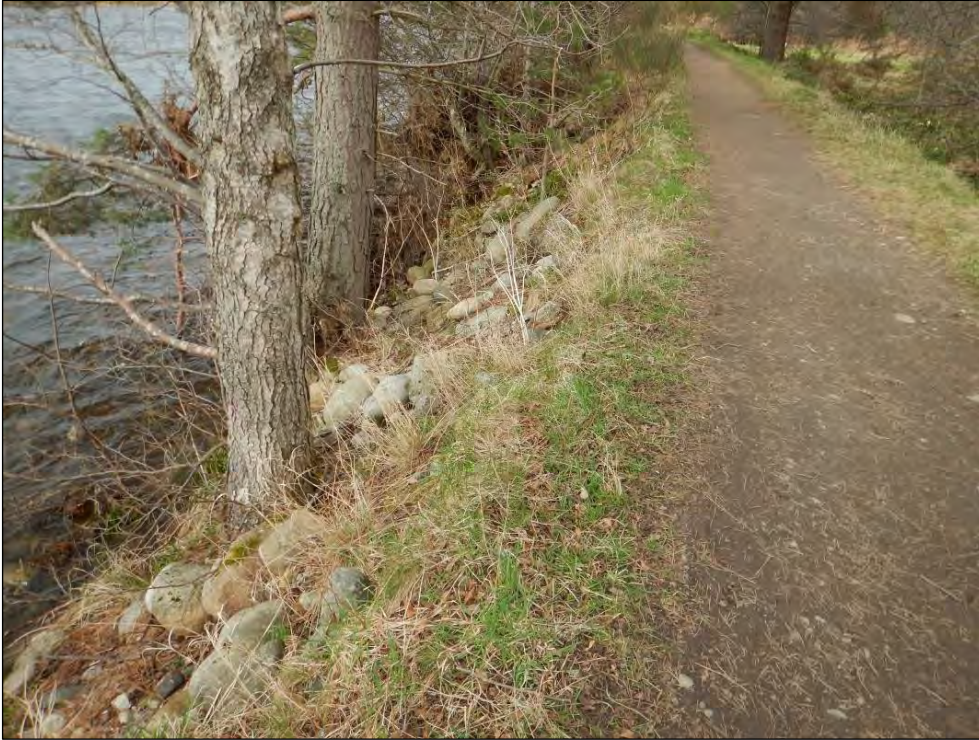
Plate 44 River face of embankment north of 14th Tee (2018)

Immediately north of the 14th Tee the landward face of the embankment is composed of built masonry as shown in [Plate 42](#) and [Plate 43](#). This form of construction may also have extended to the riverside face, however it is now interrupted by the establishment of mature trees and other vegetation as shown in [Plate 44](#) and [Plate 45](#). Generally, this section of the embankment appears to be in **Fair to Good** condition.

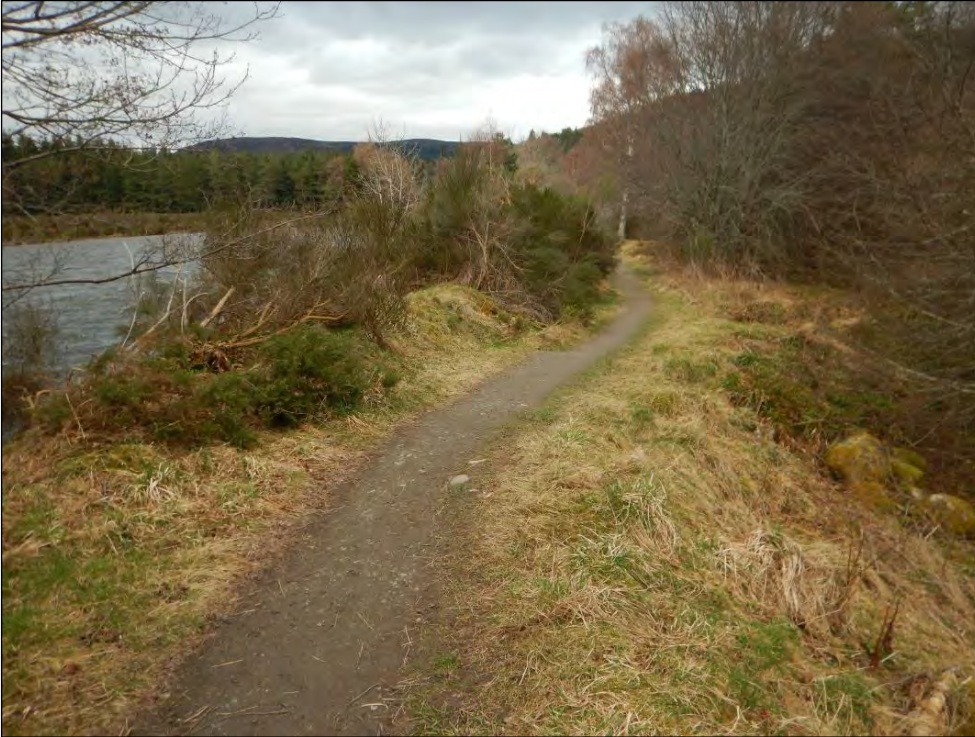
Plate 46 Transition of riverside path from top of embankment to land behind (2018)

North of approximately 36020,95756 the riverside path drops off the crest of the embankment to run along the ground behind the embankment as shown in [Plate 46](#) and [Plate 47](#) and continues like this until circa

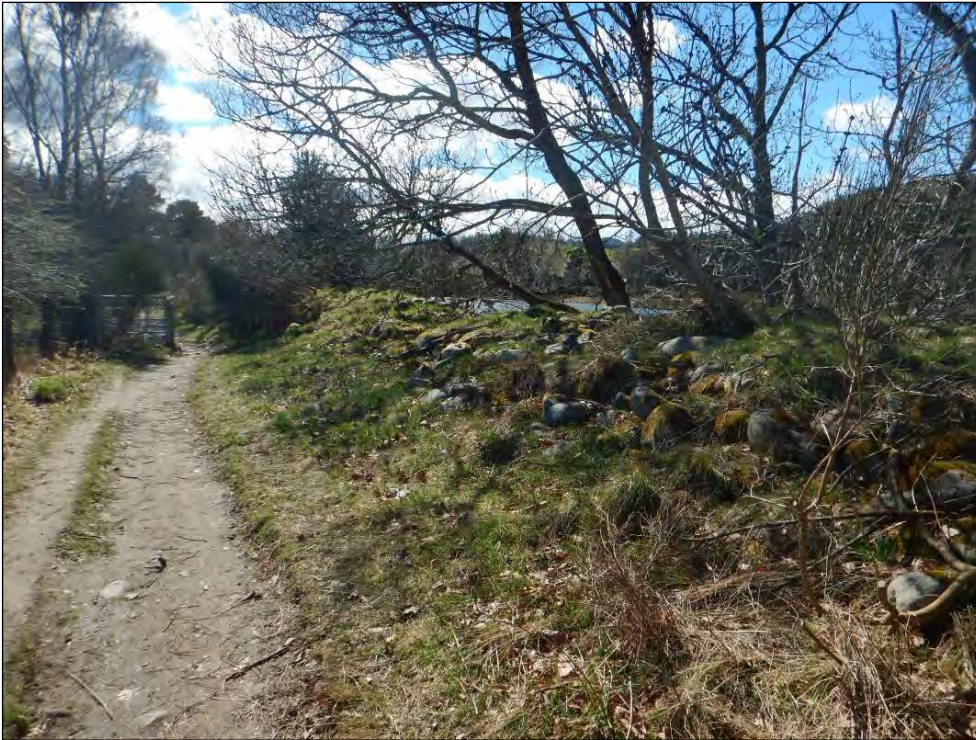
Plate 48 Typical view of embankment north of 36020,95756 (2018)

36034,95854. The embankment along this section comprised a narrow bank approximately 1.2-1.3m high with no significant crest, [Plate 48](#) and [Plate 49](#).
