# Ballater Flood Protection Scheme

Fluvial Audit Report

cbec eco-engineering UK Ltd

June 2022

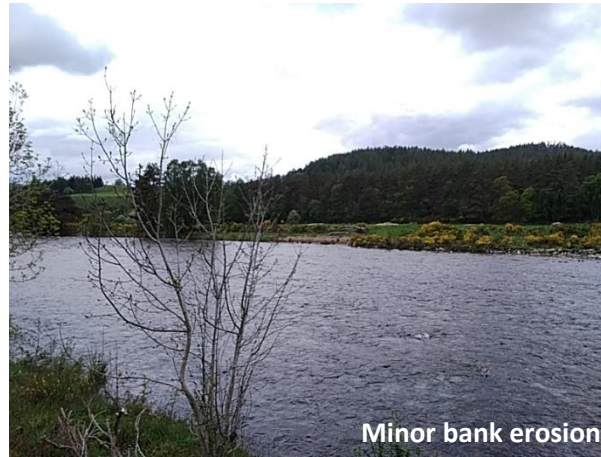
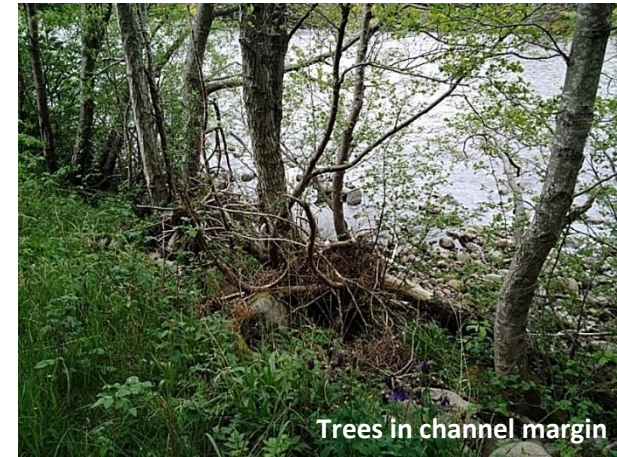
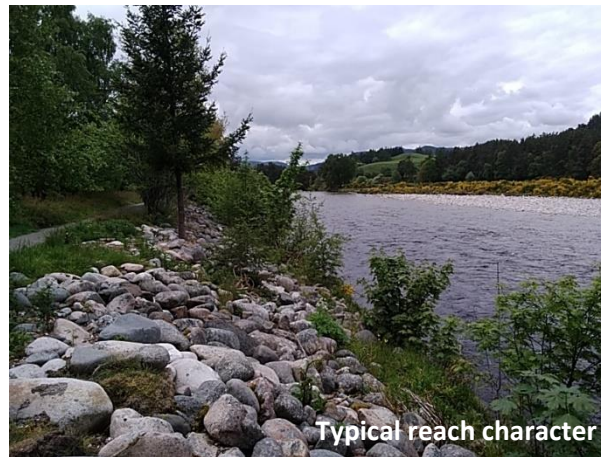
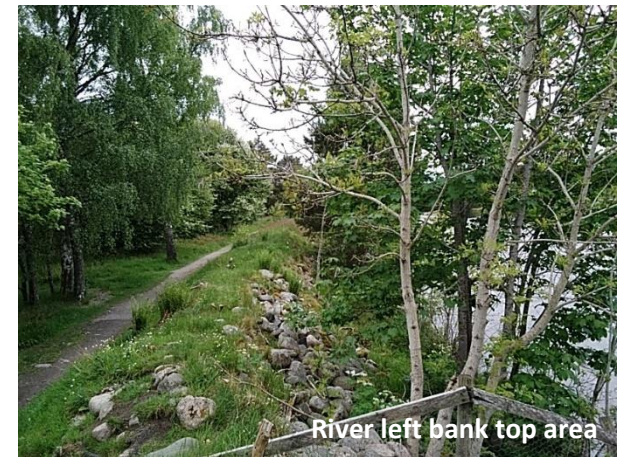
- No notable change in planform
- Still dominated by run and glide morphology, although run section more extensive
- General coarsening of bed substrate with less gravel observed now
- No notable change in configuration of alluvial bar forms (lateral bar)

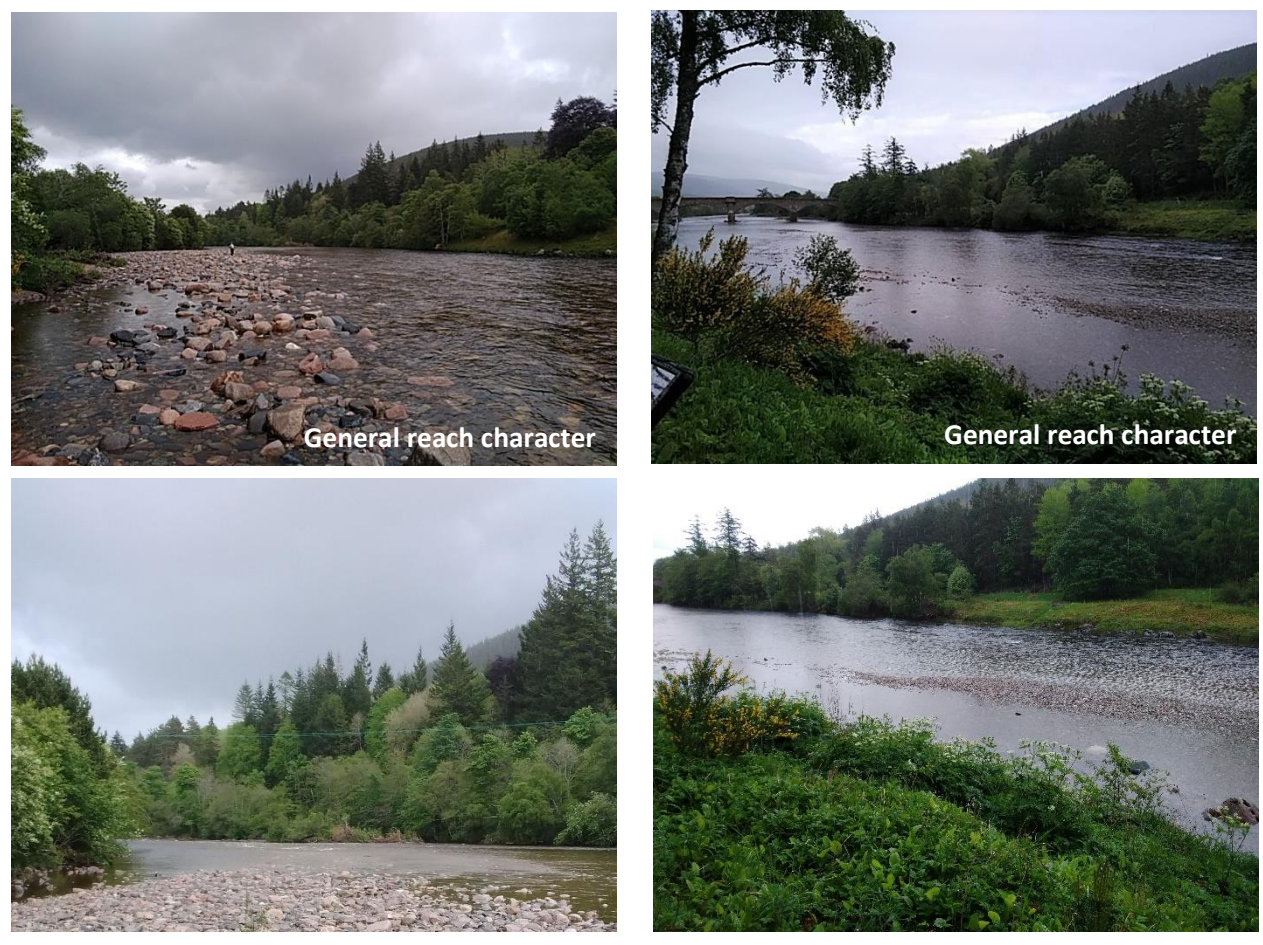
**Table 2.4. Summary of fluvial form and process: Reach 3.**

<b>River Dee at Ballater, Reach 3</b>	
<p><b>Dominant features</b></p> <ul style="list-style-type: none"><li>• Interspersed riffle, run and glide sections</li><li>• Banks generally stable and well vegetated with extensive tree cover, with little bank erosion</li><li>• Bank protection present locally</li><li>• Medial and lateral bar forms present, including vegetated island</li><li>• Bars and bed substrate dominated by cobbles and gravel in upper section and gravel downstream towards bridge</li><li>• Bed substrate generally active and clean</li><li>• Large wood generally absent except as trees in channel margin</li><li>• Channel more confined here, with steep wooded slope to river right providing constraint to lateral movement</li><li>• Caravan park and residential areas to river left</li><li>• No tributaries or drains here</li><li>• Bridge forms downstream boundary</li></ul>

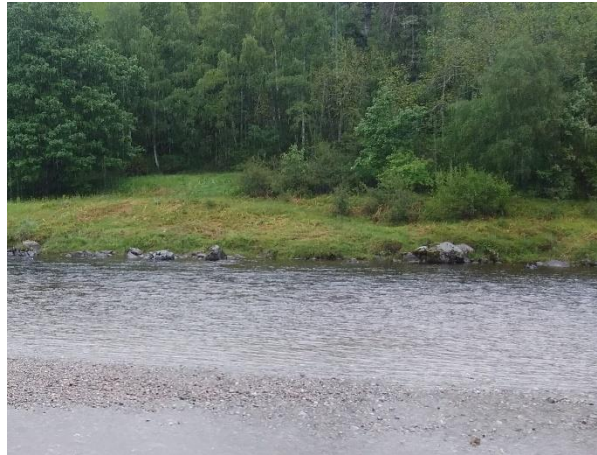
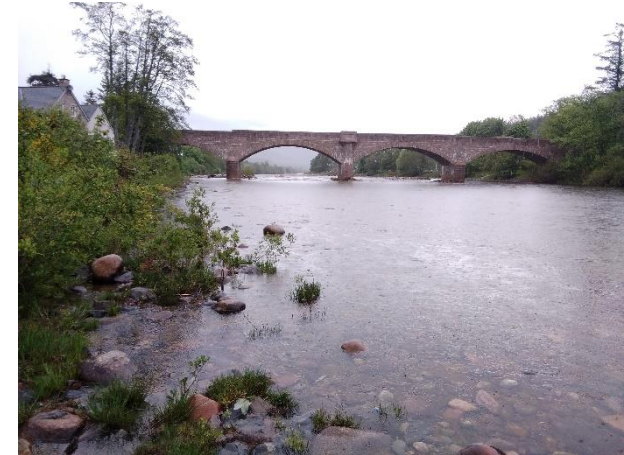
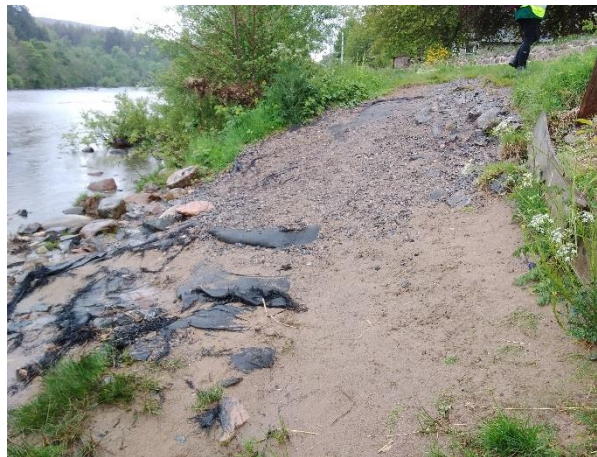
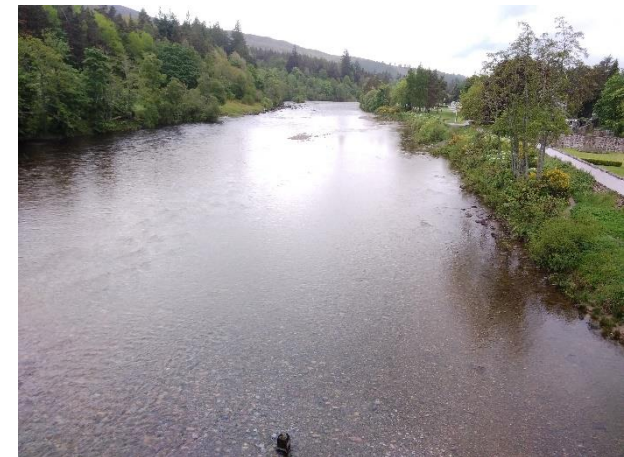
## River Dee at Ballater, Reach 3

- No notable change in planform
- No notable change in morphological units
- General fining of bed substrate with gravel dominant in section upstream of bridge
- No notable change in alluvial bar forms
